## Supplement of

# Larger lake outbursts despite glacier thinning at ice-dammed Desolation Lake, Alaska

Natalie Lützow et al.

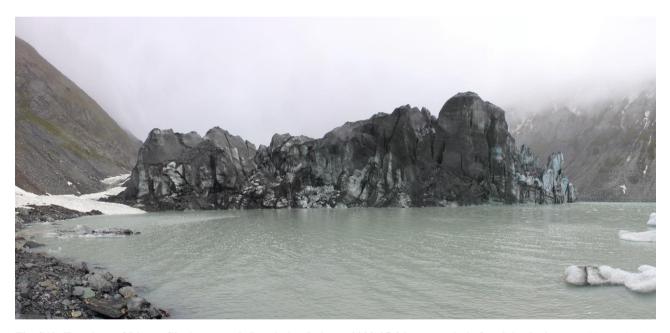
Fig. S10: Terminus of Lituya Glacier towards Desolation Lake on 2023-05-24, two weeks before lake drainage. Wide-angle photo was taken by Georg Veh. The ice front had a height of ca. 30 m above the lake level.

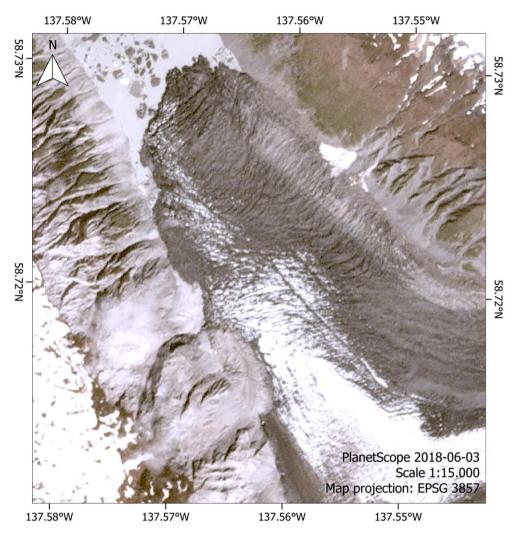
Fig S11: PlanetScope image of the ice dam on 2018-06-03 showing the flow-perpendicular crevasses and detachment of ice at the glacier front towards Desolation Lake.
