The 2020 glacial lake outburst flood at Jinwuco, Tibet: causes, impacts, and implications for hazard and risk assessment

20 **Abstract.** We analyze and reconstruct a recent Glacial Lake Outburst Flood (GLOF) process chain on 26 June 2020, involving
the moraine-dammed proglacial lake Jinwuco (30.356°N, 93.631°E) in eastern Nyainqentanglha, Tibet, China. Satellite images
reveal that from 1965 to 2020, the surface area of Jinwuco has expanded by 0.2 km² (+56%) to 0.56 km², and subsequently
decreased to 0.26 km² (−54%) after the GLOF. Estimates based on topographic reconstruction and sets of published empirical
relationships indicate that the GLOF had a volume of 10 million m³, an average breach time of 0.62 hours, and an average
25 peak discharge of 5,390 m³/s at the dam. Based on pre- and post-event high-resolution satellite scenes, we identified a large
progressive debris landslide originating from western lateral moraine, having occurred 5–17 days before the GLOF. This
landslide was most likely triggered by extremely heavy, south Asian monsoon-associated rainfall in June. The time lag between

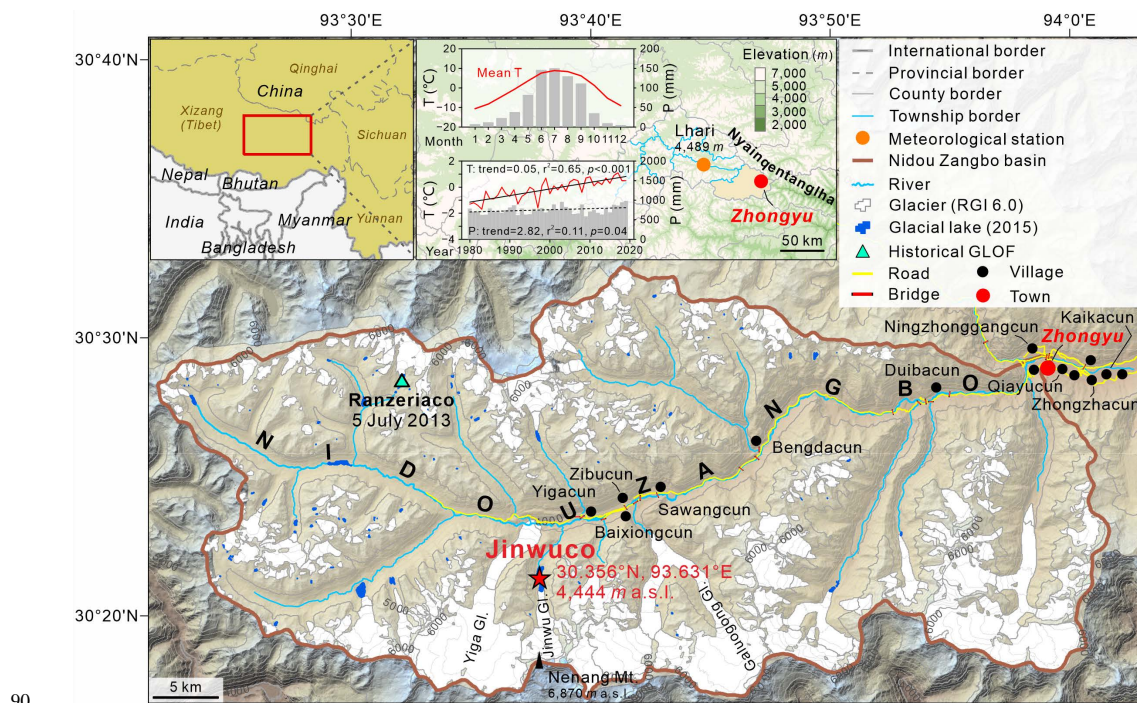
Figure 1. Location of Jinwucu and surrounding geographic features, including terrain, rivers, glaciers, glacial lakes, settlements and major infrastructures (roads and bridges) downstream. The climate statistics in the upper middle panel are based on the Lhari weather station, approx. 50 km away from Jinwucu, 1980–2019. Topographic base map is based on the DEM generated from Ziyuan-3 stereoscopic pairs. The borders and location of the villages are from © Baidu Maps.

The study area is located at the Nidou Zangbo (“Zangbo” refers to rivers in Tibetan) watershed in the eastern Nyainqentanglha, Tibet Autonomous Region, China (Fig. 1). The Nidou Zangbo originates from the eastern foothills of the Luola Mountains near the north of Zhongyu township in Lhari County with a length of 68 km (Liu, 2014) and is the right tributary of Yi’ong Zangbo. The watershed covers an area of 1,267 km² with an elevation difference of 3,715 m. The topography of the watershed
80 is high in the west and low in the east, with an average elevation of >5,000 m. Most of the peaks in the watershed reach more than 6,000 m, with the highest peak, Nenang Peak, at 6,870 m. The glacial and paraglacial landscapes are highly developed in the watershed, with a total of 294 glaciers covering a combined area of 396 km² (RGI Consortium, 2017). There are 96 glacial lakes (≥900 m²) distributed in the watershed with a total area of 3.2 km² and an average area of 0.03 km² (Zheng et al., 2020), of which the majority are moraine-dammed lakes. The watershed is part of the sub-humid monsoon climate zone of the plateau

From the administrative location, the Zhongyu township where Jinwucu is situated is part of the southeastern Lhari County, 118 km from the county seat. It contains 14 administrative villages in total. Six of them are within the middle and upper reaches of the Nidou Zangbo basin (Fig. 1).

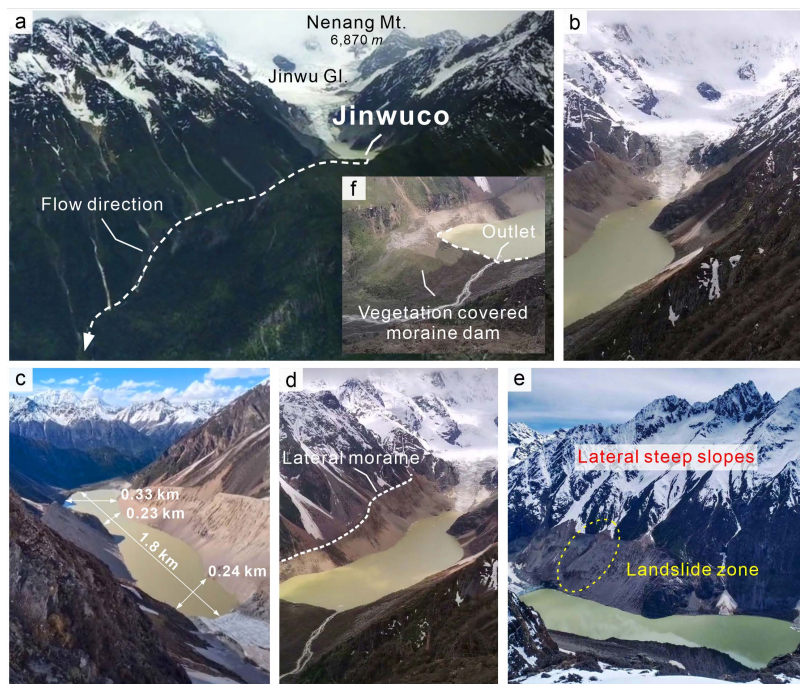
115 **Figure 2.** Overview of Jinwuco before the collapse of the dam. (a) An overall view of Jinwuco and surroundings taken from the opposite side. (b) Crevassed hanging glacier ice terminated in Jinwuco, taken from front to back. (c) Morphological parameters of Jinwuco, photo taken from back to front. (d) Lateral moraine and steep mountain slopes from right to left and (e) from left to right. (f) Vegetation covered moraine dam and the position of the outlet. Photos: Q. Quying (used with permission).

Jinwucu (also known as Jiwengco, 30.356°N, 93.631°E) is a proglacial moraine-dammed lake (Fig. 2) which is also the largest glacial lake within the Nidou Zangbo basin (Zheng et al., 2020). It is situated at the terminal of the Jinwu Glacier that covers an area of 7.9 km² and the lake is in contact with the steep ice tongue. The ice tongue enters the lake about 350 m below the steep ice cliff that has a height of approx. 250 m and an average slope of 35° measured based on the satellite scene and DEM acquired on 25 August 2020 (Table 1). The main axis of the lake is oriented in a north-south direction, flanked by steep slopes and lateral moraines. The average height of the lateral moraines is over 100 m and the slopes are about 40°. The upper end and both lateral moraine slopes surrounding the lake are seasonally snow-covered, with an ablation period from April to September and an accumulation period from October to March. The lake shows a typical elongated irregular oblong shape with a straight-line length of approx. 1.8 km and its width varies in different positions. Before the GLOF of 26 June 2020, it exhibited wider front and rear sections and a narrow middle section, with the section near the dam being 0.33 km wide. The part near the glacier is 0.24 km and the middle section is about 0.23 km wide. The dam of the lake is formed by a vegetation-covered terminal moraine, and has a length of about 400 m perpendicular to the streamline with an average slope of the distal (outer) face of 20° and an average height of 10 m. The outlet channel is located on the western side of the moraine dam where there is a permanent surficial outflow (i.e. dam freeboard = 0 m).

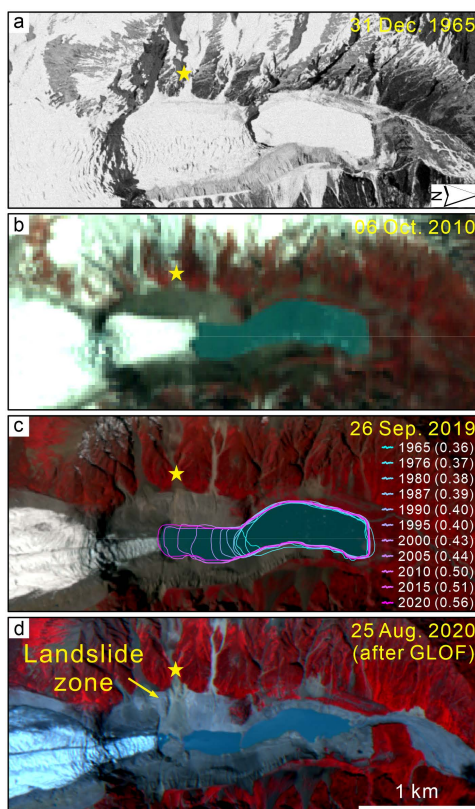
Figure 3. Satellite images documenting the evolution of Jinwucuo during 1965–2020 and the location of the debris landslide. The lake area in parentheses of panel (c) is given in square kilometers. The backgrounds are from Corona KH-4A, Landsat-5 TM, Sentinel-2A and Ziyuan-3, respectively.

Historical satellite images reveal that Jinwucuo has undergone significant areal expansion since 1965 (Fig. 3). In 1965, its surface area was $0.36 \pm 0.003 \text{ km}^2$. By 10 May 2020, the lake area has increased to $0.56 \pm 0.02 \text{ km}^2$, showing an increase of approx. 56% relative to 1965 (Fig. 4). Overall, the surface area of Jinwucuo shows a non-linear growth trend from 1965 to 2020 – with an accelerated growth rate observed from 1995. Importantly, the rear part of the lake, where the landslide deposited, is shown to have developed since 2010 (Fig. 3). After the GLOF event on June 26, 2020, the lake area is reduced by approx. 54% to $0.26 \pm 0.01 \text{ km}^2$ (Fig. 4).

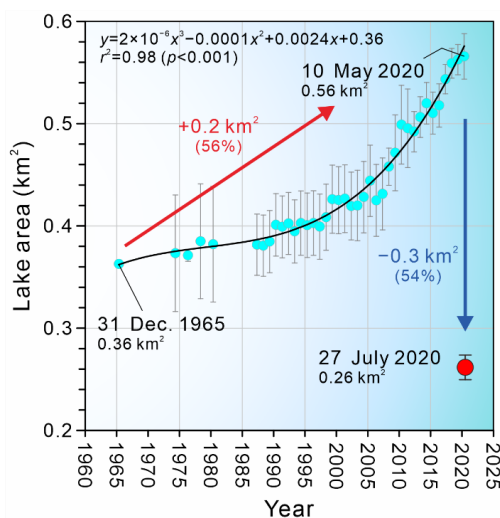
245 **Figure 4. Inter-annual dynamics of Jinwuco during 1965–2020 (prior to the GLOF), and the abrupt decrease in lake area after the GLOF.**

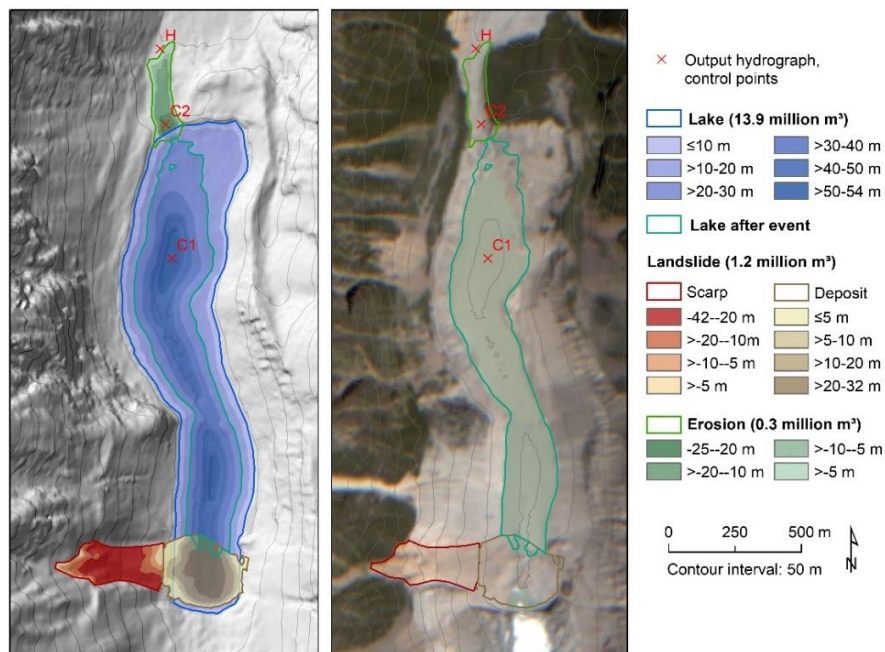
Figure 5. Reconstruction of the lake depth, landslide, and breach of the moraine dam. Base map is shaded relief map (left) based on the DEM generated from Ziyuan-3 stereoscopic pairs, and the Ziyuan-3 satellite scene (right) acquired on 25 August 2020.

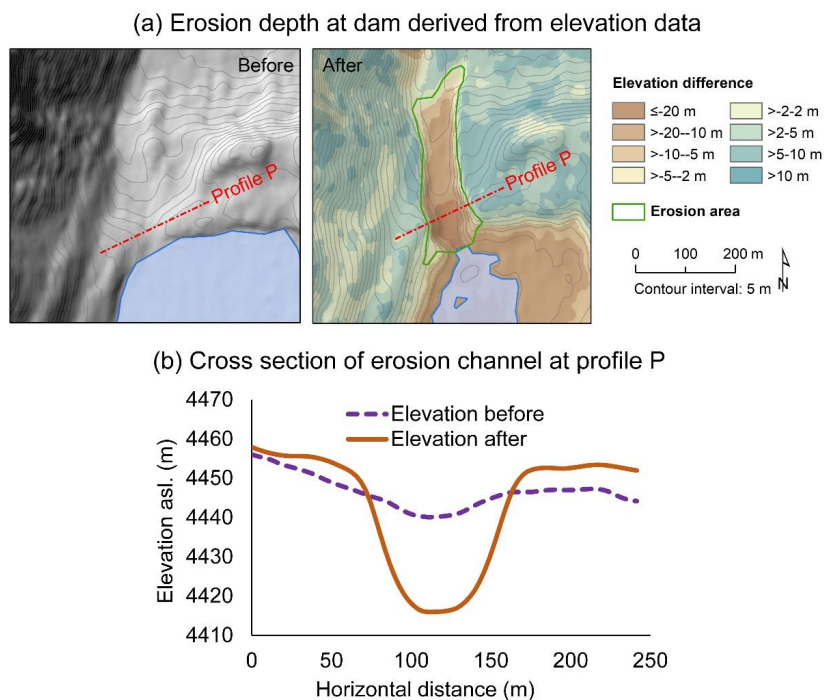
290 **Figure 6.** Breach of the moraine dam of Jinwuco. (a) Situation before and after the event of 26 June 2020, with difference in elevation between the DEMs derived before and after the event. (b) Cross section along the profile P (see (a)) before and after the event. Topographic base map is based on the DEM generated from Ziyuan-3 stereoscopic pairs.

before the breach. However, as it is clearly shown in Fig. 6, there is a vertical offset between the pre- and post-event DEMs, limiting the accuracy of the estimates. Even though the offset is not constant in space, it is likely that the pre-event DEM would have to be uplifted in the area of the terminal moraine, relative to the post-event-DEM, to bring the two in line, which would increase the maximum breach depth by up to approx. 7 m. However, the data basis is too insufficient to justify such a correction.

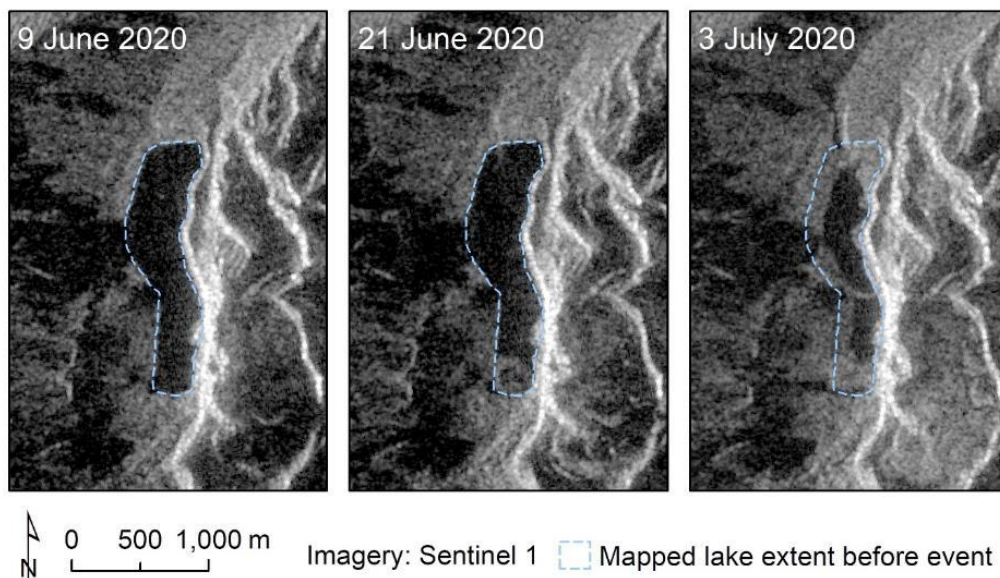
295 **Figure 7.** Sentinel-1 radar satellite images of Jinwuco and surroundings representing the situation on 9 June, 21 June, and 3 July 2020.

Analysis of the Sentinel-1 radar imagery reveals that landslide activity impacting the lake has started already in the period between 9 June and 21 June 2020 (Fig. 7). The pattern in the rear part of the lake visible in the scene of 21 June most likely represents a landslide deposit, possibly of significant size, even though the available data do not allow for volume quantification at this point. However, a scenario whereby the GLOF process chain was maybe not directly triggered by the landslide appears likely (Section 3.5 and Section 5.1).

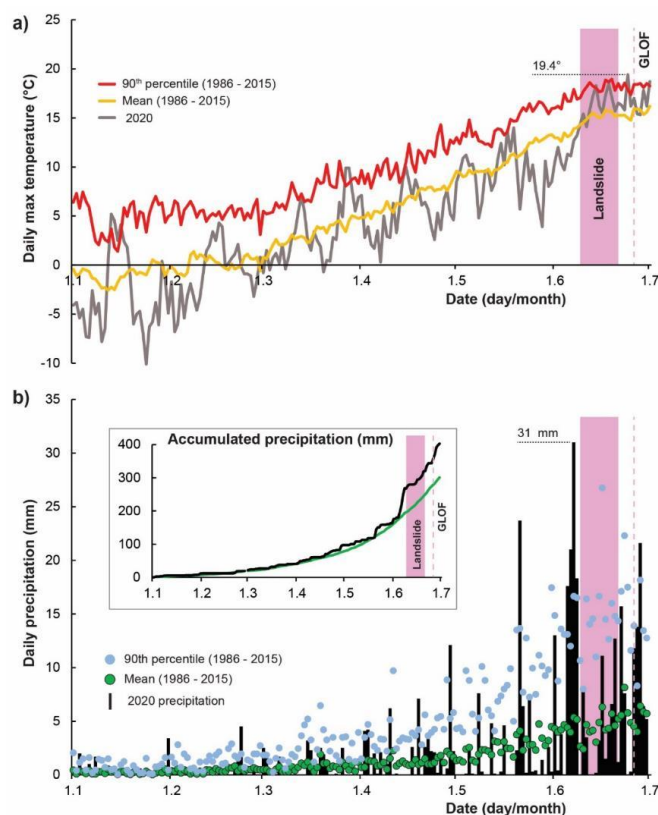
315 **Figure 8.** Meteorological conditions from January - June 2020, measured at the Lhari weather station, compared to the longer-term climatology (1986–2015).

When compared to the longer-term climatology it becomes immediately obvious that the landslide and GLOF process chain at Jinwuco occurred during a period of unusually warm and wet weather (Fig. 8). Over the dry winter and into the pre-monsoon months, precipitation measured at Lhari station was consistent with the longer-term mean, as seen in the accumulated totals (Fig. 8b). However, through May and particularly June 2020, notable periods of extremely heavy precipitation occurred, regularly exceeding 90th and even 95th percentile levels. In June, the 1986–2015 average precipitation total was 141 mm, compared to 240 mm in 2020, corresponding to an anomaly of +70%. A particularly wet period is observed from 5–8 June 2020, with a total of 88 mm and a daily maximum of 31 mm of precipitation on 7 June 2020. This wet period directly preceded the time window in which the landslide into the lake is identified in Fig. 7 (Section 4.2). Temperatures transitioned from unusually cold conditions in late May and early June (preceding the landslide window), to anonymously warm temperatures from mid-June onwards, peaking at an extremely warm daily maximum of 19.4°C on 24 June, immediately prior to the GLOF event. During the cold period prior to the landslide window, minimum temperatures were at or below freezing, suggesting some of the heavy precipitation from 5–8 June would have fallen as snow around Jinwuco. Subsequent gradual snowmelt could provide a plausible explanation for the lag between this heavy precipitation episode, landslide initiation, and eventual moraine breach, given that the GLOF event was preceded by two relatively dry, yet warm days (Fig. 8a).

While the available evidence does not permit to exclude any single hypothesis, the meteorological conditions in June 2020 (Fig. 8) strongly supports the third hypothesis. We consider it likely that the extremely high precipitation in the period from 5–8 June has triggered slope instability in the western lateral moraine area. However, this has not resulted in immediate rapid failure, but rather delayed, gradual landslide processes, as supported by the evidence. Further rainfall and snowmelt under
455 unusually warm conditions after 8 June may have enhanced this gradual destabilisation of the moraine. The rather dry and extremely warm conditions immediately prior to the GLOF may have resulted in increased melting and thawing processes, possibly triggering new instabilities (including calving) into the lake and/or an increased lake level, leading to the final tipping point of a system which had already been at the verge of collapse.

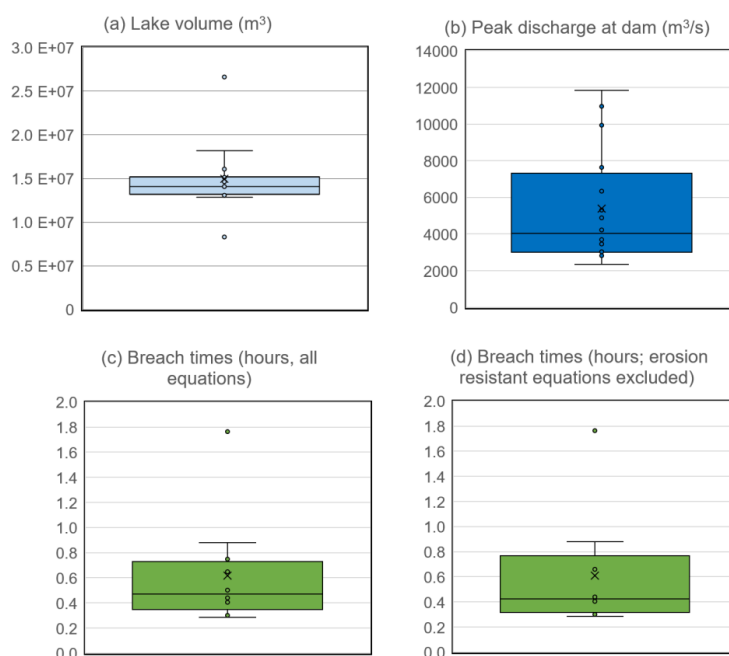
330 **Figure 9.** Lake, dam breach and flood parameters, derived from sets of published empirical relationships. (a) Volume
of Jinwuco. (b) Peak discharge at the dam. (c) Breach time, considering all available equations. (d) Breach time,
considering only those equations derived for easily erodible dams (an assumption we consider likely to hold for the dam
of Jinwuco).

Out of 15 lake volume equations, 13 yielded meaningful results, ranging from 8.3 to 26.6 million m³. Mean calculated lake
320 volume is 15.0 million m³ and the median value is 14.1 million m³. This compares favorably to a reconstructed volume of 13.9
million m³ used in the process chain simulations (Section 3.6). The first (Q1) and the third quartile (Q3) are 13.2 million m³
and 15.2 million m³ respectively (Fig. 9a). Accordingly, calculated mean depth of the lake ranges from 14.8 to 47.6 m (average
mean depth 26.7 m, median mean depth 25.2 m, Q1 is 23.6 m and Q3 is 27.2 m). Calculated breach times range from 0.28 to

1.76 hours, with 11 out of 12 calculated values suggesting a breach time <1 hour, with the mean value of 0.62 hours and a
325 median of 0.47 hours (0.61 hours and 0.43 hours, respectively, if equations for erosion resistant dam are excluded; Fig. 9c, d).
Calculated peak discharge at the dam ranges from 2,354 m³/s to 11,832 m³/s. The average value of calculated peak discharges
is 5,390 m³/s while the median is 4,406 m³/s. Q1 and Q3 are 3,029 m³/s and 6,662 m³/s respectively (Fig. 9b).

340 initiating retrogressive erosion. This time span is well within, even though in the lower part, of the range revealed in Fig. 9d. After the breach has developed to its full depth, lake drainage continues and asymptotically approaches the level of the eroded gully, which is almost reached after two hours (Fig. 10a). The peak discharge associated with the landslide-induced impact wave reaches $10,900 \text{ m}^3/\text{s}$ after 100 s (computed at a higher temporal resolution, therefore not visible in Fig. 10b). Afterwards, discharge decreases and then increases again due to retrogressive erosion of the moraine dam. The simulated peak discharge during the retrogressive erosion stage reaches $5,000 \text{ m}^3/\text{s}$ at $t = 24$ minutes, being well within the range indicated in Fig. 9b. With dropping lake level, the simulated discharge slowly decreases to a small residual value after two hours (Fig. 10b). At all stages, the simulated flow is dominated by water, with a peak of approx. $240 \text{ m}^3/\text{s}$ of solid discharge at $t = 19$ minutes, when retrogressive erosion is the most intense.

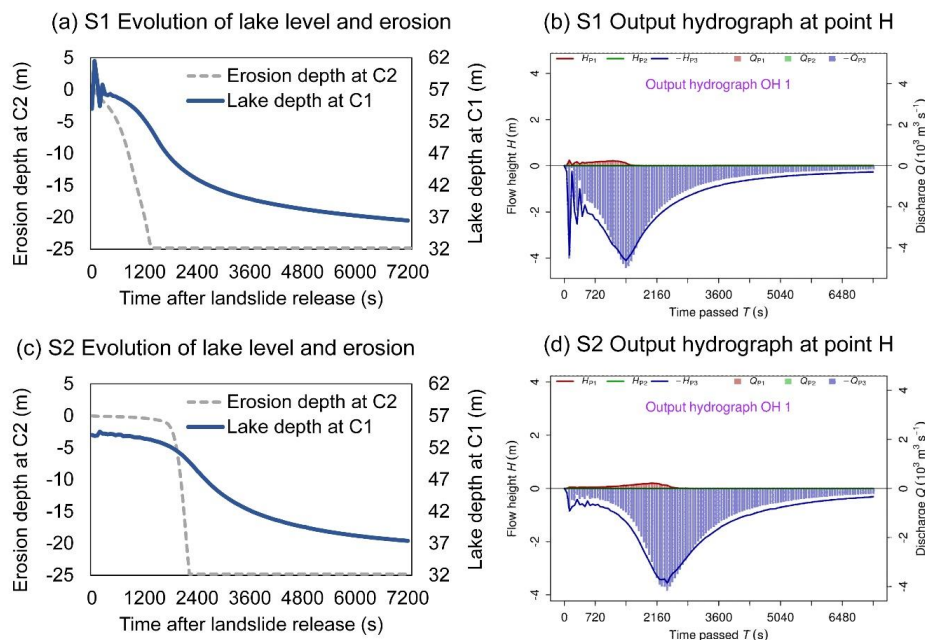
Figure 10. Dam breach as simulated with r.avaflo. (a) Scenario 1, evolution of lake level and the erosion channel. (b) Scenario 1, output hydrograph. (c) Scenario 2, evolution of lake level and the erosion channel. (d) Scenario 2, output hydrograph. Locations of the points C1, C2, and H are indicated in Figure 5 and Figure 11.

355 The patterns yielded with the simulation of Scenario B (Fig. 9c and d) are similar in general, with the exception of the initial impact wave that is only observed in Scenario A. However, onset of erosion takes more time, so that the breach and associated emptying of the lake are delayed. The tipping point where slight channel erosion turns into a rapid dam breach occurs at approx. 30 minutes after the start of the simulation. Thereafter, the base level of the erodible material is reached at $t = 37$ minutes (0.62 hours – within the range indicated in Fig. 9d). The peak discharge of $4,200 \text{ m}^3/\text{s}$ is reached at $t = 40$ minutes. As is also the case in Scenario A, the flow is entirely dominated by fluid: solid discharge peaks at $210 \text{ m}^3/\text{s}$ at $t = 36$ minutes. Emptying of the lake continues at a decreasing rate afterwards. The lake level has dropped by 18 m after two hours, meaning that the final drop of 20 m has not yet been reached.

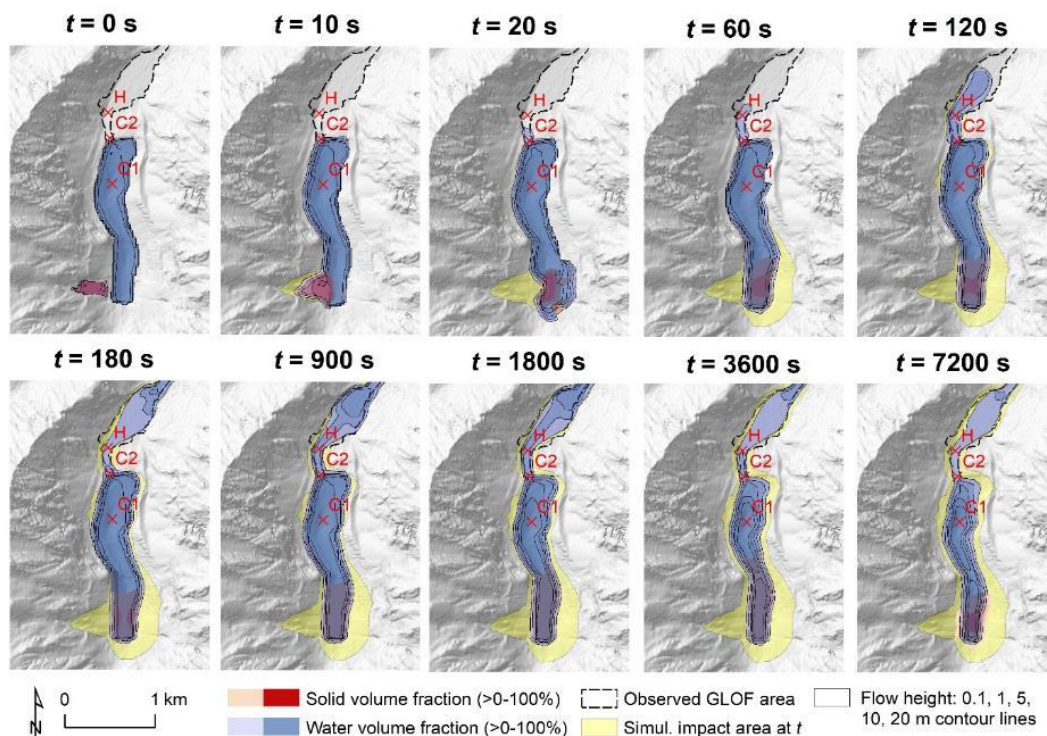
380 **Figure 11. Scenario A: evolution of flow height and GLOF impact area as well as solid and water volume fractions during the first two hours of the event, as simulated with r.avaflow. Only the section until the floodplain immediately downstream of the moraine dam is considered in this simulation. Base map is shaded relief map based on the DEM generated from Ziyuan-3 stereoscopic pairs.**

Fig. 11 illustrates the evolution of the GLOF process chain for Scenario A (Section 3.6). This simulation only considers the section until the floodplain downstream of the moraine dam of Jinwuco. Initially, the landslide impacts the lake ($t = 10$ s), inducing a push wave that runs up the opposite slope ($t = 20$ s). The minor outflow at the moraine dam represents the usual surficial lake drainage and is not related to the landslide impact. The impact area shown at $t = 60$ s and the increased lake width near point C1 reveal the evolution of the impact wave towards the front of Jinwuco. Still, at this point there is no major signal of the impact wave at the outlet of the lake. The maximum height of the impact wave at C1, with 8.5 m, is reached at $t = 70$ s. At $t = 85$ s, a sudden increase of flow height at the point C2 from 0.4 m to 9.7 m within 10 s indicates the onset of overtopping. Retrogressive erosion takes place along the main outflow channel, induced by the signal of the initial impact wave. Some of the wave energy is reflected at the shore of the lake towards the terminal moraine, so that a secondary wave with a height of 5.4 m passes through C1 at $t = 125$ s. Linear retrogressive erosion of the moraine dam leads to a continuous lowering of the base of the outflow channel, and consequently, lowering of the lake level. Two hours after the onset of the initial landslide, the lake has shrunk to both a size and level which come close to the post-event observations. Until this point of time, approx. 9.2 million m^3 of water have drained through the hydrograph profile at point H (Fig. 10), according to the simulation. The simulated impact area on the floodplain immediately downstream of the dam corresponds fairly well to the observed impact area in that section.

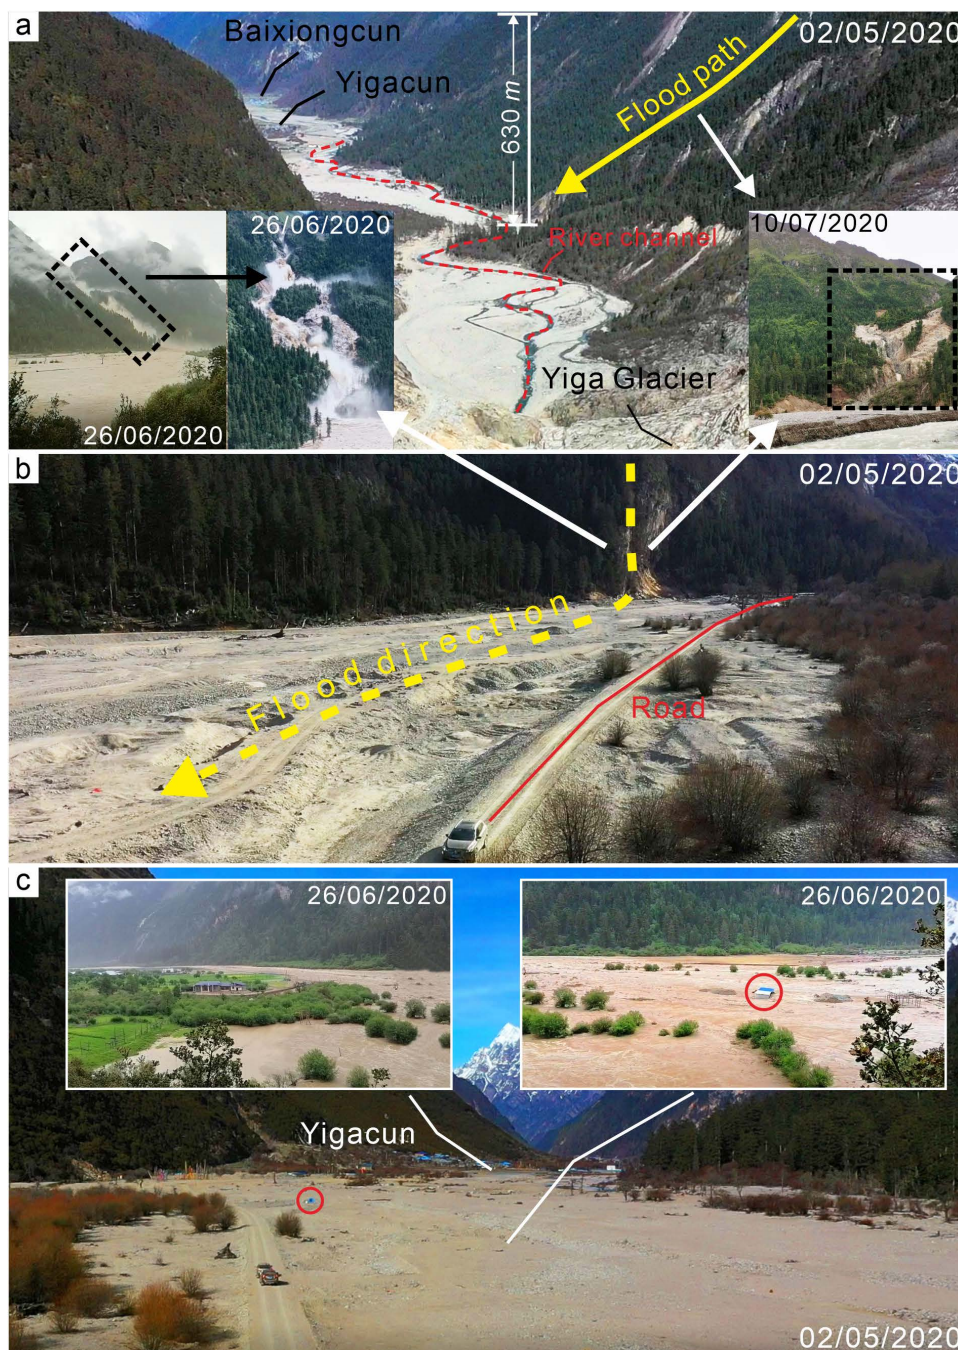
Figure 12. The situations in the valley and river channel below Jinwucu before, during, and after the GLOF. (a) Photo taken from Yiga Glacier looking to Yigacun. Insets showing the situations in the valley during and after the GLOF (photos: Q. Quying and Y. Quzhen). (b) The river channel and road before the GLOF taken from Yigacun looking upstream. The yellow dashed line is the flood flow direction. (c) A view taken from upstream looking to Yigacun. Insets showing the situations in the river channel during the GLOF (photos: Q. Quying). Aerial photos from 2 May 2020 were taken by K. Liang.

Fig. 12 shows the valley and river channel below Jinwuco before, during and after the GLOF. It is evident from the comparison of the photographs that the floodwaters almost inundated the wide river valley downstream and reached the location of Yigacun, located in a relatively high position. The large elevation difference between the surface of Jinwuco and the downstream river channel (approx. 630 m) provides significant potential energy, setting the stage for enhanced erosion and greater damage. Further, the flood caused severe erosion of the lower valley and alteration of the river channel below through the formation of alluvial fans. Fig. 13 gives a picture of the situation during the flood further downstream at the location of Zhongyucun. The aerial photograph shows that the massive impact of the flood washed away roads, bridges and put some buildings along the river at risk. The Zhongyu township has experienced rapid development and expansion of infrastructure over the past fifteen years (some examples are shown in Fig. 14). Such development has increased the level of exposure to potential GLOFs, as shown in Fig. 13c: these buildings were constructed recently in areas located directly on the riverbanks and exposed to flooding.

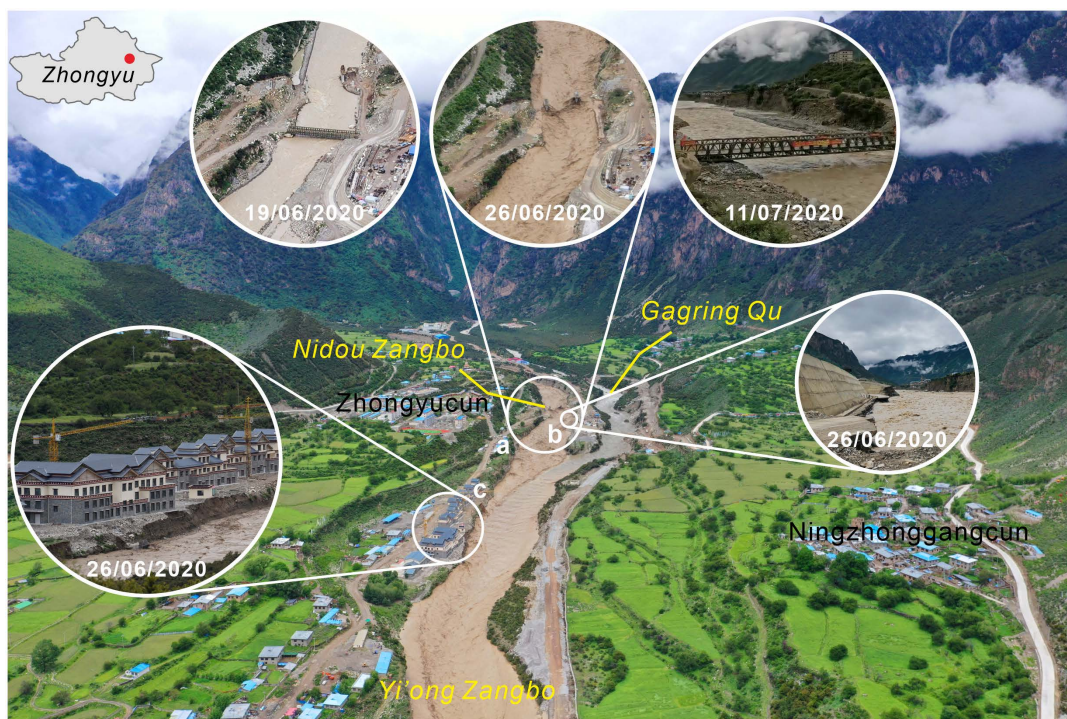
Figure 13. Examples of GLOF damage to downstream infrastructure and buildings at the confluence of Nidou Zangbo and Gagring Qu. Background aerial photo by H. Li taken on 26 June 2020. (a) Comparison of the bridge connecting Zhongyucun and Ningzhonggangcun before, during (photos: H. Li) and after the GLOF (rebuilt, photo: K. Ma). (b) Destroyed roads (photo: H. Li). (c) Affected buildings at risk (photo: H. Li).

According to the news report from the Lhari Radio and Television Station on 15 July 2020, this GLOF event caused severe destruction to villages and infrastructure to various degrees on both sides of the downstream river. The destruction consists mainly of damage to buildings, roads, bridges, or farmlands, just to name a few (detailed statistics are provided in Table 3). Fortunately, this event did not lead to any fatalities or injuries largely because it took place during the daytime, and the villagers collecting medicinal herbs upstream observed the flood and promptly informed the downstream villages to evacuate. The affected area includes almost all the villages on both sides of the river, especially Baixiongkun and Zibucun. These were also the most affected by the 2013 Ranzeriaco GLOF (Fig. 1; Liu, 2014). The power of the flood is noticeably weakened after its confluence with the Gaging Qu in the Zhongyucun and hence does not result in much damage to areas further downstream. This flood damaged a major proportion of 43.9 km of roads between Yigacun and Zhongyu township (Fig. 1; Fig 12), as well as the only steel bridge to the township office (Fig. 13a), which caused certain difficulties for timely emergency rescue operations.

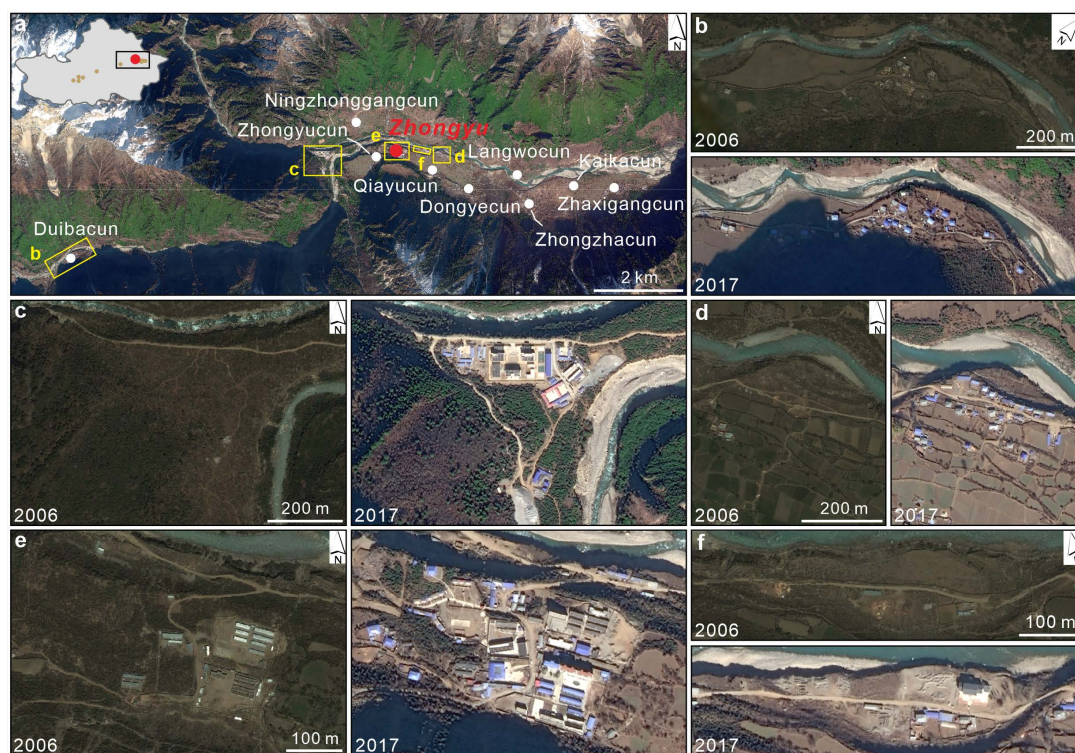
Figure 14. Examples of rapid development and expansion of the villages of lower Zhongyu township during 2006–2017. The background of panel a and the satellite scenes for 2017 panels are a true-colour composite Gaofen-2 image acquired on 7 December 2017. The satellite images for the 2006 panels are from © Google Earth acquired on 30 April 2006.
