The 2020 glacial lake outburst flood at Jinwuco, Tibet: causes, impacts, and implications for hazard and risk assessment

Abstract. We analyze and reconstruct a recent glacial lake outburst flood (GLOF) process chain on 26 June 2020, involving the moraine-dammed proglacial lake – Jinwuco (30.356° N, 93.631° E) in eastern Nyainqentanglha, Tibet, China. Satellite images reveal that from 1965 to 2020, the surface area of Jinwuco has expanded by 0.2 km² (+56 %) to 0.56 km² and subsequently decreased to 0.26 km² (−54 %) after the GLOF. Estimates based on topographic reconstruction and sets of published empirical relationships indicate that the GLOF had a volume of 10 million cubic meters, an average breach time of 0.62 h, and an average peak discharge of 5602 m³/s at the dam. Based on pre- and post-event high-resolution satellite scenes, we identified a large debris landslide originating from western lateral moraine that was most likely triggered by extremely heavy, south-Asian-monsoon-associated rainfall in June 2020. We back-calculate part of the GLOF process chain, using the GIS-based open-source numerical simulation tool r.avaflow. Two scenarios are considered, assuming a debris-lan

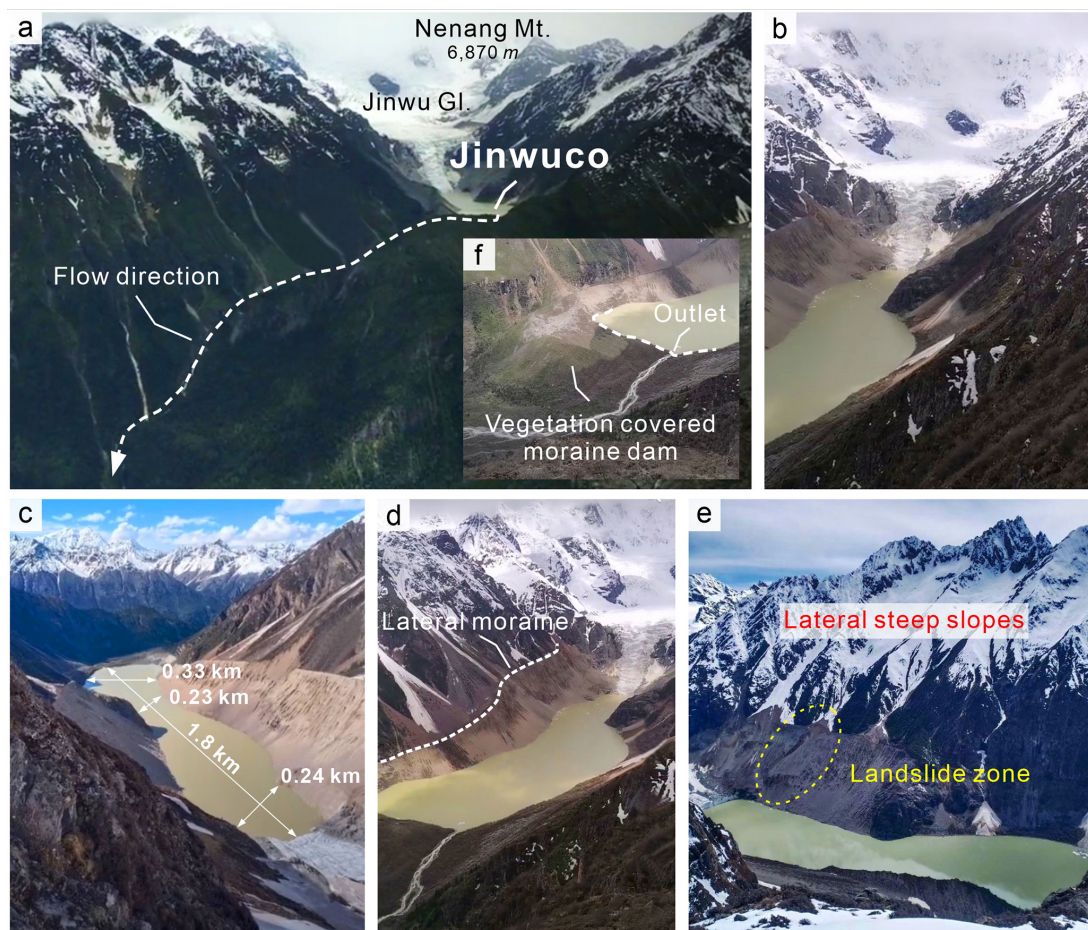
Figure 2. Overview of Jinwuco before the collapse of the dam. (a) An overall view of Jinwuco and surroundings taken from the opposite valley on 19 June 2020. (b) Crevassed hanging glacier ice terminated in Jinwuco, taken from downstream to upstream of the lake on 11 June 2020. (c) Morphological parameters of Jinwuco; photo taken from upstream to downstream of the lake on 15 June 2020. (d) Lateral moraine and steep mountain slopes from west to east (11 June 2020) and (e) from east to west (30 May 2020). (f) Vegetation-covered moraine dam and the position of the outlet (11 June 2020). Photos: Qiangba Quying (used with permission).

Jinwuco (also known as Jiwengco, 30.356°N , 93.631°E) is a proglacial moraine-dammed lake (Fig. 2) which is also the largest glacial lake within the Nidou Zangbo basin (Zheng et al., 2021). It is situated at the terminal of the Jinwu Glacier that covers an area of 7.9 km², and the lake is in contact with the steep ice tongue. The ice tongue enters the lake

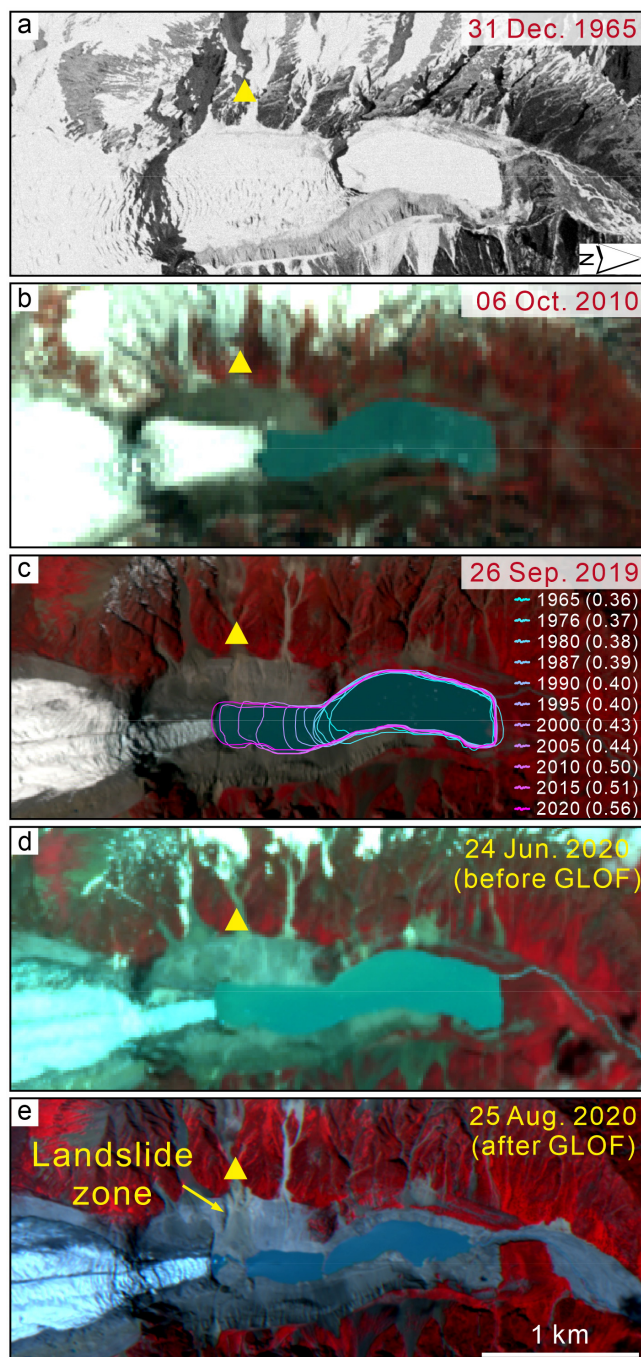
Figure 3. Satellite images documenting the evolution of Jinwucuo during 1965–2020 and the location of the debris landslide. The lake area in parentheses of panel (c) is given in square kilometers. The backgrounds are from Corona KH-4A, Landsat-5 TM, Sentinel-2A, Gaofen-1, and Ziyuan-3, respectively.

Historical satellite images reveal that Jinwuco has undergone significant areal expansion since 1965 (Fig. 3). In 1965, its surface area was $0.36 \pm 0.003 \text{ km}^2$. By 10 May 2020, the lake area has increased to $0.56 \pm 0.02 \text{ km}^2$, showing an increase of approx. 56 % relative to 1965 (Fig. 4). Overall, the surface area of Jinwuco shows a non-linear growth trend from 1965 to 2020 – with an accelerated growth rate observed from 1995. Importantly, the rear part of the lake, where the landslide deposited, is shown to have developed since 2010 (Fig. 3). After the GLOF event on 26 June 2020, the lake area is reduced by approx. 54 % to $0.26 \pm 0.01 \text{ km}^2$ (Fig. 4).

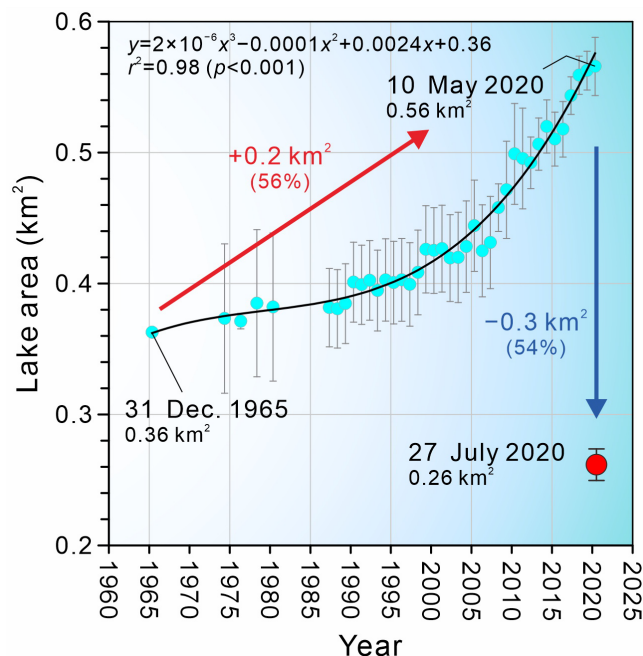
Figure 4. Inter-annual dynamics of Jinwucuo during 1965–2020 (prior to the GLOF), and the abrupt decrease in lake area after the GLOF.

1. *Lake.* The pre-event lake area was approx. $560\,000 \text{ m}^2$ (Fig. 4), with a maximum width of ca. 360 m. A lake volume of 13.9 million cubic meters is reconstructed (Sect. 4.4), corresponding to a maximum lake depth of 54 m. The pre-event lake level is set to 4444 m, whereas the post-event lake level is set to 4424 m, resulting in a drop of 20 m during the event. In the frontal portion of Jinwuco, some discrepancies exist between the post-event lake extent derived from the DEM and the satellite image (Fig. 5): this mismatch most likely indicates inaccuracies of the DEM.
2. *Landslide.* The Gaofen-1 imagery of 24 June reveals that the landslide had not yet happened until this point in time. Assuming that the landslide occurred before the GLOF, we constrain the timing of the landslide to the period 24–26 June 2020. A landslide release volume of

(Bolch et al., 2019) and particularly align to the period of accelerated expansion of Jinwuco (Fig. 4). While there are few studies directly linking the response of individual or even regional glacial changes to anthropogenic warming, it is considered extremely likely that anthropogenic emissions have been the primary driver of the cumulative glacier mass loss observed globally since 1850, with a central estimate of up to 100 % (Roe et al., 2021). Physically there is no obvious argument to suggest glaciers in this region of Tibet have responded anomalously from what has been established globally. If we therefore consider that anthropogenic warming has at least played a major (if not dominant) role in the retreat of Jinwu Glacier and associated lake growth, the discussion turns to how this retreat could have increased the likelihood and/or magnitude of the 26 June GLOF event. It is well established that paraglacial landscapes are characterized by anomalously high rates of erosion and mass movements compared to other environments, with debris flows, slides, and avalanches being the primary mode of failure (McColl, 2012; Knight and Harrison, 2014). The reworking and modification of paraglacial landscapes occurs rapidly following glacial retreat, with stabilization of proximal slopes occurring within a few decades to centuries (Ballantyne, 2002). Over this time, paraglacial slopes remain particularly susceptible to heavy rainfall or melt processes (Blair, 1994; Evans and Clague, 1994; Chiarle et al., 2007), and when mass movements of rock or debris enter adjacent lakes, GLOFs

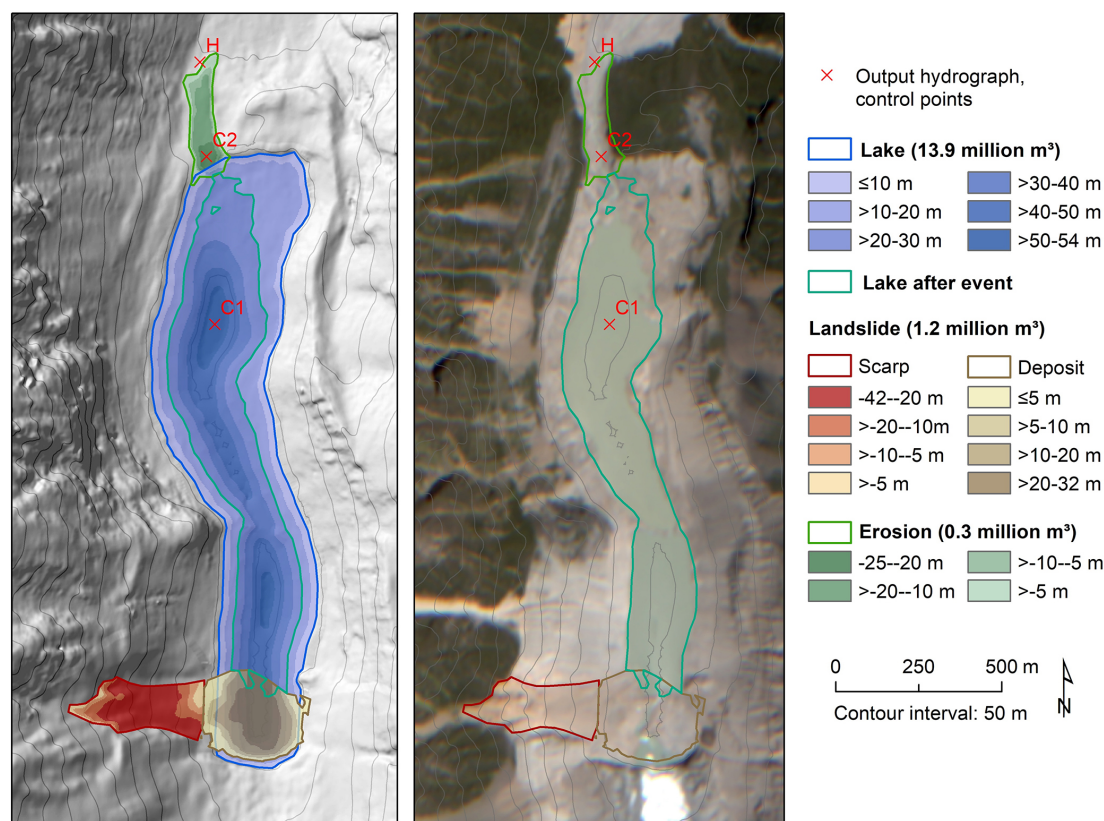
Figure 5. Reconstruction of the lake depth, landslide, and breach of the moraine dam. The base map is a shaded relief map (left) based on the DEM generated from Ziyuan-3 stereoscopic pairs and the Ziyuan-3 satellite scene (right) acquired on 25 August 2020.

The reconstruction of the main features allows for drawing some conclusions about the mechanisms involved in the GLOF process chain and for estimating the mobilized volumes (Figs. 5 and 6).

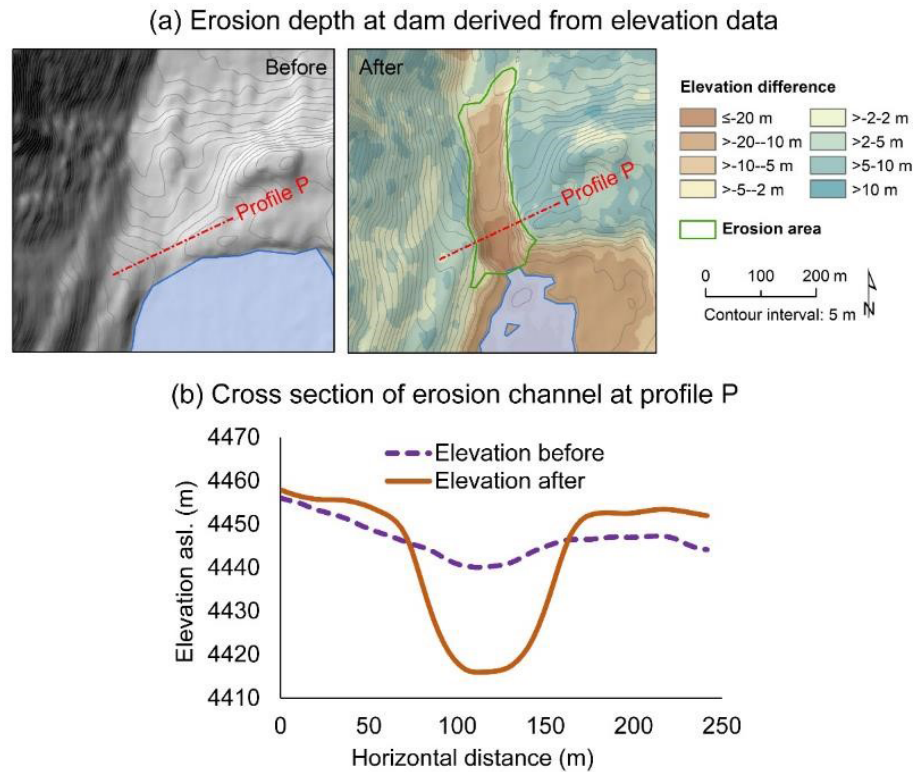
Figure 6. Breach of the moraine dam of Jinwuco. (a) Situation before and after the event of 26 June 2020, with difference in elevation between the DEMs derived before and after the event. (b) Cross section along the profile P (see a) before and after the event. The topographic base map is based on the DEM generated from Ziyuan-3 stereoscopic pairs.

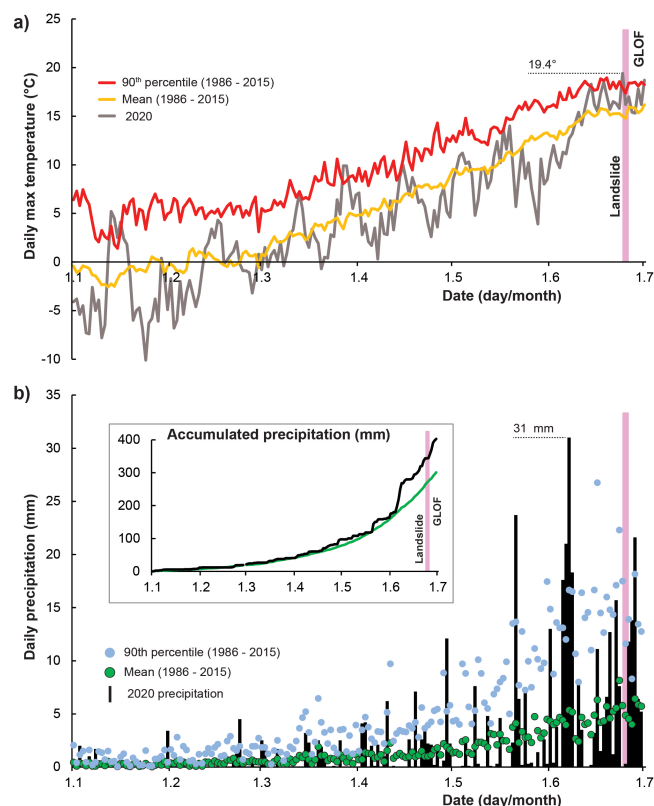
**Figure 7.** Meteorological conditions from January–June 2020, measured at the Lhari weather station, compared to the longer-term climatology (1986–2015).

We now elaborate on the possible triggers of the landslide. The meteorological conditions in June 2020 (Fig. 7) were characterized by extremely high precipitation in the period from 5–8 June. Further rainfall and snowmelt under unusually warm conditions after 8 June are factors which most likely caused a gradual destabilization of the moraine. The

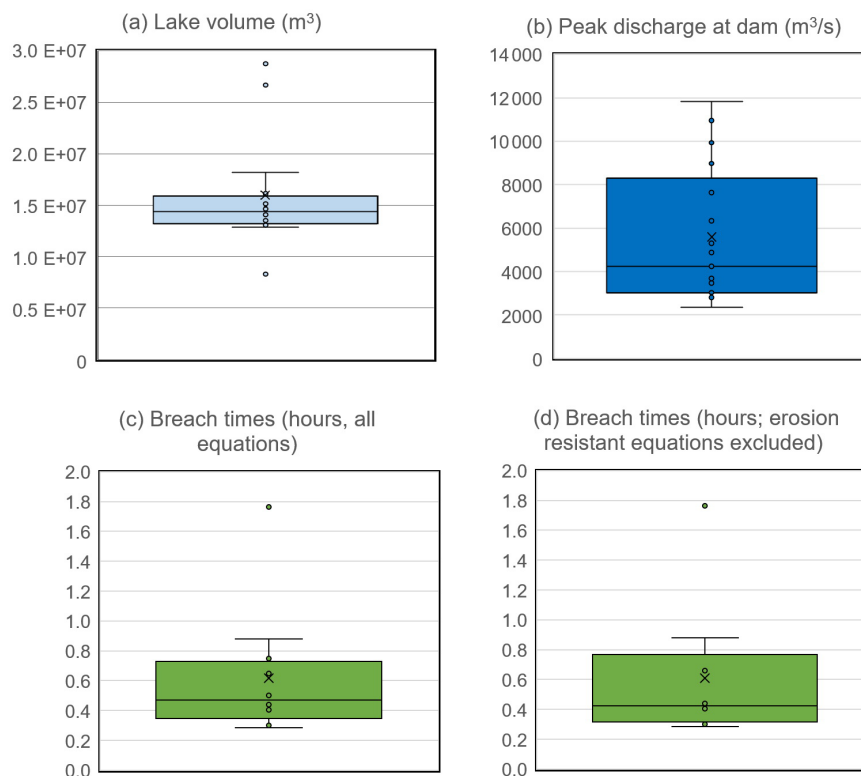
Figure 8. Lake, dam breach, and flood parameters, derived from sets of published empirical relationships. **(a)** Volume of Jinwuco. **(b)** Peak discharge at the dam. **(c)** Breach time, considering all available equations. **(d)** Breach time, considering only those equations derived for easily erodible dams (an assumption we consider likely to hold for the dam of Jinwuco).

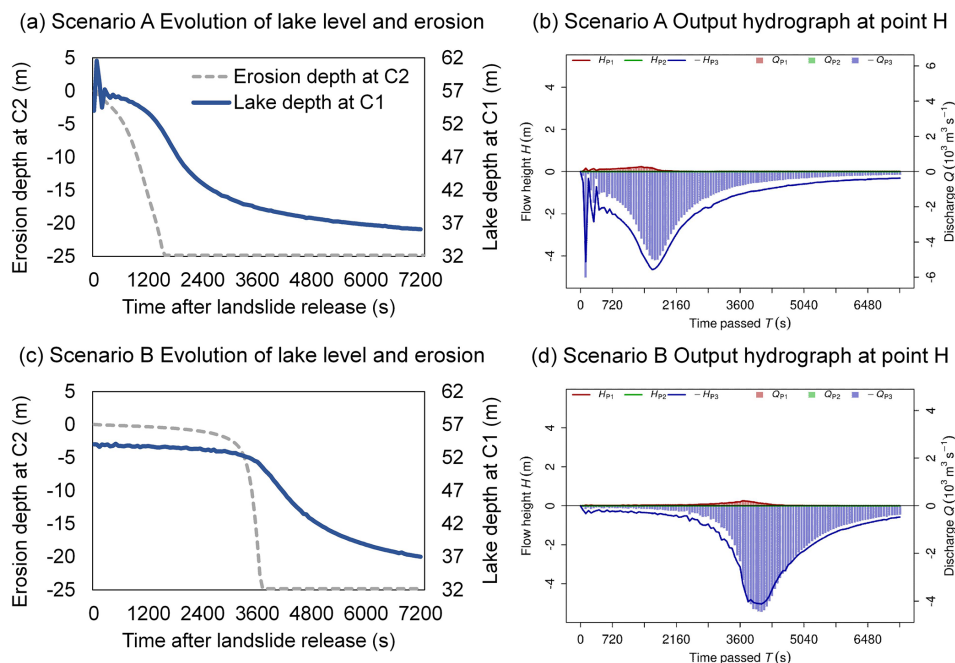
Figure 9. Dam breach as simulated with r.avaflow. **(a)** Scenario A, evolution of lake level and the erosion channel. **(b)** Scenario A, output hydrograph. **(c)** Scenario B, evolution of lake level and the erosion channel. **(d)** Scenario B, output hydrograph. Locations of the points C1, C2, and H are indicated in Figs. 5 and 11. In the output hydrographs, H means flow height, and Q means discharge. The subscript P1 refers to phase 1 (rock), P2 to phase 2 (not existent in this case), and P3 to phase 3 (water). Fluid discharge and flow height are plotted in the negative direction for better readability.

A detailed look at the dam breach (Fig. 9) reveals that the simulation results for both scenarios A and B are in good correspondence with the ranges of peak discharge and breach depth derived through the empirical relationships described in Sect. 4.4 and illustrated in Fig. 8. For Scenario A, at the point C2 (Figs. 5 or 10), depth erosion is completed at $t = 26$ min after landslide release, i.e., 24–25 min (0.41 h) after the impact wave had reached the outlet of the lake, initiating retrogressive erosion. This time span is well within, although in the lower part of, the range revealed in Fig. 8d. After the breach has developed to its full depth, lake drainage continues and asymptotically approaches the level of the eroded gully (Fig. 9a). The peak discharge associated with the landslide-induced impact wave reaches 17 900 m³/s after 100 s (computed at a higher temporal resolution and therefore not visible in Fig. 9b). Afterwards, discharge decreases and then increases again due to retrogressive erosion of the moraine dam. The simulated peak discharge during the retrogressive erosion stage reaches 5200 m³/s at $t = 28$ min, being well within the range indicated in Fig. 8b. With dropping lake level, the simulated discharge slowly decreases to a small residual value after 2 h (Fig. 9b). At all stages, the simulated flow is dominated by water, with a peak of approx. 220 m³/s of solid discharge at $t = 23$ min, when retrogressive erosion is the most intense.

The patterns yielded with the simulation of Scenario B (Fig. 9c and d) are similar in general, with the exception of the initial impact wave that is only observed in Scenario A. However, onset of erosion takes more time, so that the breach and associated emptying of the lake are delayed. The tipping point where slight channel erosion turns into a rapid dam breach occurs at approx. 35–39 min after the start of the simulation, depending on the definition. The base level of the erodible material is reached at $t = 62$ min (23–27 min or 0.38–0.45 h after the tipping point – in the lower part of the range indicated in Fig. 8d). The peak discharge of 4600 m³/s

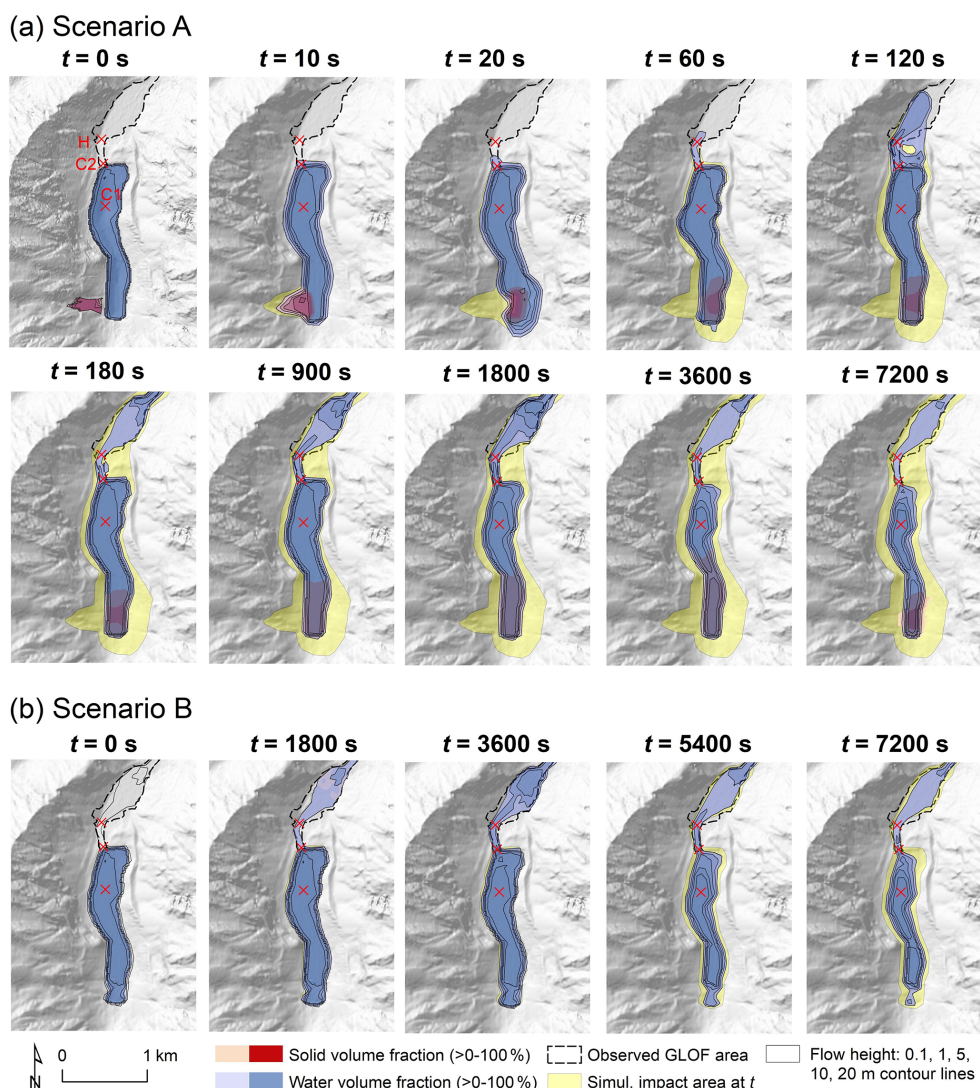
Figure 10. Evolution of flow height and GLOF impact area as well as solid and water volume fractions during the first 2 h of the event, as simulated with r.avaflow for (a) Scenario A and (b) Scenario B. Only the section until the floodplain immediately downstream from the moraine dam is considered in these simulations. The base map is a shaded relief map based on the DEM generated from Ziyuan-3 stereoscopic pairs and the simulation results.

timing and mechanisms of high-mountain process chains such as GLOFs. The understanding of events in earlier history sometimes suffers from the impossibility of determining the cause of a GLOF due to lacking data: in the 1941 event at Lake Palcacocha in the Peruvian Andes (Mergili et al., 2020), there is still speculation about triggering of the catastrophic moraine dam breach by calving or an ice avalanche, however poorly supported by evidence. In the case of the Jinwuco event, in contrast, there is clear evidence that a landslide has entered the lake not more than 2 d before the GLOF (Fig. 3), even though the quantification of landslide volume is to be interpreted as a rough estimate rather than exact value, given the hard-to-quantify uncertainties in the available pre- and post-event DEMs. We assume a direct temporal coincidence between the two processes, with the landslide having triggered the GLOF, as the most likely set of scenarios. However, there is strong evidence that there was no massive, extremely rapid landslide impact into the lake: comparison of pre-event and post-event satellite imagery reveals no overtopping of the dam and not even the run-up of lake water on the inner side of the moraine dam (Figs. 3 and 5). Both the simulation (Scenario A; Fig. 10a) and observations of other GLOFs (e.g., Schneider et al., 2014) would reveal such a behavior. Therefore, we consider a rather slow and/or progressive movement of the landslide into the lake much more likely, represented by Scenario B (Fig. 10b).

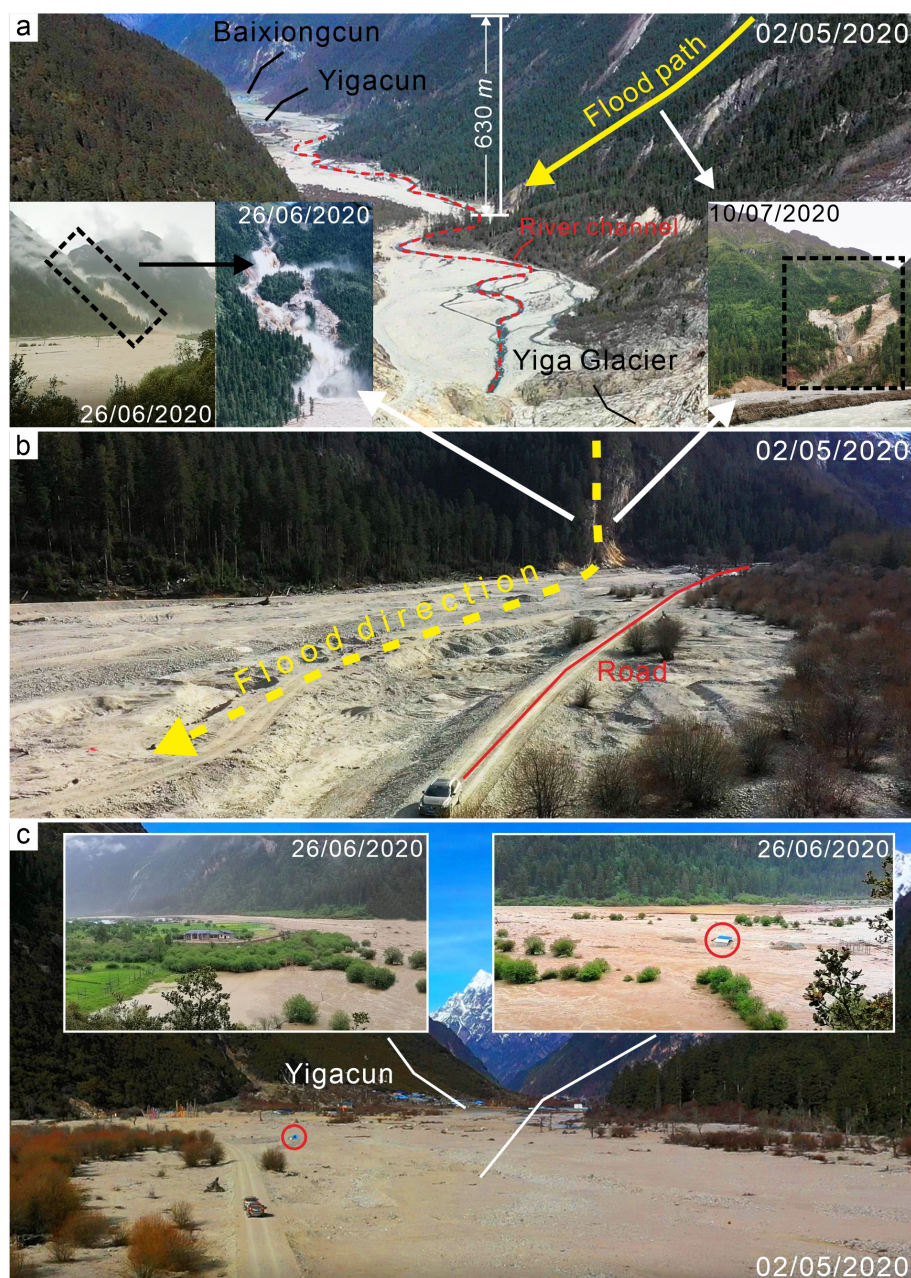
Figure 11. The situations in the valley and river channel below Jinwuco before, during, and after the GLOF. (a) Photo taken from Yiga Glacier looking to Yigacun. Insets showing the situations in the valley during and after the GLOF (photos: Qiangba Quying and Yixi Quzhen). (b) The river channel and road before the GLOF taken from Yigacun looking upstream. The yellow dashed line is the flood flow direction. (c) A view taken from upstream looking to Yigacun. Insets showing the situations in the river channel during the GLOF (photos: Qiangba Quying). Aerial photos from 2 May 2020 were taken by Kejun Liang.

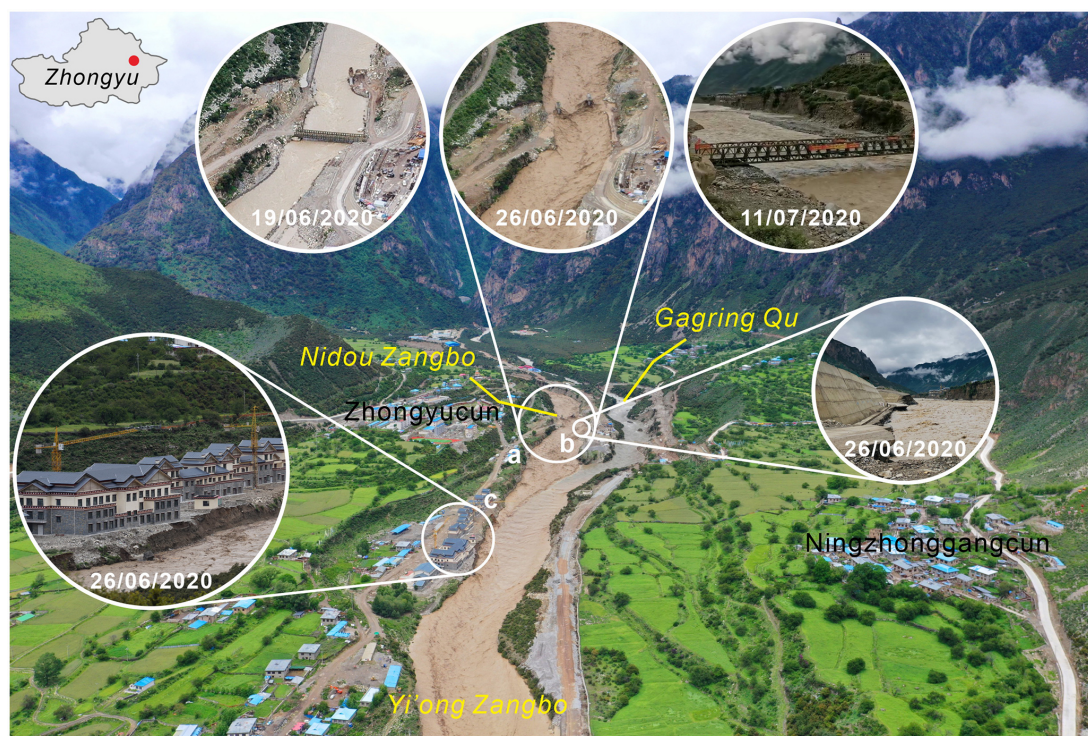
Figure 12. Examples of GLOF damage to downstream infrastructure and buildings at the confluence of Nidou Zangbo and Gagring Qu. Background aerial photo by Heng Li taken on 26 June 2020. (a) Comparison of the bridge connecting Zhongyucun and Ningzhonggangcun before, during (photos: Heng Li), and after the GLOF (rebuilt, photo: Kejun Ma). (b) Destroyed roads (photo: Heng Li). (c) Affected buildings at risk (photo: Heng Li).

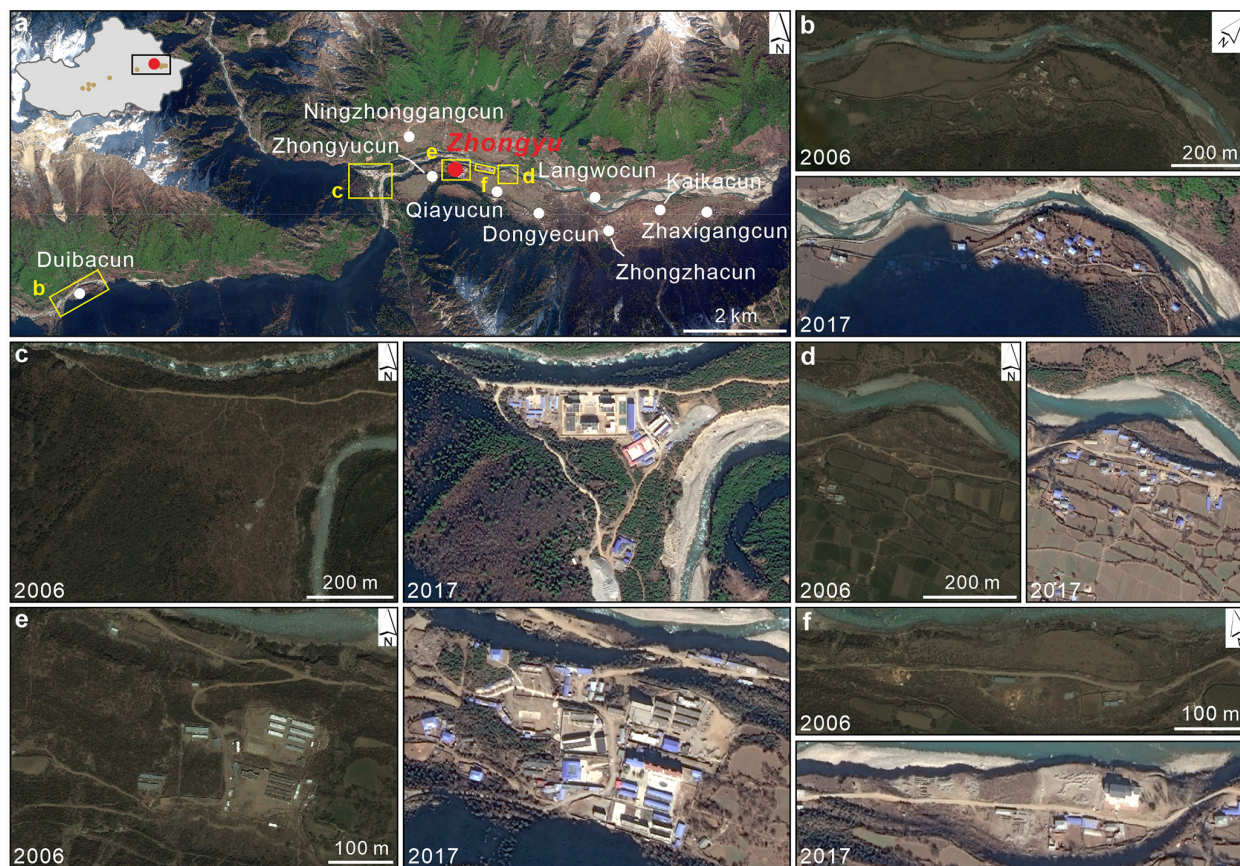
Figure 13. Examples of rapid development and expansion of the villages of lower Zhongyu township during 2006–2017. The background of panel (a) and the satellite scenes for the 2017 panels are a true-color composite Gaofen-2 image acquired on 7 December 2017. The satellite images for the 2006 panels are from © Google Earth, acquired on 30 April 2006.
