Supplement of

Brief communication: Alternation of thaw zones and deep permafrost in the cold climate conditions of the East Siberian Mountains, Suntar-Khayata Range

Robert Sysolyatin et al.

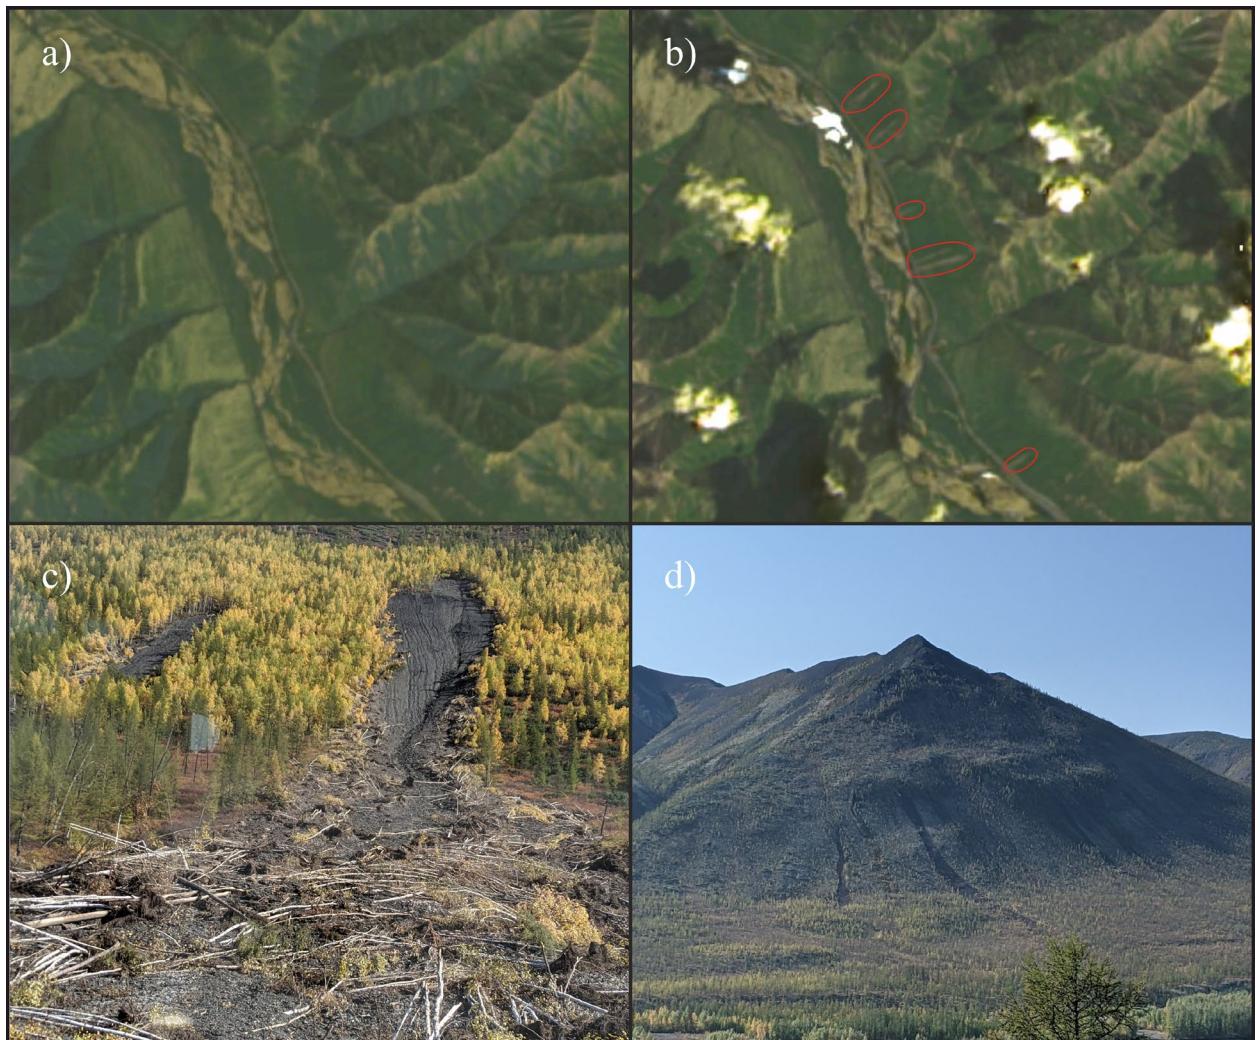
Figure S1: The MAXAR image of Kolyma Route section before landslides caused to heavy rains in 2020 (a) and after in 2022 (b). Field observation of debris landslides (c) the souths aspect slope and (d) the north aspect slope.
