Larger lake outbursts despite glacier thinning at ice-dammed Desolation Lake, Alaska

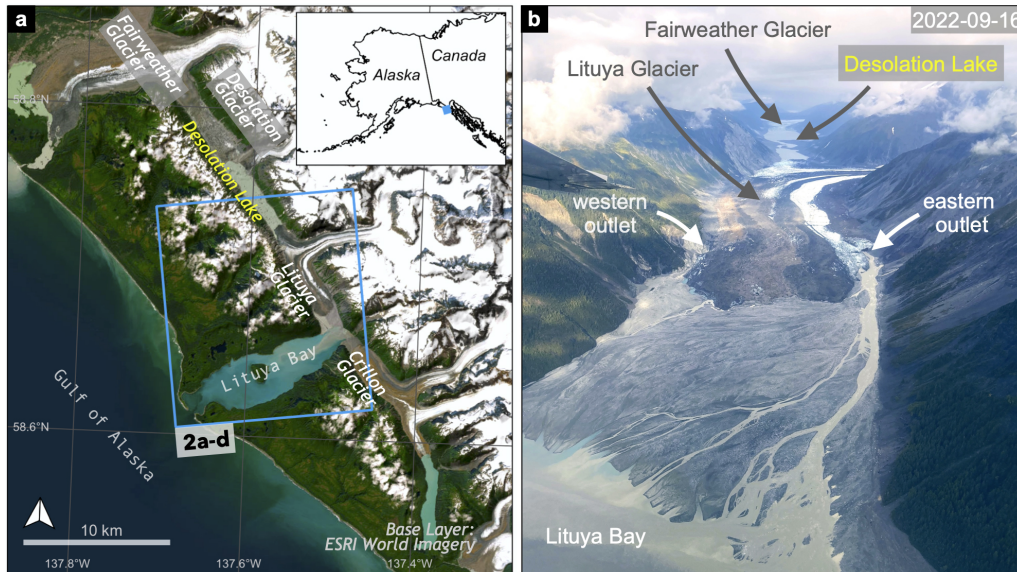
Figure 1. Location of Desolation Lake. (a) Location map and glacial setting of Desolation Lake. (b) Oblique aerial view into Desolation Valley from the head of Lituya Bay. Desolation Lake is only partially filled. White arrows indicate the location of the two flood outlets.

2024). Desolation Lake (58.765° N, 137.627° W) in southern coastal Alaska is dammed by Lituya Glacier, which flows from the Fairweather Range into Desolation Valley, where it separates into two ice tongues, one damming Desolation Lake on the northwest and the other flowing southeast towards Lituya Bay (Fig. 1a and b; Ward and Day, 2010). Lituya Glacier has an area of 77 km² (RGI Consortium, 2017), of which about 13 % is covered by rocks and debris (Scherler et al., 2018). The glacier area in Desolation Valley that dams the lake is heavily crevassed and in the ablation zone with only seasonal snow cover. Desolation Lake is further bordered by Fairweather Glacier to the northwest and Desolation Glacier flowing into the valley from the northeast (Fig. 1a).

Desolation Lake is surrounded by steep valley walls with an average slope of $\sim 32^\circ$ (ArcticDEM from 11 September 2020; Table S1 in the Supplement). Field observations, satellite imagery, and elevation models show that frequent mass movements of different size occur on these slopes. Since the onset of the GLOF cycle, sediment carried to the terminus of Lituya Glacier has formed a rapidly advancing proglacial delta, which today separates the glacier from Lituya Bay. Accordingly, Lituya Glacier ceased to be a tidewater glacier and became a landlocked valley glacier between 1990 and 1992. Crillon Glacier flows into Lituya Bay south of the head of the bay. A lake dammed by Crillon Glacier ~ 10 km from its terminus (Fig. 1a) has had no reported outbursts.

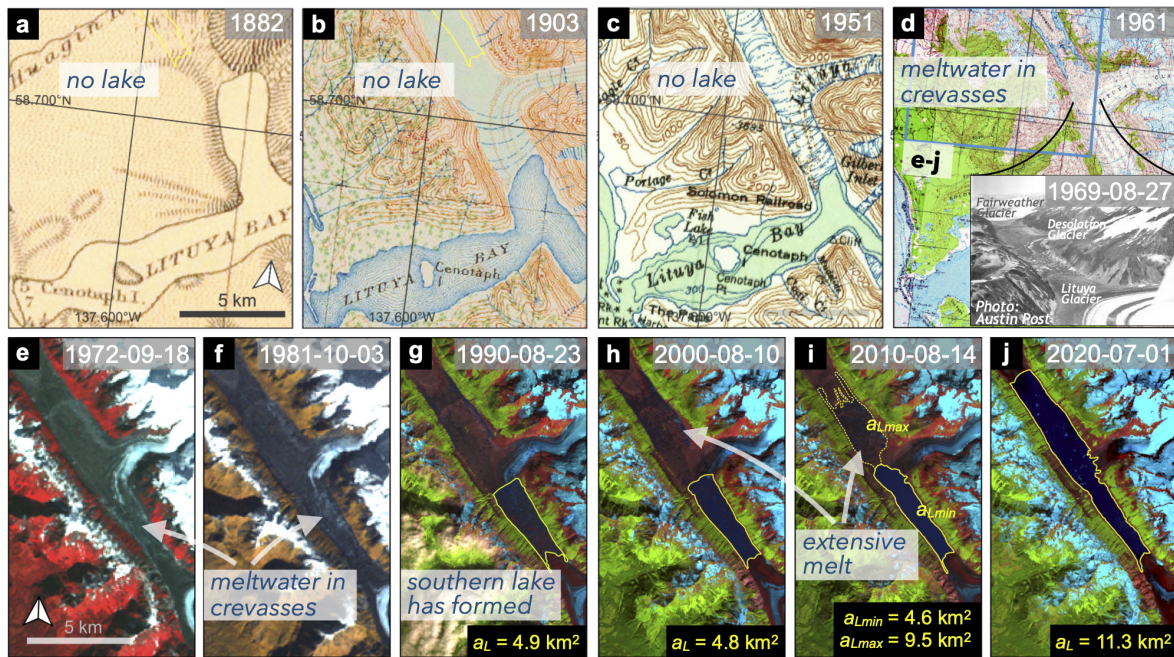
Figure 2. Formation of Desolation Lake. Time series of georeferenced historic maps (a–d; U.S. Coast Survey, 1882; Bien, 1903; U.S. Geological Survey, 1951, 1961) and Landsat images (e–j; derived from the USGS Earth Explorer and Google Earth Engine Data Catalog) showing the formation and growth of Desolation Lake between 1882 and 2020. The yellow outlines in (g)–(j) show the mapped lake areas (a_L). The photograph by Austin Post inset into (d) is a view into Desolation Valley and Lituya Glacier from the head of Lituya Bay in 1969, shortly before modern Desolation Lake formed.

The lake axis follows that of Desolation Valley and the NW–SE-striking, tectonically active Fairweather Fault. In 1958, before modern Desolation Lake began to form (Fig. 2d–f), a magnitude 7.9 earthquake triggered a landslide that entered Lituya Bay in front of Lituya Glacier, which was a tidewater glacier at that time (Miller, 1960; Lander, 1996; Mader and Gittings, 2002). The landslide triggered a tsunami that reached up to 524 m above sea level on the opposite hillslope and travelled the length of the bay and into the open Pacific Ocean. The run-up remains the highest of any reported tsunami worldwide (Mader and Gittings, 2002; Miller, 1960).

Desolation Lake began to form in the late 1960s when meltwater accumulated in longitudinal crevasses of Desolation and Lituya glaciers. This meltwater is visible in topographic maps and air photos of Austin Post in 1963 and 1969 (Fig. 2d). In the early 1980s, a single coherent waterbody formed and started growing on the surface of Desolation and Lituya glaciers (Fig. 2e and f). In the following years, the lake expanded towards rapidly retreating Desolation and Fairweather glaciers in the northwest (Fig. 2g and h). In 2013, Desolation Glacier retreated so far that it no longer blocked the valley. This allowed Desolation Lake to double its surface area by connecting to meltwater trapped in crevasses in the northwestern part of the valley (Figs. 2i, j and 3a). In 2014, Desolation and Fairweather glaciers separated, leaving only floating ice on the lake. Until then, Desolation Lake had grown by about 10 km^2 within 35 years to a total area of 12.7 km^2 (Figs. 2 and 3a). Since 2014, the maximum annual area of the lake decreased by about 4 km^2 and covered 8.6 km^2 in 2023 (Fig. 3a).

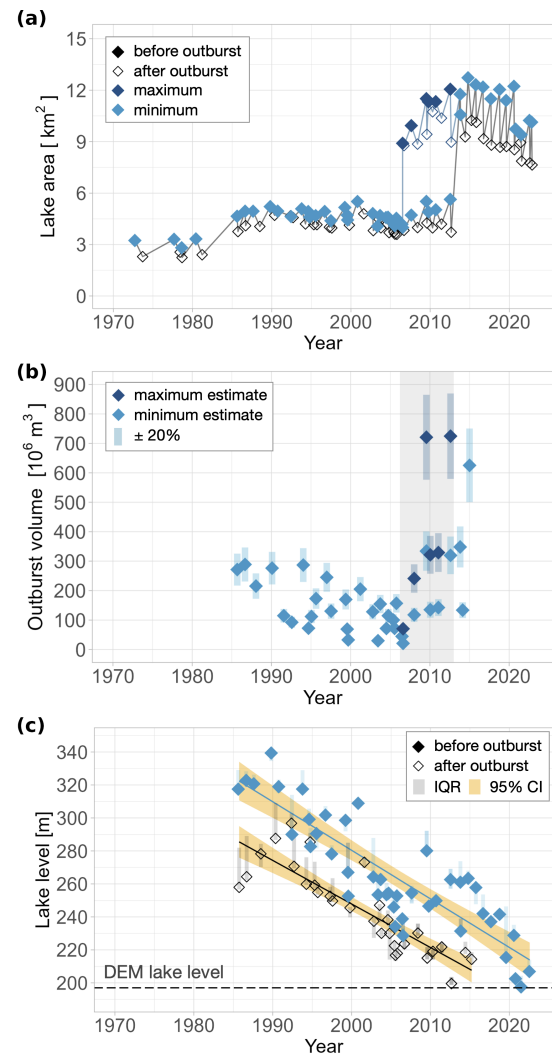
Figure 3. Temporal changes in lake size, outburst volumes, and lake levels from 1972 to 2023. **(a)** Lake area before and after the flood. **(b)** Outburst volumes with error bars, assuming an uncertainty of $\pm 20\%$. In **(a)** and **(b)**, data for GLOFs between 2006 and 2012 are colour-coded to minimum and maximum estimates from mapped lake extents, constrained by the uncertain lake shores along the rapidly melting Fairweather Glacier (this interval is grey-shaded in **b**). **(c)** Lake level before and after GLOFs. The blue and black lines are linear regression models fitted to pre- and post-outburst levels, including the 95 % confidence interval (CI; orange). The horizontal dashed line is the lower limit of the volume calculation (see Sect. 3.2). Pale blue and vertical grey intervals for outbursts mark the 25th and 75th percentiles (interquartile range, IQR) of the lake elevations extracted from the DEM. Diamonds in **(a)** and **(c)** bracket the timing of the outburst, with filled diamonds representing the last available image before the GLOF and open diamonds the first available image after the GLOF.

The minimum estimated outburst volumes of Desolation Lake range between $33 \pm 7 \times 10^6 \text{ m}^3$ and $625 \pm 125 \times 10^6 \text{ m}^3$ (Fig. 3b). Over the 30 years for which we have reliable estimates (1985–2014), flood volumes have at least tripled, with volumes between 200×10^6 and $300 \times 10^6 \text{ m}^3$ in the late 1980s and up to $\sim 700 \times 10^6 \text{ m}^3$ in the early 2010s (Fig. 3b). Flood volumes increased when the lake doubled its area by expanding towards Fairweather Glacier between 2006 and 2014 (Figs. 2h–j and 3b). This disintegration of Fairweather Glacier had already started in the 1980s when water-filled crevasses began to form and increase in number and size. Even before the lake claimed the area north of Desolation Glacier, the water from these crevasses drained during outbursts. We were unable to estimate the additional volume of water discharged from these crevasses, so our total estimated flood volumes are minima for this period. The lowest flood volumes were associated with floods in 2005 and 2006, just before this large-scale expansion. This 2-year period had at least five detected partial drainages.

While flood volumes increased, pre- and post-flood lake levels of Desolation Lake fell substantially (Fig. 3c). The lake level before the 2022 GLOF was 207 m h.a.e., which is about 110 to 130 m lower than the pre-GLOF lake levels in the late 1980s. The post-flood levels decreased in a similar manner and dropped below the DEM-derived lake level of 197 m h.a.e. in 2016 (Fig. 3c), hindering the approximation of outburst volumes between 2016 and 2023. Satellite images show that the width of the remaining lake after each drainage continued to decrease in the following years, indicating that the post-flood lake levels have further dropped since 2015 (Fig. S6 in the Supplement). In reference to our mapped lake outlines, ICESat-2 data acquired approximately 2 months after a drainage event in summer 2020 show that the post-flood levels dropped below 183 m until then (Table S3 in the Supplement). Since 2021, post-flood levels have remained below 172 m, accounting for a decrease of at least 25 m within 6 years. In 2023, the last year of our record, the pre-flood lake level remained below the DEM lake level of 197 m h.a.e.

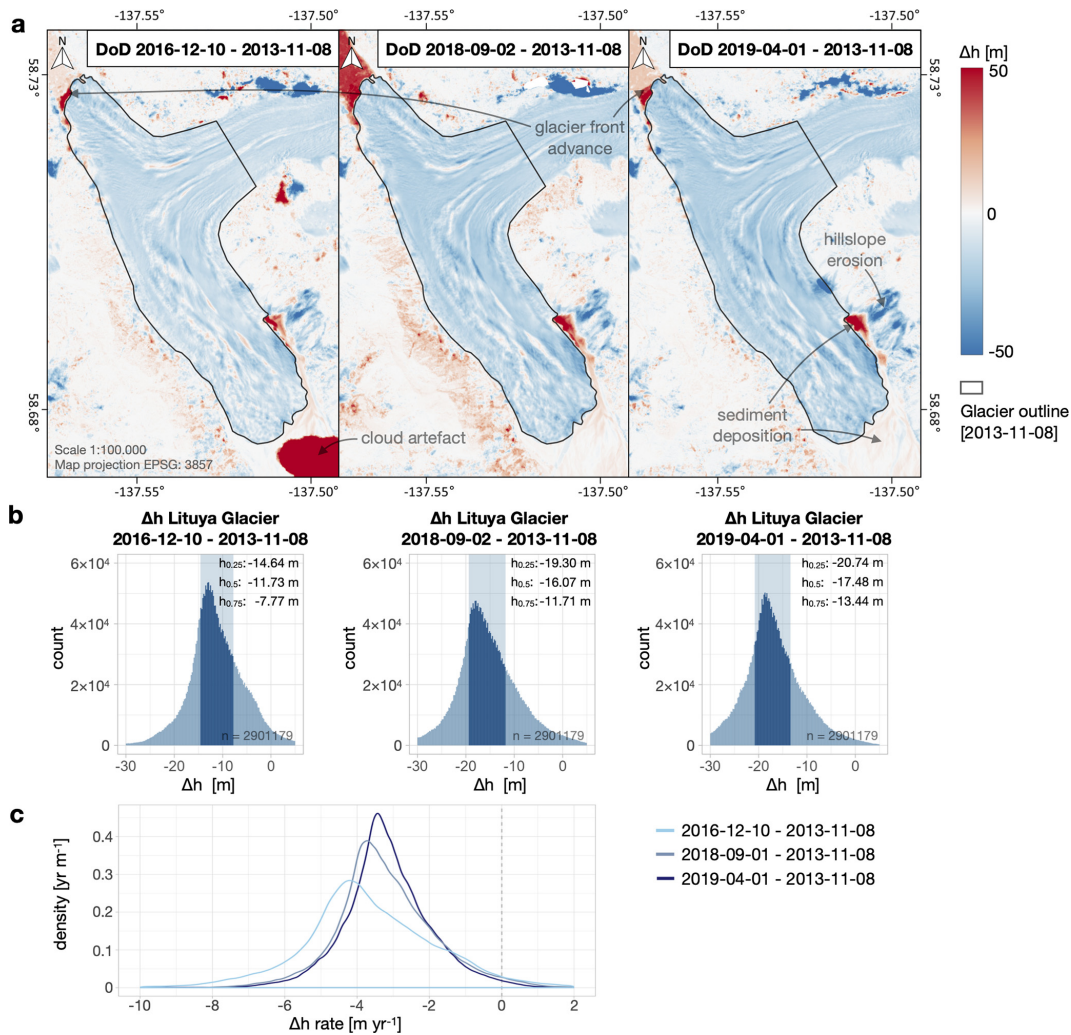
Figure 5. Elevation time series of Lituya Glacier between 2013 and 2019. **(a)** Elevation differences of ArcticDEMs (Porter et al., 2022) between 10 December 2016, 2 September 2018, and 1 April 2019, referenced to 8 November 2013. The 8 November 2013 glacier outline for estimating the elevation change (Δh) across the glacier is outlined in black. The high positive values on the proglacial delta in the left panel are an artefact from cloud cover in the 2016 DEM. **(b)** Pixel-wise elevation changes within the 8 November 2013 glacier outline using histograms with a bin width of 0.2 m. Highlighted areas in dark blue mark the interquartile range; h values refer to the quartiles and median. **(c)** Density plots of the mean annual elevation change rate across Lituya Glacier derived from the difference to the 2013 DEM.

between 1977 and 2013 to $-3.2_{-3.8}^{-2.4} \pm 0.6 \text{ myr}^{-1}$ between 2013 and 2019. Between 2013 and 2019, most parts of the glacier surface dropped 2 to 6 myr^{-1} (Fig. 5c). The elevation loss of the glacier dam corresponds to a mass loss of $-0.8 \pm 0.1 \text{ m w.e. yr}^{-1}$ between 1977 and 2013 and $-2.9 \pm 0.6 \text{ m w.e. yr}^{-1}$ between 2013 and 2019. The elevation change error ($\sigma_{\Delta h}$) calculated over the static surfaces is 4.4 m for the aligned point clouds (2013–1977) and ranges between 2.8 and 3.8 m for the co-registered ArcticDEMs (2019–2013, 2018–2013, 2016–2013) (Fig. S5). This is only 14%–23% of the median surface elevation change over the respective time period and thus well below the measured elevation changes across Lituya Glacier dam.

2013 and 2019, outwash and rockfall has accumulated at the base of the slope where the glacier front retreated with up to 80 m thickness (Fig. 5a).

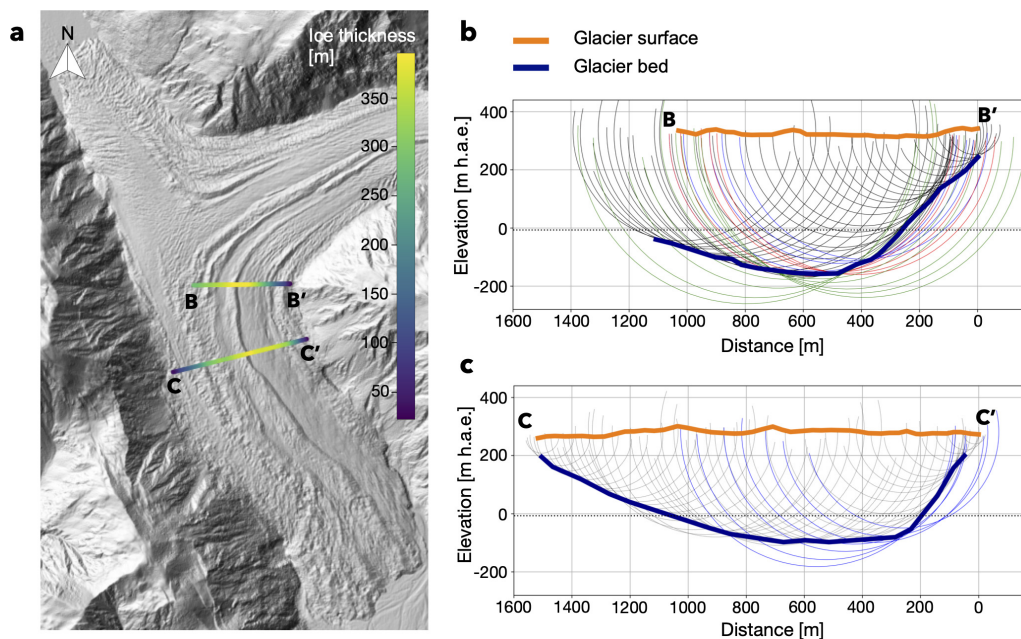
Figure 7. Glacier geometry of Lituya Glacier along two profiles derived from an ice-penetrating radar (IPR) survey in June 2023. (a) Location of the IPR profiles plotted on the 2019 ArcticDEM (Porter et al., 2022). The colour along the profiles show the ice thickness. (b, c) Elevation of the glacier surface (orange) and estimated glacier bed (blue) along the profiles. The dotted line shows the mean sea level (EGM96 geoid). The light curves are the return ellipses, and black colours indicate first return (Sect. 3.4).

Our ice-penetrating radar (IPR) survey in June 2023 revealed striking differences in ice thickness and subglacial topography along Lituya Glacier (Fig. 7a). Ice in the higher northern profile has an estimated maximum thickness of

492 ± 20 m (Fig. 7b). Along the northern and southern profiles, the glacier has a mean elevation of 325 and 280 m, respectively. We infer that more than a third of the cross-sectional area of the glacier is below sea level, with a maximum depth of 158 m below ellipsoid (h.b.e.). The lower southern profile is characterised by a shallower glacier bed with a maximum depth of 97 m h.b.e. (Fig. 7c). Both profiles are asymmetric, with a more gentle west and a steeper east wall (Fig. 7b and c). Thus, the area with the greatest ice thickness and the lowest elevation of the glacier bed is located closer to the eastern valley wall, close to where the glacier enters Desolation Valley and separates into two branches with numerous longitudinal ice ridges covered by debris (Figs. 6d and 7a).

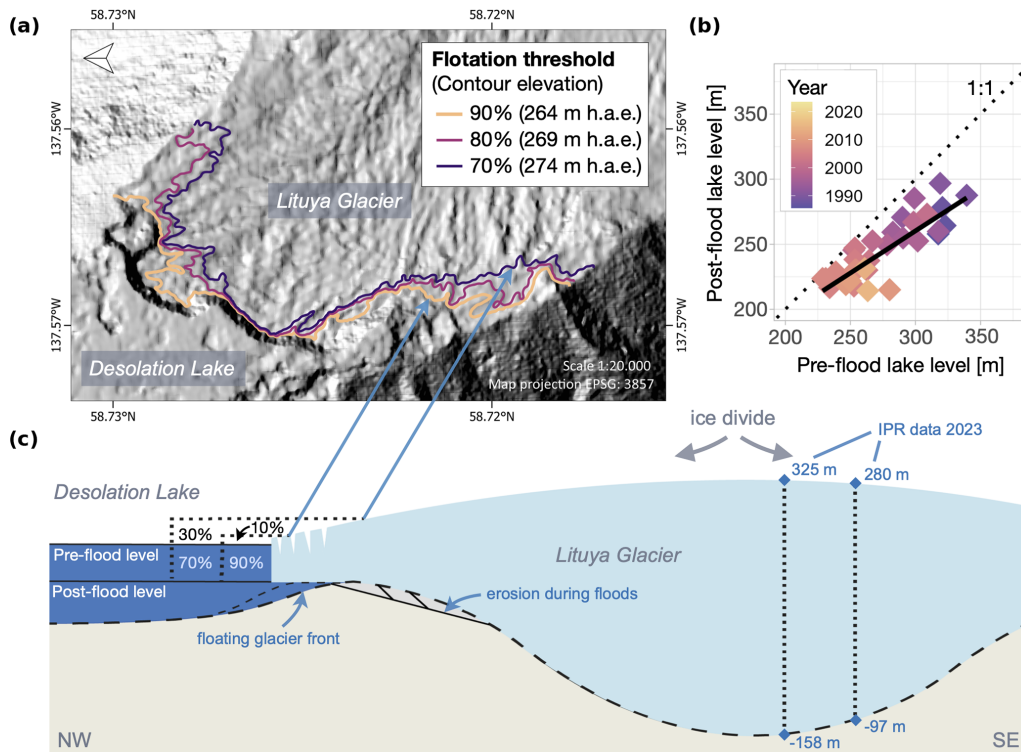
Figure 8. Exploration of possible flotation ratios at Desolation Lake. **(a)** Contour lines of Lituya Glacier on hillshade generated from the 11 August 2013 ArcticDEM (Porter et al., 2022). The contours show the reconstructed glacier elevation above the seal for the outburst of Desolation Lake between October and November 2013 based on different flotation thresholds (60%–95%) (Sect. 5.3). **(b)** Post-flood versus pre-flood levels of Desolation Lake with fitted linear regression (black line) of data colour-coded according to the timing of the outbursts. The dotted line shows a 1 : 1 ratio. **(c)** Schematic cross section of Lituya Glacier along Desolation Valley with simplified subglacial topography below the ice dam. The marked elevations towards the ice divide are derived from the IPR survey in June 2023. The dotted lines at the ice dam schematically show the reconstruction of the glacier surface above the seal, with different thresholds displayed in **(a)**.

Our time series of lake levels shows that the lake partially empties to 85 %–95 % of its initial elevation on average (Fig. 8b). In contrast, other lakes that are hypothesised to drain by ice-dam flotation drain completely, for example, Hidden Creek Lake (Anderson et al., 2003) and Summit Lake, BC (Mathews, 1965). Considering that Desolation Lake always drained only partially, we suspect that a moraine or bedrock sill is located at a level above the lake bed to prevent the lake from completely emptying (Fig. 8c). Subglacial erosion could have left a bedrock high or, alternatively, provided material for a terminal moraine that is now buried beneath Lituya Glacier after its advance during the Little Ice Age. Based on these assumptions, we expect that the lake drains down to the elevation of the sill or beyond. To allow for the observed negative trend in the post-flood lake levels, the sill would have to erode over time. Considering that the post-flood lake levels declined by at least 100 m, remobilisation of unconsolidated material of a purported moraine may be more likely rather than bedrock erosion.

Where is the seal of the lake located? The simple assumption that the post-flood lake level is equivalent to the elevation of the glacier bed at the ice dam allows us to explore possible flotation ratios. Following this assumption, the lake-level drop is equivalent to the water depth at which ice-dam flotation at the seal is initiated (Fig. 8c). We can thus reconstruct the ice thickness and elevation of the glacier surface at the seal based on different flotation thresholds. We neglect potential siphoning of water at the seal through a narrow channel that may lead to drainage below the seal elevation and thus would result in a smaller pre-flood water depth at the seal than derived from the lake-level drop during the out-
