The 2020 glacial lake outburst flood at Jinwuco, Tibet: causes, impacts, and implications for hazard and risk assessment

20 **Abstract.** We analyze and reconstruct a recent Glacial Lake Outburst Flood (GLOF) process chain on 26 June 2020, involving
the moraine-dammed proglacial lake – Jinwuco (30.356°N, 93.631°E) in eastern Nyainqentanglha, Tibet, China. Satellite
images reveal that from 1965 to 2020, the surface area of Jinwuco has expanded by 0.2 km² (+56%) to 0.56 km², and
subsequently decreased to 0.26 km² (–54%) after the GLOF. Estimates based on topographic reconstruction and sets of
published empirical relationships indicate that the GLOF had a volume of 10 million m³, an average breach time of 0.62 hours,
25 and an average peak discharge of 5,602 m³/s at the dam. Based on pre- and post-event high-resolution satellite scenes, we
identified a large debris landslide originating from western lateral moraine that was most likely triggered by extremely heavy,
south Asian monsoon-associated rainfall in June 2020. We back-calculate part of the GLOF process chain, using the GIS-

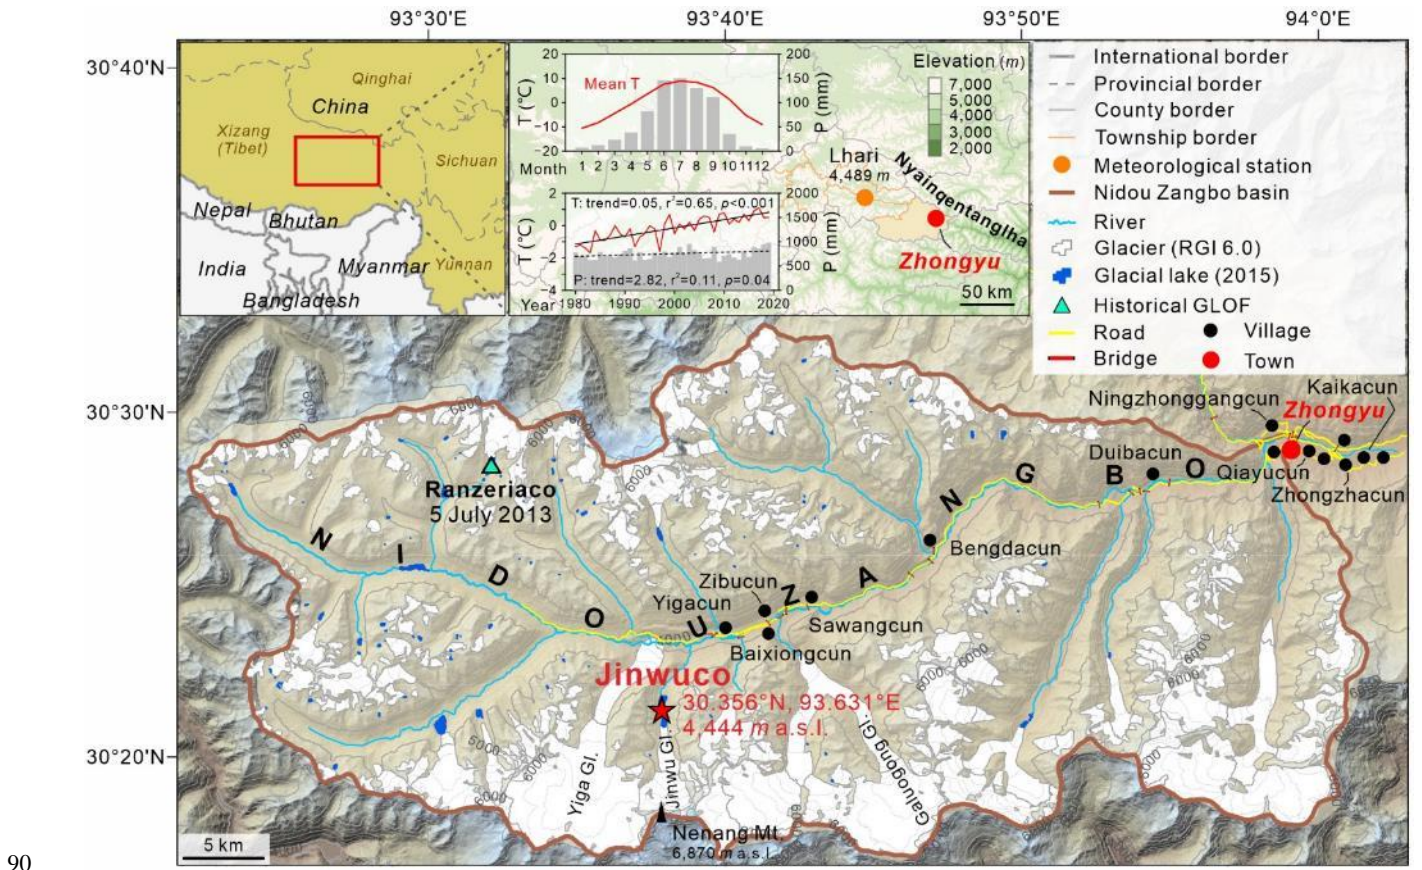
Figure 1. Location of Jinwuco and surrounding geographic features, including terrain, rivers, glaciers, glacial lakes, settlements and major infrastructures (roads and bridges) downstream. The climate statistics in the upper middle panel are based on the Lhari weather station, approx. 50 km away from Jinwuco, 1980–2019. Topographic base map is based on the DEM generated from Ziyan-3 stereoscopic pairs. The borders and location of the villages are from © Baidu Maps.

75 The study area is located at the Nidou Zangbo (“Zangbo” refers to rivers in Tibetan) watershed in the eastern Nyainqentanglha, Tibet Autonomous Region, China (Fig. 1). The Nidou Zangbo originates from the eastern foothills of the Luola Mountains near the north of Zhongyu township in Lhari County with a length of 68 km (Liu, 2014) and is the right tributary of Yi’ong Zangbo. The watershed covers an area of 1,267 km² with an elevation difference of 3,715 m. The topography of the watershed is high in the west and low in the east, with an average elevation of >5,000 m. Most of the peaks in the watershed reach more
 80 than 6,000 m, with the highest peak, Nenang Peak, at 6,870 m. The glacial and paraglacial landscapes are highly developed in the watershed, with a total of 294 glaciers (≥ 0.05 km² around 2005) covering a combined area of 396 km² (RGI Consortium, 2017). There are 96 glacial lakes (≥ 900 m² around 2015) distributed in the watershed with a total area of 3.2 km² and an average area of 0.03 km² (Zheng et al., 2021), of which the majority are moraine-dammed lakes. The watershed is part of the sub-humid monsoon climate zone of the plateau with cold winters and cool summers (Sun et al., 2014). The average annual

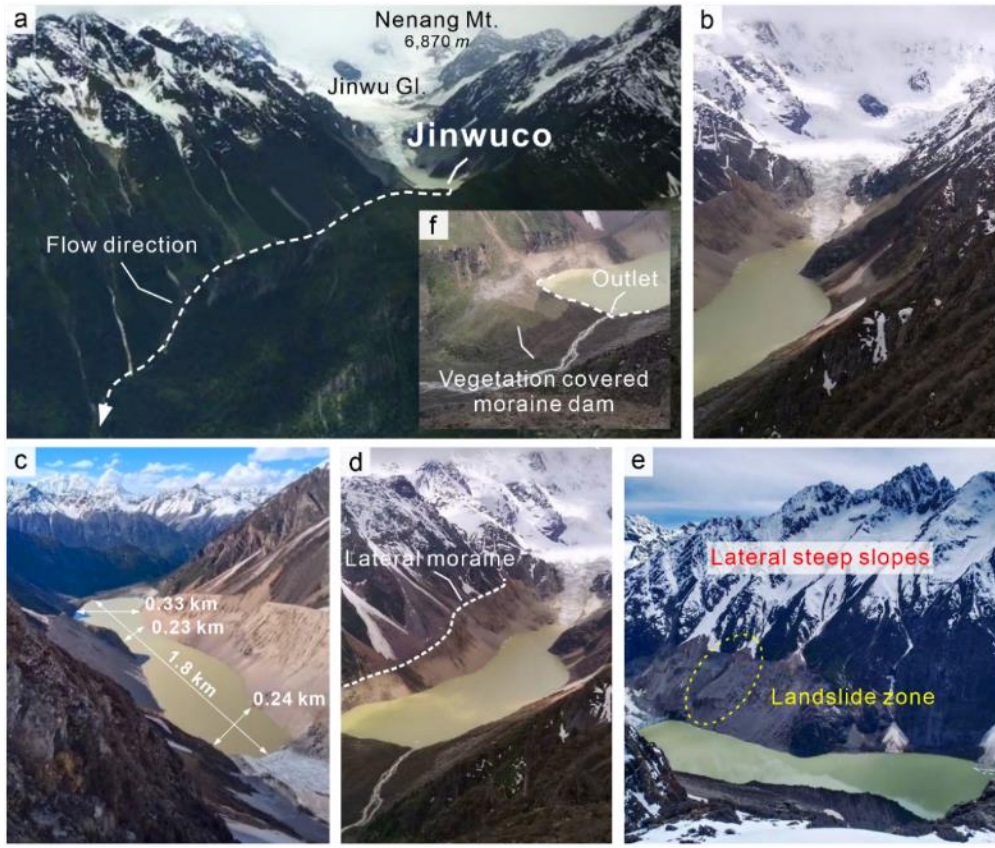
Figure 2. Overview of Jinwuco before the collapse of the dam. (a) An overall view of Jinwuco and surroundings taken from the opposite valley on 19 June 2020. (b) Crevassed hanging glacier ice terminated in Jinwuco, taken from downstream to upstream of the lake on 11 June 2020. (c) Morphological parameters of Jinwuco, photo taken from upstream to downstream of the lake on 15 June 2020. (d) Lateral moraine and steep mountain slopes from west to east (11 June 2020) and (e) from east to west (30 May 2020). (f) Vegetation covered moraine dam and the position of the outlet (11 June 2020). Photos: Q. Quying (used with permission).

Jinwuco (also known as Jiwengco, 30.356°N, 93.631°E) is a proglacial moraine-dammed lake (Fig. 2) which is also the largest glacial lake within the Nidou Zangbo basin (Zheng et al., 2021). It is situated at the terminal of the Jinwu Glacier that covers an area of 7.9 km² and the lake is in contact with the steep ice tongue. The ice tongue enters the lake about 350 m below the steep ice cliff that has a height of approx. 250 m and an average slope of 35° measured based on the satellite scene and DEM acquired on 25 August 2020 (Table 1). The main axis of the lake is oriented in a north-south direction, flanked by steep slopes and lateral moraines. The average height of the lateral moraines is over 100 m and the slopes are about 40°. The upper end and both lateral moraine slopes surrounding the lake are seasonally snow-covered, with an ablation period from April to September and an accumulation period from October to March. The lake shows a typical elongated irregular oblong shape with a straight-line length of approx. 1.8 km and its width varies in different positions. Before the GLOF of 26 June 2020, it exhibited wider front and rear sections and a narrow middle section, with the section near the dam being 0.33 km wide. The part near the glacier is 0.24 km and the middle section is about 0.23 km wide. The dam of the lake is formed by a vegetation-covered terminal moraine, and has a length of about 400 m perpendicular to the streamline with an average slope of the distal (outer) face of 20° and an average height of 10 m. The outlet channel is located on the western side of the moraine dam where there is a permanent surficial outflow (i.e. dam freeboard = 0 m).

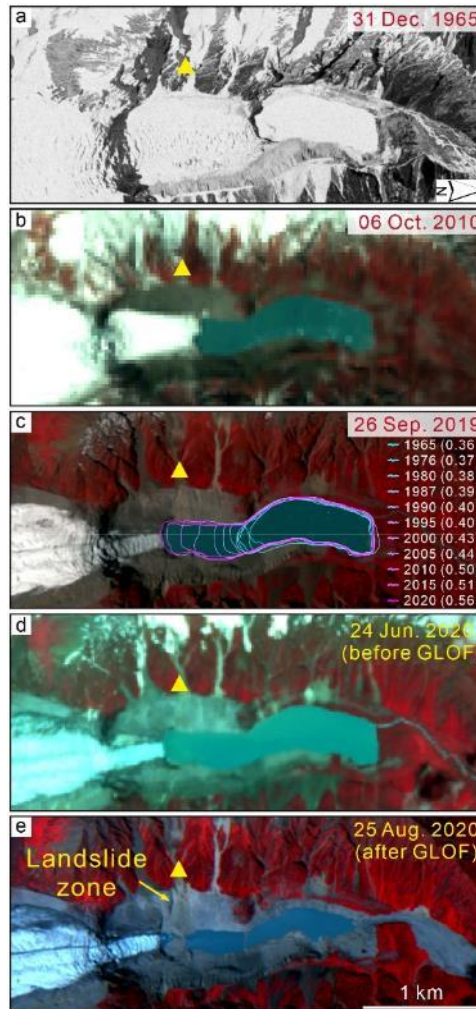
Figure 3. Satellite images documenting the evolution of Jinwuco during 1965–2020 and the location of the debris landslide. The lake area in parentheses of panel (c) is given in square kilometers. The backgrounds are from Corona KH-4A, Landsat-5 TM, Sentinel-2A, Gaofen-1 and Ziyuan-3, respectively.

Historical satellite images reveal that Jinwuco has undergone significant areal expansion since 1965 (Fig. 3). In 1965, its surface area was 0.36 ± 0.003 km². By 10 May 2020, the lake area has increased to 0.56 ± 0.02 km², showing an increase of approx. 56% relative to 1965 (Fig. 4). Overall, the surface area of Jinwuco shows a non-linear growth trend from 1965 to 2020

– with an accelerated growth rate observed from 1995. Importantly, the rear part of the lake, where the landslide deposited, is shown to have developed since 2010 (Fig. 3). After the GLOF event on June 26, 2020, the lake area is reduced by approx. 54% to $0.26 \pm 0.01 \text{ km}^2$ (Fig. 4).

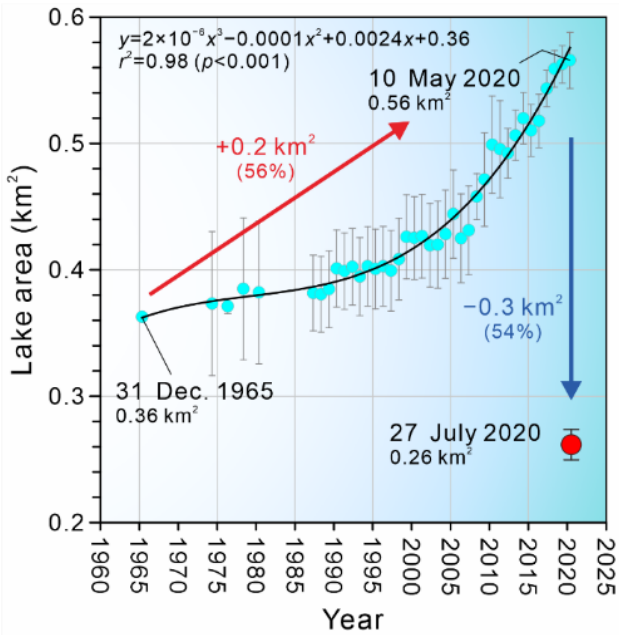
Figure 4. Inter-annual dynamics of Jinwucuo during 1965–2020 (prior to the GLOF), and the abrupt decrease in lake area after the GLOF.

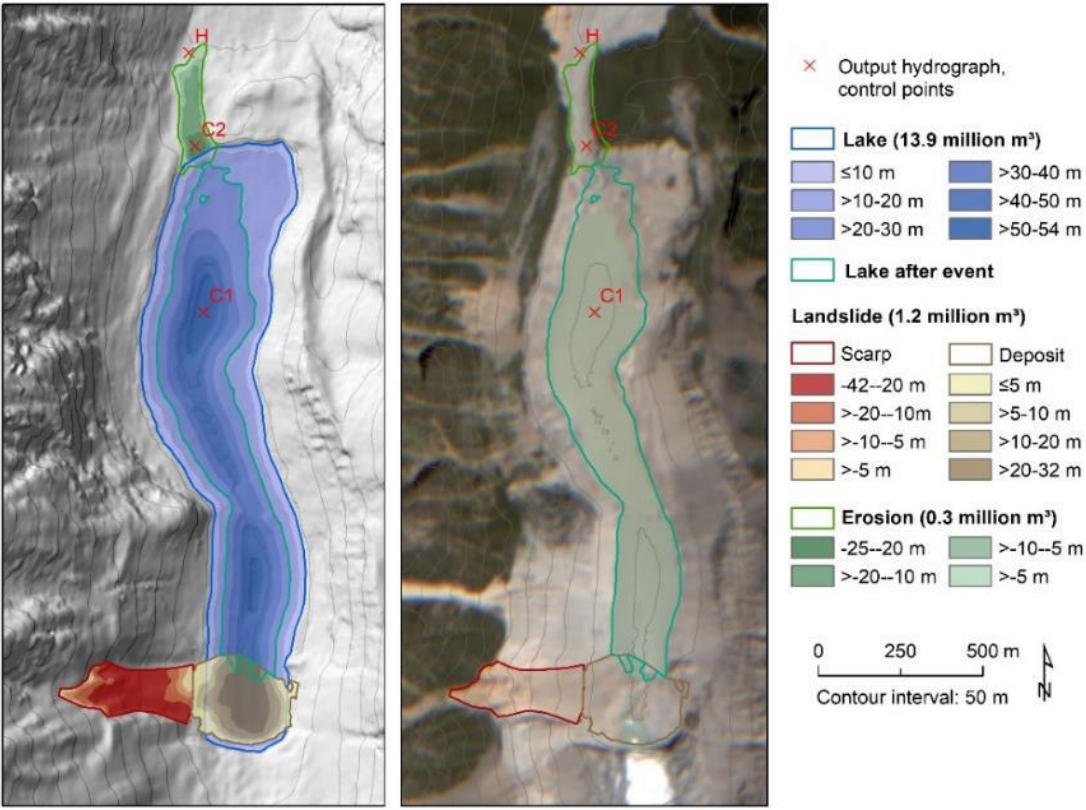
Figure 5. Reconstruction of the lake depth, landslide, and breach of the moraine dam. Base map is shaded relief map (left) based on the DEM generated from Ziyuan-3 stereoscopic pairs, and the Ziyuan-3 satellite scene (right) acquired on 25 August 2020.

3. Breach of the terminal moraine: a maximum breach depth of 25 m and an eroded volume of 300,000 m³ are derived from the DoD. The difference of 5 m between the maximum breach depth and the drop of the lake level is a result of the steeper longitudinal profile of the upper part of the drainage channel after the breach, compared to the situation before the breach. However, as it is clearly shown in Fig. 6, there is a vertical offset between the pre- and post-event DEMs, limiting the accuracy of the estimates. Even though the offset is not constant in space, it is likely that the pre-event DEM would have to be uplifted in the area of the terminal moraine, relative to the post-event-DEM, to bring the two in line, which would increase the maximum breach depth by up to approx. 7 m. However, the data basis is too insufficient to justify such a correction.

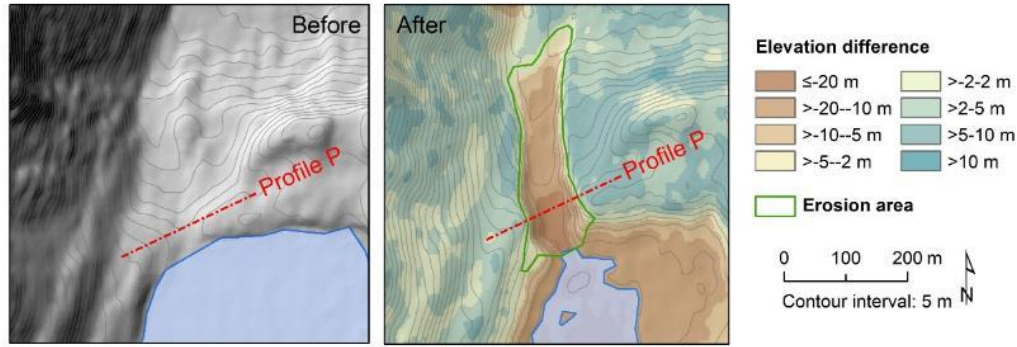
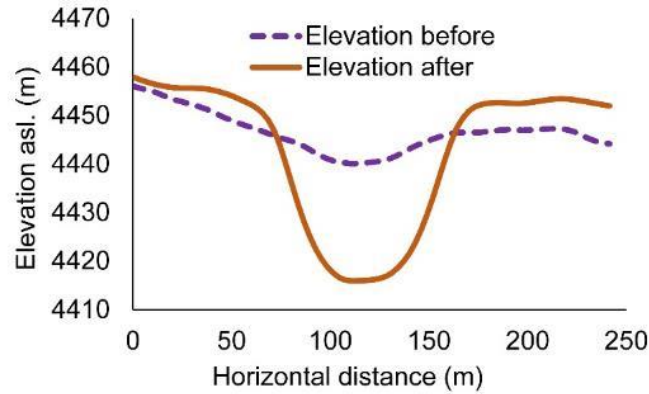
(a) Erosion depth at dam derived from elevation data

(b) Cross section of erosion channel at profile P

Figure 6. Breach of the moraine dam of Jinwucu. (a) Situation before and after the event of 26 June 2020, with difference in elevation between the DEMs derived before and after the event. (b) Cross section along the profile P (see (a)) before and after the event. Topographic base map is based on the DEM generated from Ziyuan-3 stereoscopic pairs.

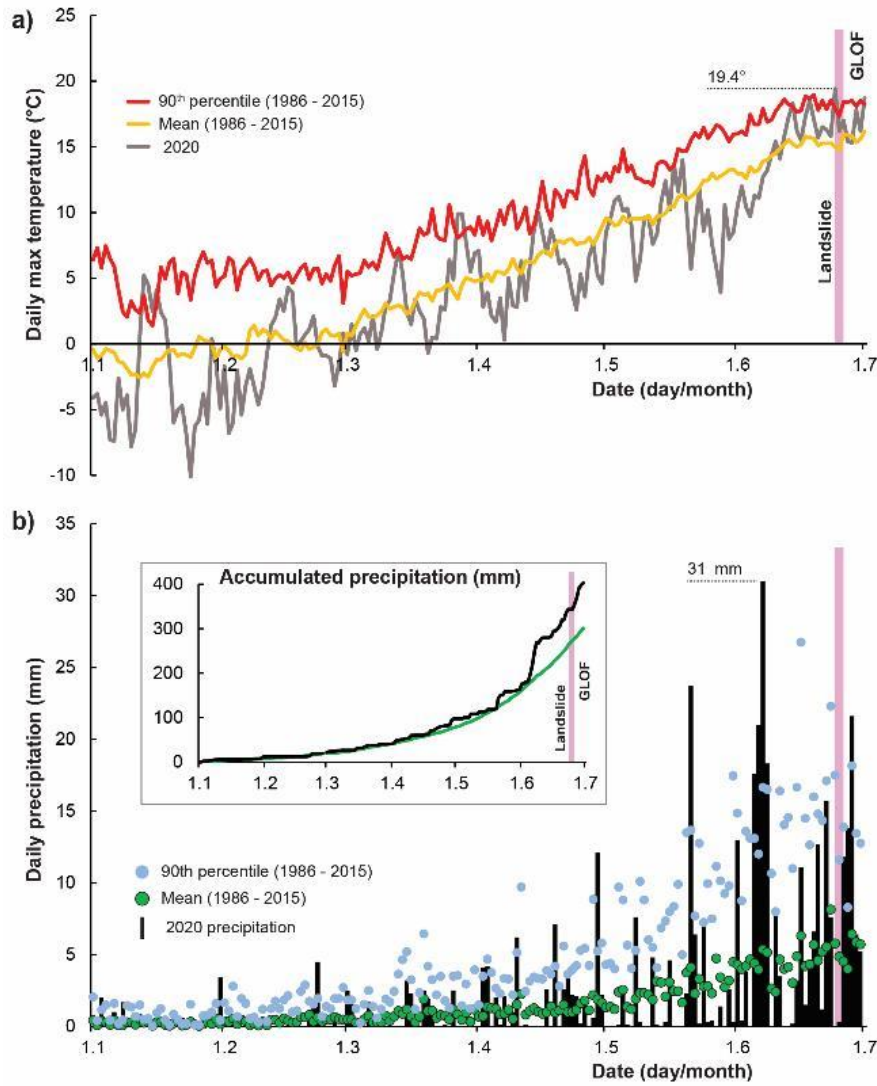
315 **Figure 7. Meteorological conditions from January - June 2020, measured at the Lhari weather station, compared to the longer-term climatology (1986–2015).**

When compared to the longer-term climatology it becomes immediately obvious that the landslide and GLOF process chain at Jinwucu occurred following a period of above average temperatures and unusually wet weather (Fig. 7). Over the dry winter and into the pre-monsoon months, precipitation measured at Lhari station was consistent with the longer-term mean, as seen in the accumulated totals (Fig. 7b). However, through May and particularly June 2020, notable periods of extremely heavy precipitation occurred, regularly exceeding 90th and even 95th percentile levels. In June, the 1986–2015 average precipitation total was 141 mm, compared to 240 mm in 2020, corresponding to an anomaly of +70%. A particularly wet period is observed from 5–8 June 2020, with a total of 88 mm and a daily maximum of 31 mm of precipitation on 7 June 2020. Temperatures transitioned from unusually cold conditions in late May and early June, to anonymously warm temperatures from mid-June onwards. Over the 14 days preceding the GLOF, temperatures were 1.6°C warmer than average, peaking at 4.4°C on 24 June, when an extremely warm daily maximum temperature of 19.4°C exceeded 90th percentile values. During the cold period minimum temperatures were at or below freezing, suggesting some of the heavy precipitation from 5–8 June would have fallen as snow around Jinwucu. Subsequent gradual snowmelt could provide a plausible explanation for the lag between this heavy precipitation episode, landslide initiation, and moraine breach, given that the GLOF event was preceded by two relatively dry, yet warm days (Fig. 7a).

We now elaborate on the possible triggers of the landslide. The meteorological conditions in June 2020 (Fig. 7) were characterized by extremely high precipitation in the period from 5–8 June. Further rainfall and snowmelt under unusually warm conditions after 8 June are factors which most likely caused a gradual destabilisation of the moraine. The rather dry and extremely warm conditions immediately prior to the GLOF may have induced increased melting and thawing processes, leading to the final tipping point of a system which had already been at the verge of collapse, resulting in slope failure and the GLOF-triggering landslide, most likely on 26 June.

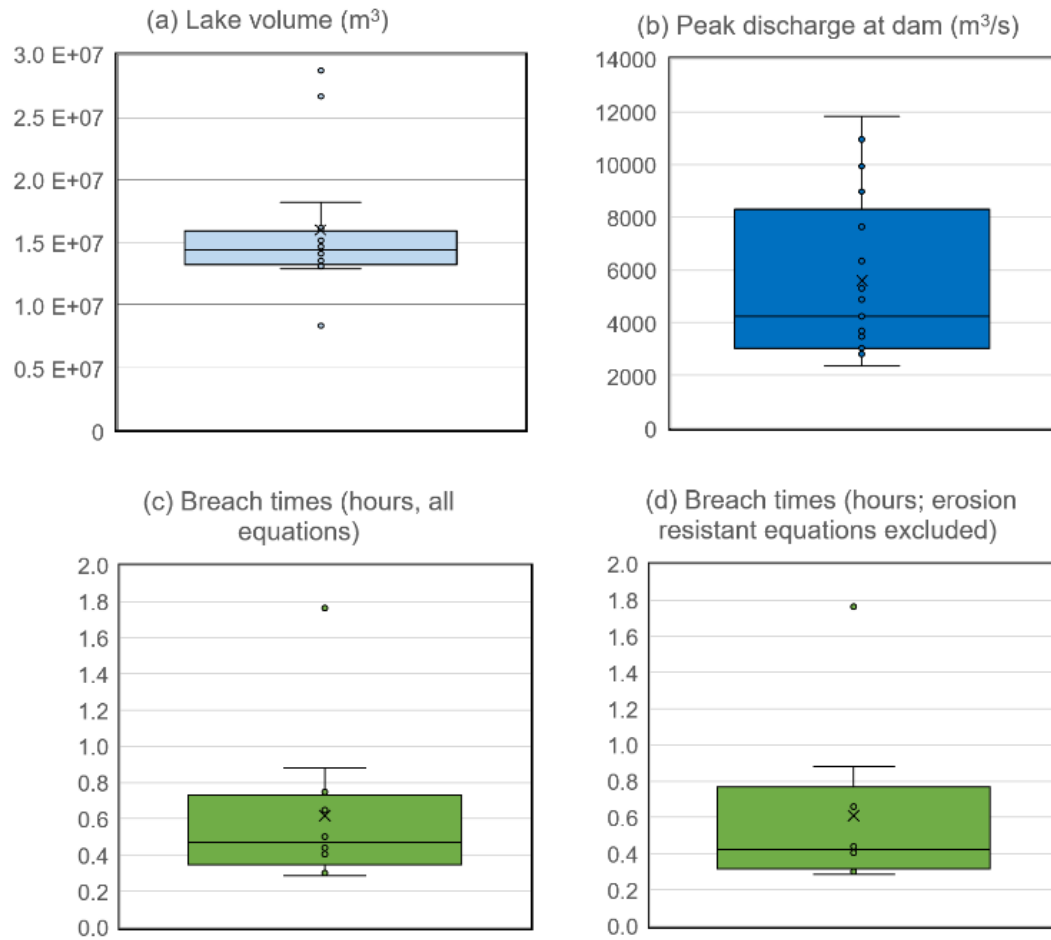
Figure 8. Lake, dam breach and flood parameters, derived from sets of published empirical relationships. (a) Volume of Jinwuco. (b) Peak discharge at the dam. (c) Breach time, considering all available equations. (d) Breach time, considering only those equations derived for easily erodible dams (an assumption we consider likely to hold for the dam of Jinwuco).

Out of 16 lake volume equations, 14 yielded meaningful results (within the range of mean \pm 1 standard deviation), ranging from 8.3 to 26.6 million m^3 . Mean calculated lake volume is 15.9 million m^3 and the median value is 14.4 million m^3 . This is slightly higher, but compares favorably to a reconstructed volume of 13.9 million m^3 used in the process chain simulations (Section 3.6). The first (Q1) and the third quartile (Q3) are 13.3 million m^3 and 15.9 million m^3 respectively (Fig. 8a). Accordingly, calculated mean depth of the lake ranges from 14.8 to 51.3 m (average mean depth 28.5 m, median mean depth 25.7 m, Q1 is 23.7 m and Q3 is 28.4 m). Calculated breach times range from 0.28 to 1.76 hours, with 11 out of 12 calculated values suggesting a breach time < 1 hour, with the mean value of 0.62 hours and a median of 0.47 hours (0.61 hours and 0.43 hours, respectively, if equations for erosion resistant dam are excluded; Fig. 8c, d). Calculated peak discharge at the dam ranges from 2,354 m^3/s to 11,832 m^3/s . The average value of calculated peak discharges is 5,602 m^3/s while the median is 4,237 m^3/s . Q1 and Q3 are 3,035 m^3/s and 7,636 m^3/s respectively (Fig. 8b).

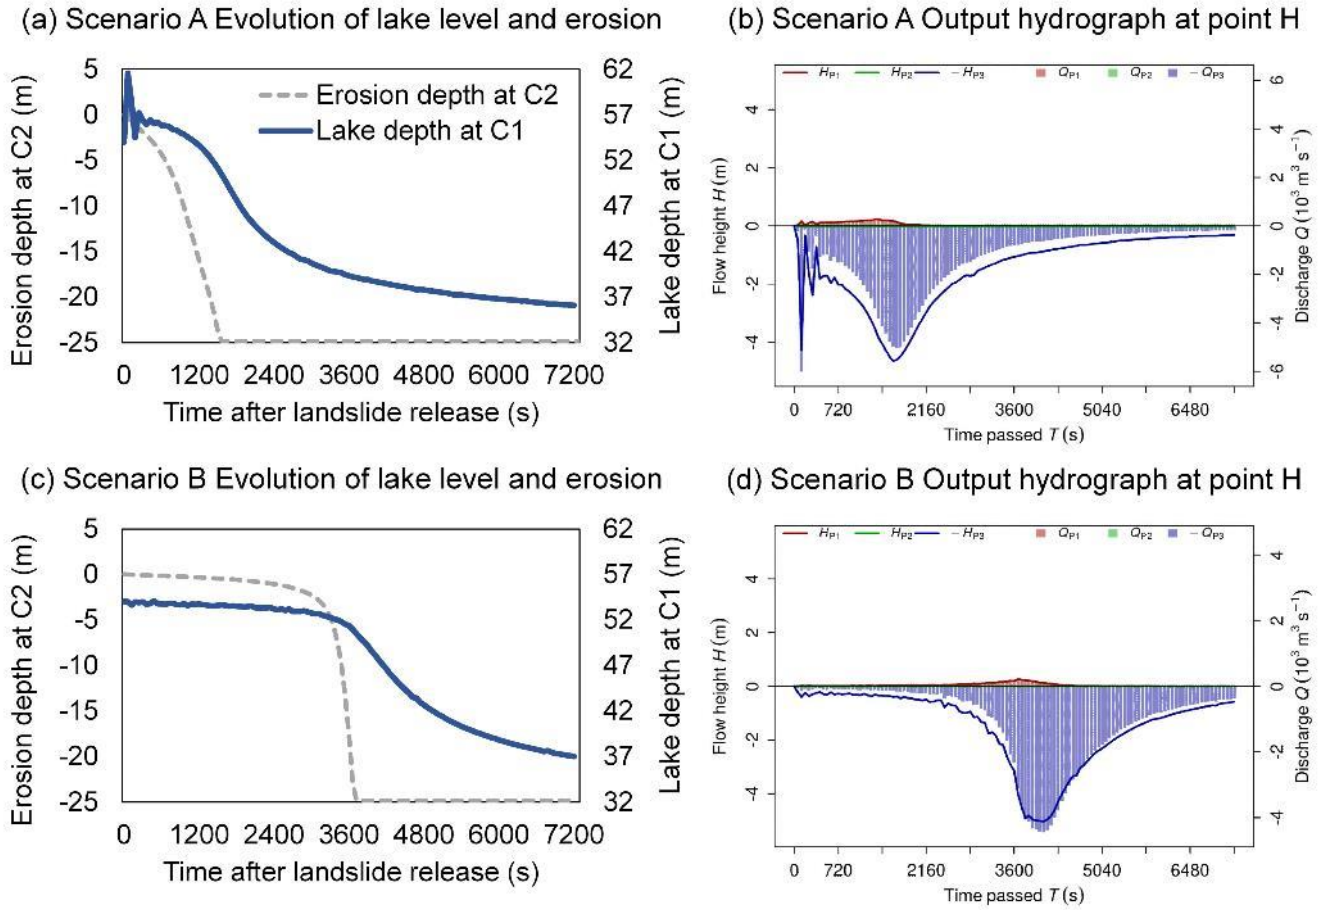
Figure 9. Dam breach as simulated with r.avaflow. (a) Scenario A, evolution of lake level and the erosion channel. (b) Scenario A, output hydrograph. (c) Scenario B, evolution of lake level and the erosion channel. (d) Scenario B, output hydrograph. Locations of the points C1, C2, and H are indicated in Figure 5 and Figure 11. In the output hydrographs, H means flow height, and Q means discharge. The subscript P1 refers to phase 1 (rock), P2 to phase 2 (not existent in this case), and P3 to phase 3 (water). Fluid discharge and flow height are plotted in negative direction for better readability.

A detailed look at the dam breach (Fig. 9) reveals that the simulation results for both scenarios A and B are in good correspondence with the ranges of peak discharge and breach depth derived through the empirical relationships described in Section 4.4 and illustrated in Fig. 8. For Scenario A: at the point C2 (Fig. 5 or Fig. 10), depth erosion is completed at $t = 26$ minutes after landslide release, i.e. 24–25 minutes (0.41 hours) after the impact wave had reached the outlet of the lake, initiating retrogressive erosion. This time span is well within, even though in the lower part, of the range revealed in Fig. 8d. After the breach has developed to its full depth, lake drainage continues and asymptotically approaches the level of the eroded gully (Fig. 9a). The peak discharge associated with the landslide-induced impact wave reaches 17,900 m³/s after 100 s (computed at a higher temporal resolution, therefore not visible in Fig. 9b). Afterwards, discharge decreases and then increases again due to retrogressive erosion of the moraine dam. The simulated peak discharge during the retrogressive erosion stage reaches 5,200 m³/s at $t = 28$ minutes, being well within the range indicated in Fig. 8b. With dropping lake level, the simulated discharge slowly decreases to a small residual value after two hours (Fig. 9b). At all stages, the simulated flow is dominated by water, with a peak of approx. 220 m³/s of solid discharge at $t = 23$ minutes, when retrogressive erosion is the most intense.

The patterns yielded with the simulation of Scenario B (Fig. 9c and d) are similar in general, with the exception of the initial impact wave that is only observed in Scenario A. However, onset of erosion takes more time, so that the breach and associated emptying of the lake are delayed. The tipping point where slight channel erosion turns into a rapid dam breach occurs at approx. 35–39 minutes after the start of the simulation, depending on the definition. The base level of the erodible material is reached at $t = 62$ minutes (23–27 minutes or 0.38–0.45 hours after the tipping point – in the lower part of the range indicated in Fig. 8d). The peak discharge of $4,600 \text{ m}^3/\text{s}$ is reached at $t = 68$ minutes. As is also the case in Scenario A, the flow is entirely dominated by fluid: solid discharge peaks at $200 \text{ m}^3/\text{s}$ at $t = 61$ minutes. Emptying of the lake continues at a decreasing rate afterwards. The lake level has dropped by 17 m after two hours, meaning that the final drop of 20 m has not yet been reached.

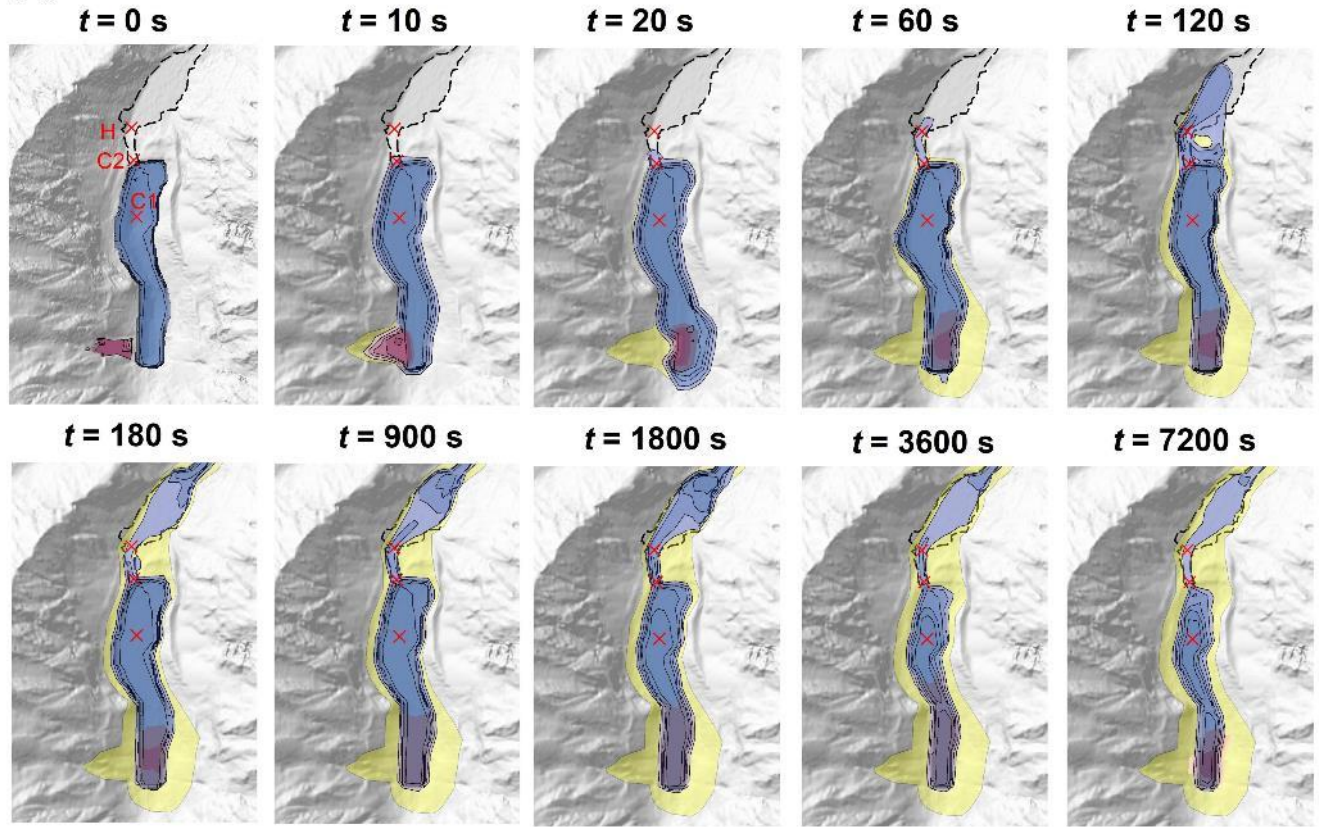
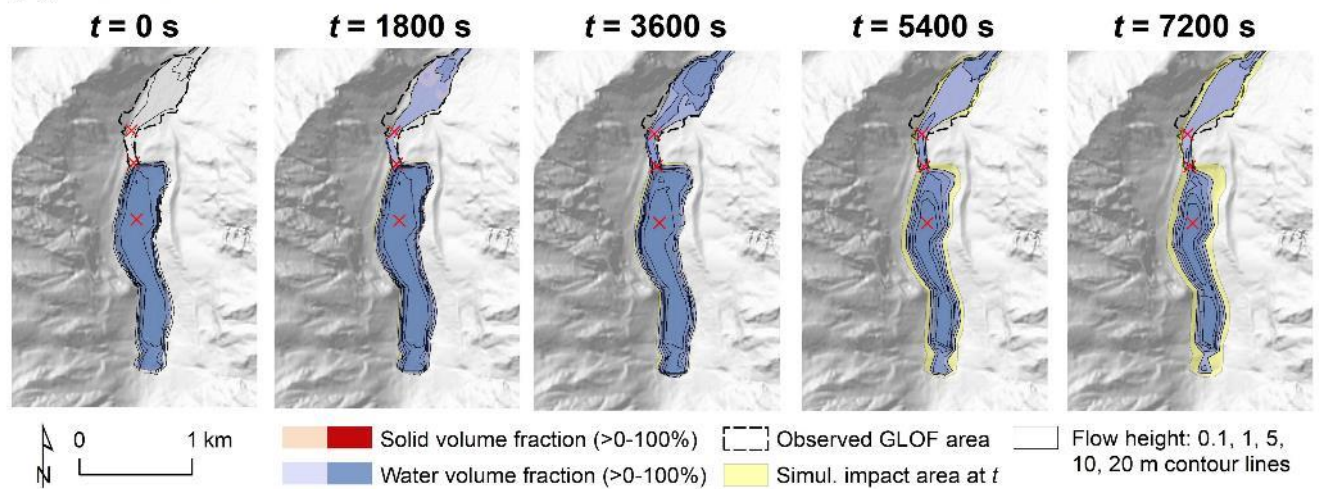
(a) Scenario A

(b) Scenario B

Figure 10. Evolution of flow height and GLOF impact area as well as solid and water volume fractions during the first two hours of the event, as simulated with r.avaflow for (a) Scenario A and (b) Scenario B. Only the section until the floodplain immediately downstream from the moraine dam is considered in these simulations. Base map is shaded relief map based on the DEM generated from Ziyuan-3 stereoscopic pairs and the simulation results.

5 s indicates the onset of overtopping. Retrogressive erosion initiates along the main outflow channel, induced by the signal of the initial impact wave. Some of the wave energy is reflected at the shore of the lake towards the terminal moraine, so that a secondary wave with a height of 5.5 m passes through C1 at $t = 140$ s. Linear retrogressive erosion of the moraine dam leads to a continuous lowering of the base of the outflow channel, and consequently, lowering of the lake level. Two hours after the onset of the initial landslide, the lake has shrunk to both a size and level which come close to the post-event observations. Until this point of time, approx. 9.5 million m^3 of water have drained through the hydrograph profile at point H (Fig. 9), according to the simulation. A main difference to the observation consists in the massive overtopping of the moraine dam (visible at $t = 120$ s), a behaviour not revealed by the available post-event imagery. The simulated impact area on the floodplain immediately downstream of the dam is slightly overestimated, compared to the observed impact area in that section. In comparison, Fig. 10b shows the flow height evolution for Scenario B where there is no initial impact wave, consequently also no sheet flow over the moraine dam, and a better correspondence of observed and simulated impact areas.

The availability of satellite imagery at high spatial and temporal resolution is invaluable for the reconstruction of the timing and mechanisms of high-mountain process chains such as GLOFs. The understanding of events in earlier history sometimes suffers from the impossibility of determining the cause of a GLOF due to lacking data: in the 1941 event at Lake Palcacocha in the Peruvian Andes (Mergili et al., 2020), there is still speculation about triggering of the catastrophic moraine dam breach by calving or an ice avalanche, however poorly supported by evidence. In the case of the Jinwuco event, in contrast, there is clear evidence that a landslide has entered the lake not more than two days before the GLOF (Fig. 3), even though the quantification of landslide volume is to be interpreted as rough estimate rather than exact value, given the hard-to-quantify uncertainties in the available pre- and post-event DEMs. We assume a direct temporal coincidence between the two processes, with the landslide having triggered the GLOF, as the most likely set of scenarios. However, there is strong evidence that there was no massive, extremely rapid landslide impact into the lake: comparison of pre-event and post-event satellite imagery reveal no overtopping of the dam, and not even the run-up of lake water on the inner side of the moraine dam (Fig. 3 and Fig. 5). Both the simulation (Scenario A; Fig. 10a) and observations of other GLOFs (e.g. Schneider et al., 2014) would reveal such a behaviour. Therefore, we consider a rather slow and/or progressive movement of the landslide into the lake much more likely, represented by Scenario B (Fig. 10b).

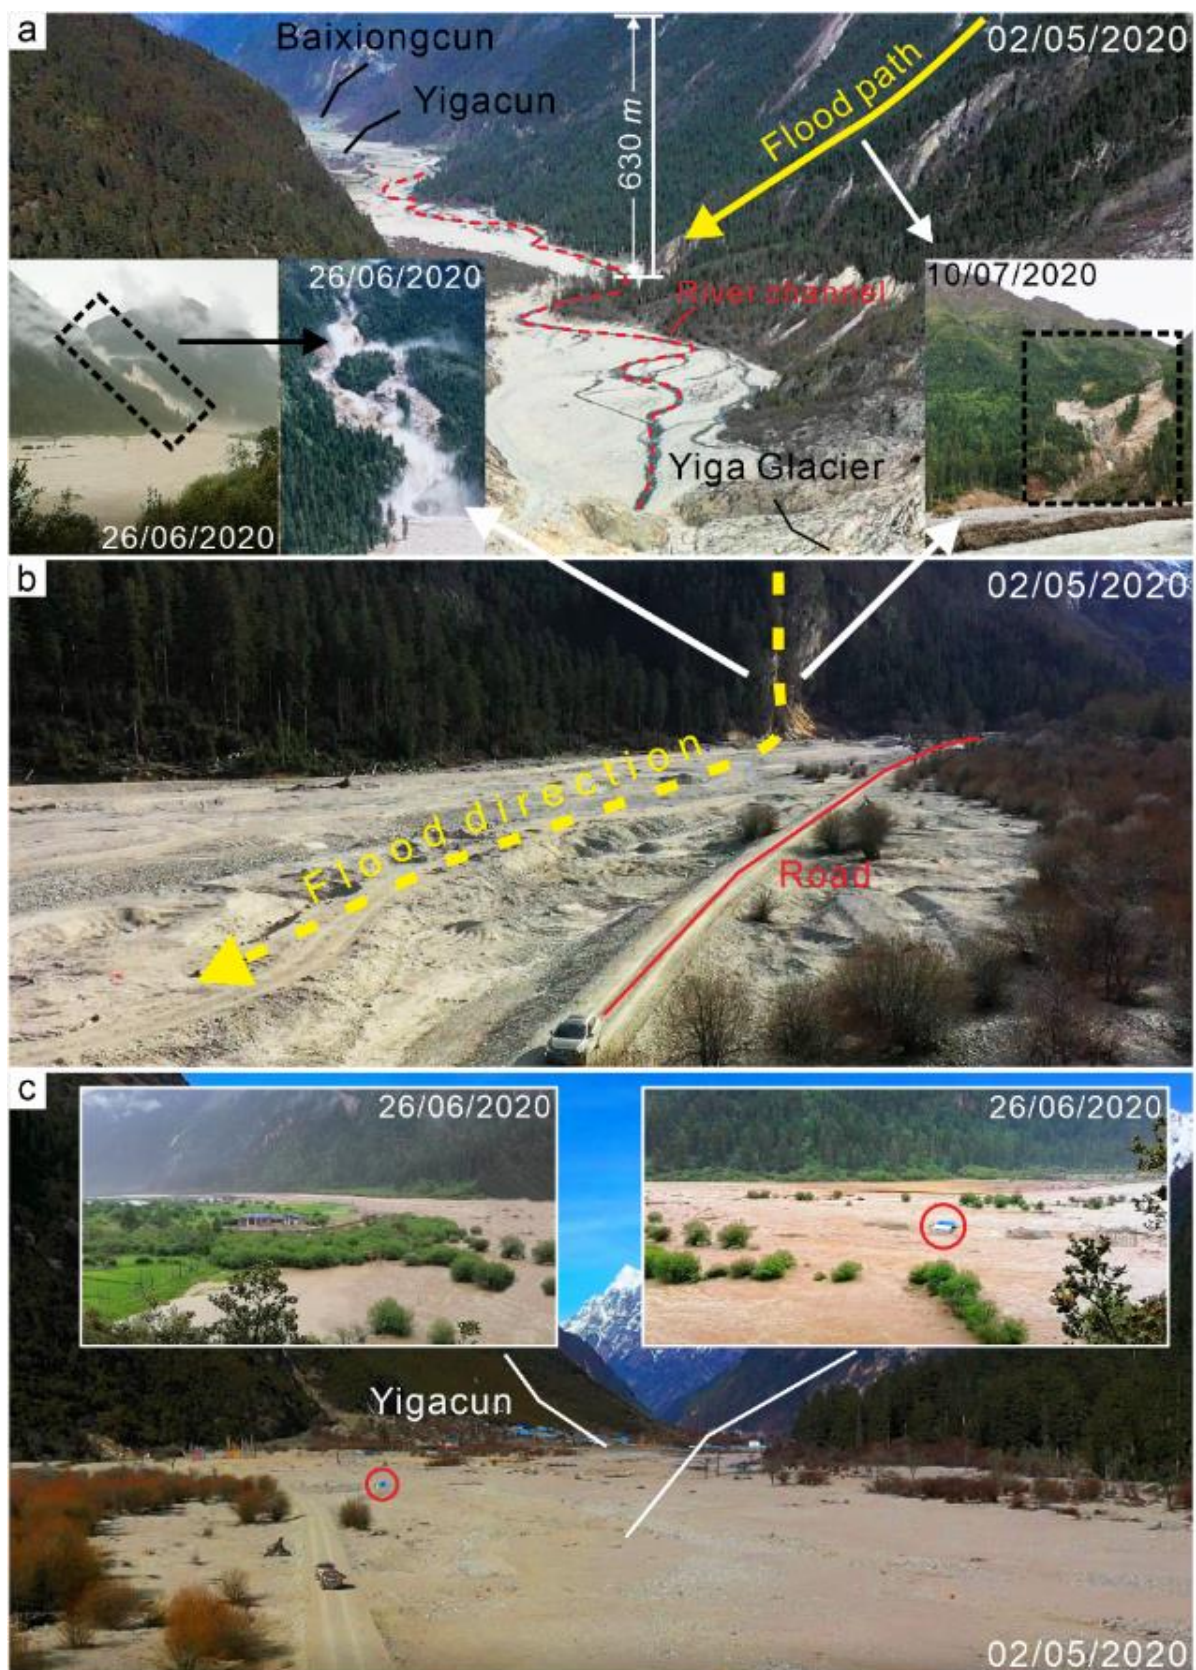
Figure 11. The situations in the valley and river channel below Jinwuco before, during, and after the GLOF. (a) Photo taken from Yiga Glacier looking to Yigacun. Insets showing the situations in the valley during and after the GLOF (photos: Q. Quying and Y. Quzhen). (b) The river channel and road before the GLOF taken from Yigacun looking upstream. The yellow dashed line is the flood flow direction. (c) A view taken from upstream looking to Yigacun. Insets showing the situations in the river channel during the GLOF (photos: Q. Quying). Aerial photos from 2 May 2020 were taken by K. Liang.

Fig. 11 shows the valley and river channel below Jinwuco before, during and after the GLOF. It is evident from the comparison of the photographs that the floodwaters almost inundated the wide river valley downstream and reached the location of Yigacun, located in a relatively high position. The large elevation difference between the surface of Jinwuco and the downstream river channel (approx. 630 m) provides significant potential energy, setting the stage for enhanced erosion and greater damage.

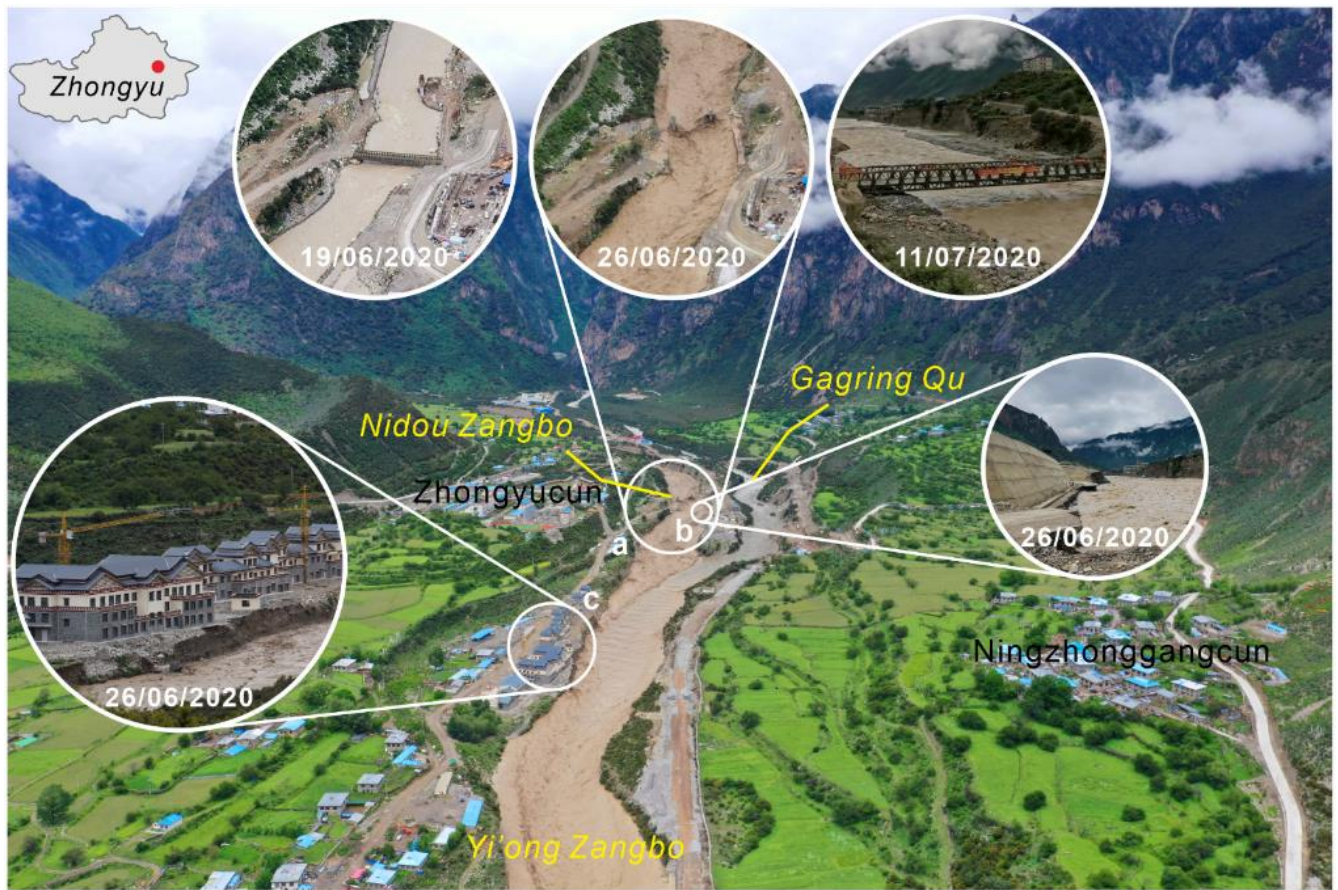
Figure 12. Examples of GLOF damage to downstream infrastructure and buildings at the confluence of Nidou Zangbo and Gagrang Qu. Background aerial photo by H. Li taken on 26 June 2020. (a) Comparison of the bridge connecting Zhongyucun and Ningzhonggangcun before, during (photos: H. Li) and after the GLOF (rebuilt, photo: K. Ma). (b) Destroyed roads (photo: H. Li). (c) Affected buildings at risk (photo: H. Li).

410 Further, the flood caused severe erosion of the lower valley and alteration of the river channel below through the formation of alluvial fans. Fig. 12 gives a picture of the situation during the flood further downstream at the location of Zhongyucun. The aerial photograph shows that the massive impact of the flood washed away roads, bridges and put some buildings along the river at risk. The Zhongyu township has experienced rapid development and expansion of infrastructure over the past fifteen years (some examples are shown in Fig. 13). Such development has increased the level of exposure to potential GLOFs, as

415 shown in Fig. 12c: these buildings were constructed recently in areas located directly on the riverbanks and exposed to flooding.

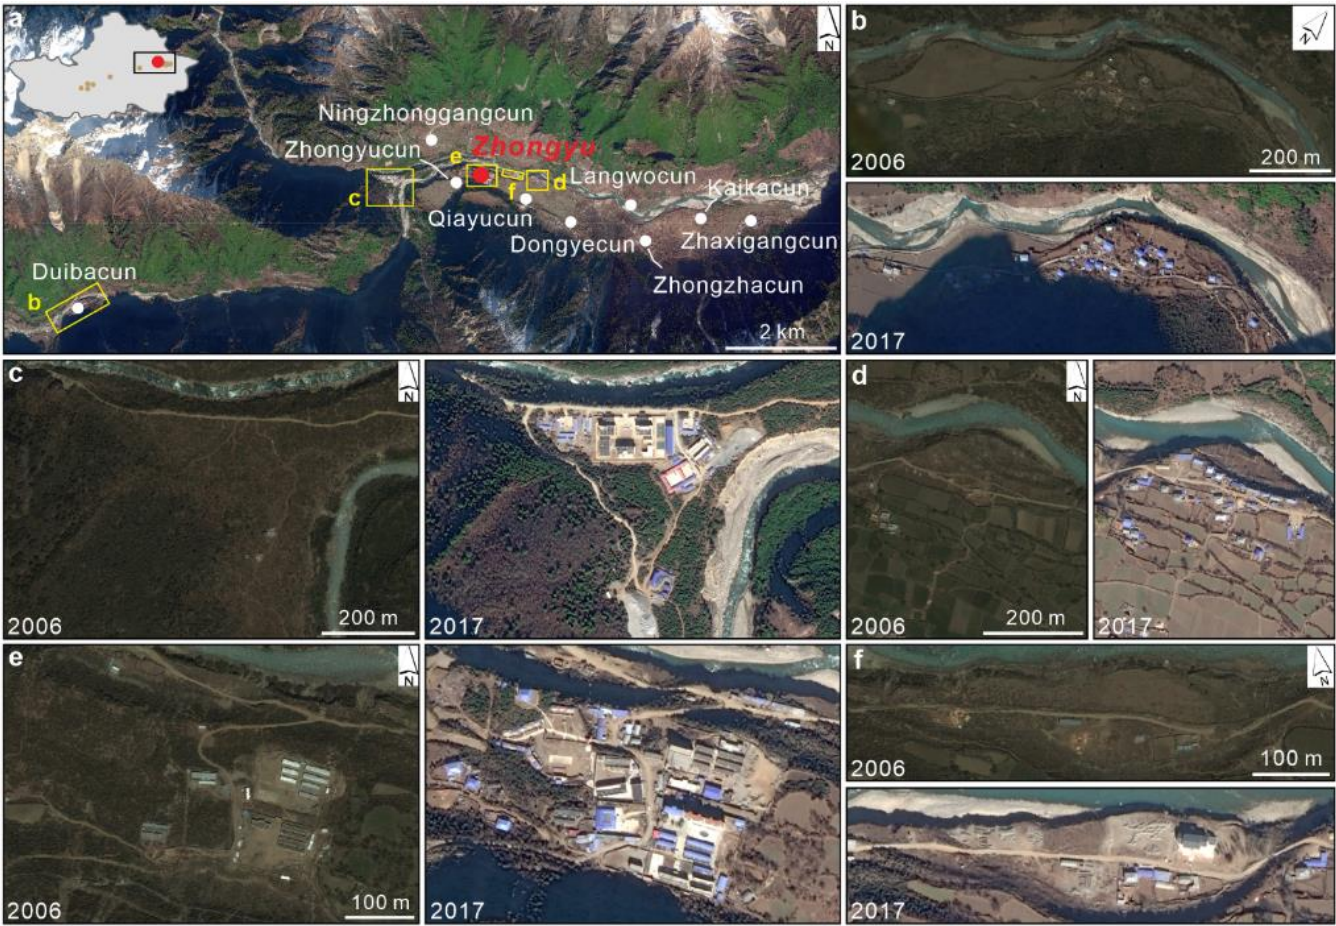
Figure 13. Examples of rapid development and expansion of the villages of lower Zhongyu township during 2006–2017. The background of panel a and the satellite scenes for 2017 panels are a true-colour composite Gaofen-2 image acquired on 7 December 2017. The satellite images for the 2006 panels are from © Google Earth acquired on 30 April 2006.
