# The temperature-dependent shear strength of ice-filled joints in rock mass considering the effect of joint roughness, opening and shear rates

**Abstract.** Global warming causes many rockfall activities of the alpine mountains, especially when ice-filled joints in the rock mass become thawed. The warming and thawing of frozen soils and intact rocks were widely studied in the past several decades, however, the variation of shear strengths of ice-filled joints was not fully understood. In this study, a series of compression-shear experiments were conducted to investigate the shear strength of ice-filled rock joints by considering the effects of joint roughness, temperature, opening, shear rates and normal stress. The joint roughness can improve the shear strength of ice-filled joints. However, the contribution of joint roughness is controlled by some noticeable bulges instead of the JRC index. The shear strength linearly increases with increasing the aggregation of rupture ice area before these noticeable bulges. As the joint opening increases, the effect of joint roughness decreases and the shear strength of ice-filled joints tends to be equal to the shear strength of pure ice. I

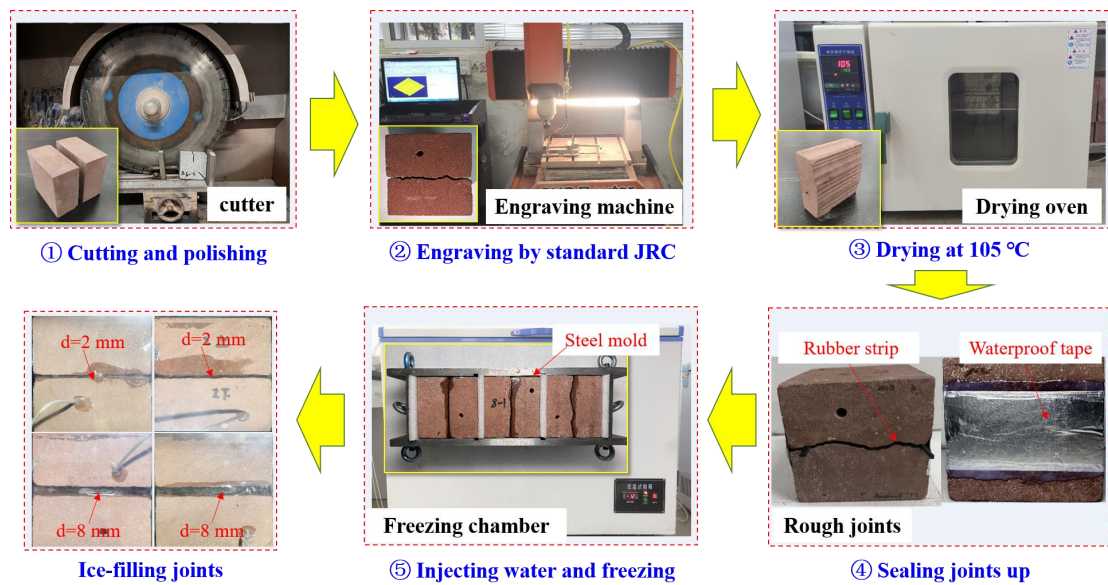
**Figure 1.** Preparation of ice-filled joints. The preparation steps are as follows: ① Cutting and polishing, ② Engraving by standard, ③ Drying at 105 °C, ④ Sealing joints up, ⑤ Injecting water and freezing.

⑤ When the waterproof tape was tightly bonded on the rock surface, liquid water should be injected into the artificial joint until no water leaks out. After that, the water-filled joint rock mass was put into a steel mold to freeze in a freezing chamber. The steel mold was used to control the joint opening because the volume of joint water would expand during freezing. Then ice-filled joint samples can be derived after freezing at -20 °C for 12 h. The manufacturing procedure and related ice-filled joint samples were shown in Fig. 1.

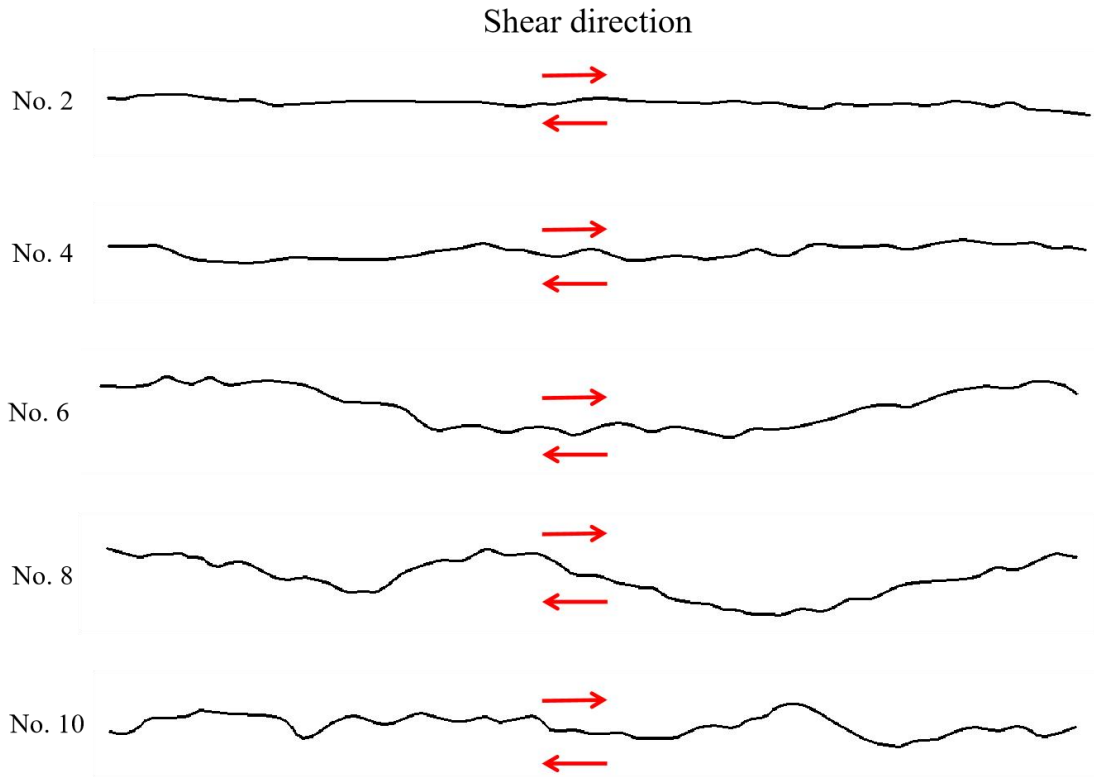
**Figure 2.** The shear directions for different joint profiles.

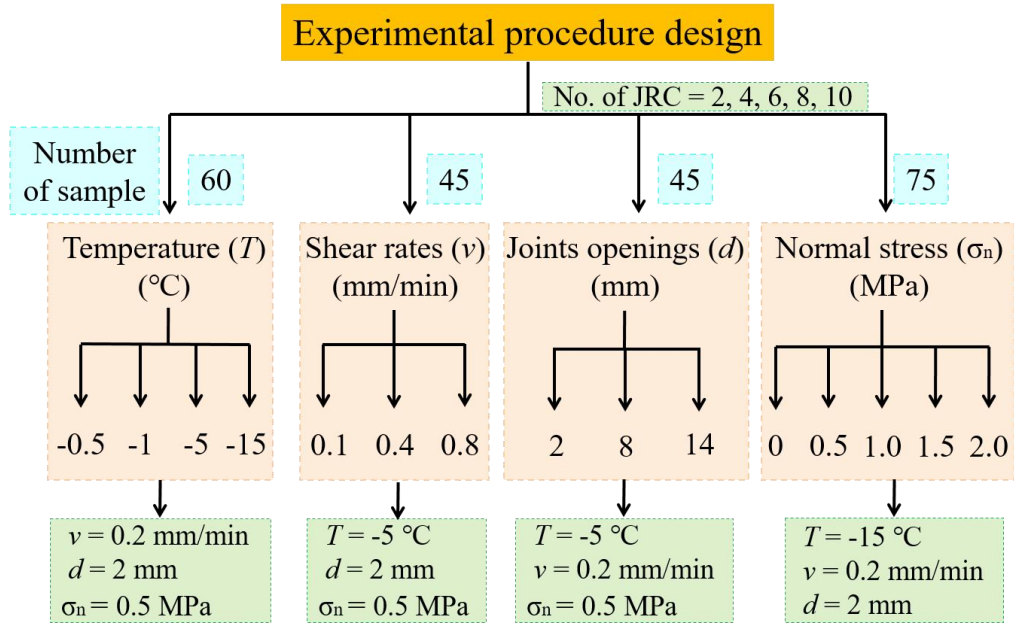
**Figure 3.** Distribution of rock samples containing ice-filled joints.  $T$ : Temperature.  $v$ : Shear rates.  $d$ : Joint openings.  $\sigma_n$ : Normal stress.

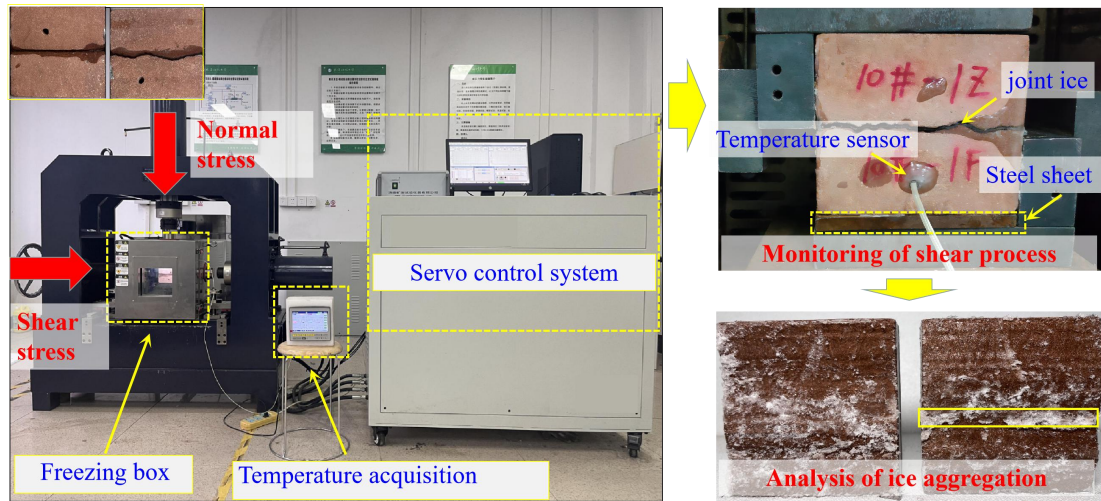
**Figure 4.** Shear experiment procedure and equipment

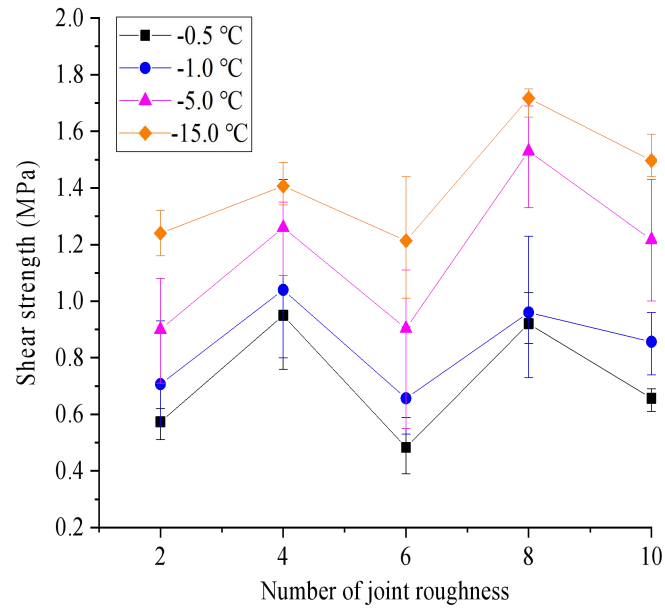
**Figure 5.** Shear strength against joint roughness at different freezing temperatures. Experimental condition:  $\nu = 0.2$

mm/min,  $d = 2$  mm,  $\sigma_n = 0.5$  MPa.

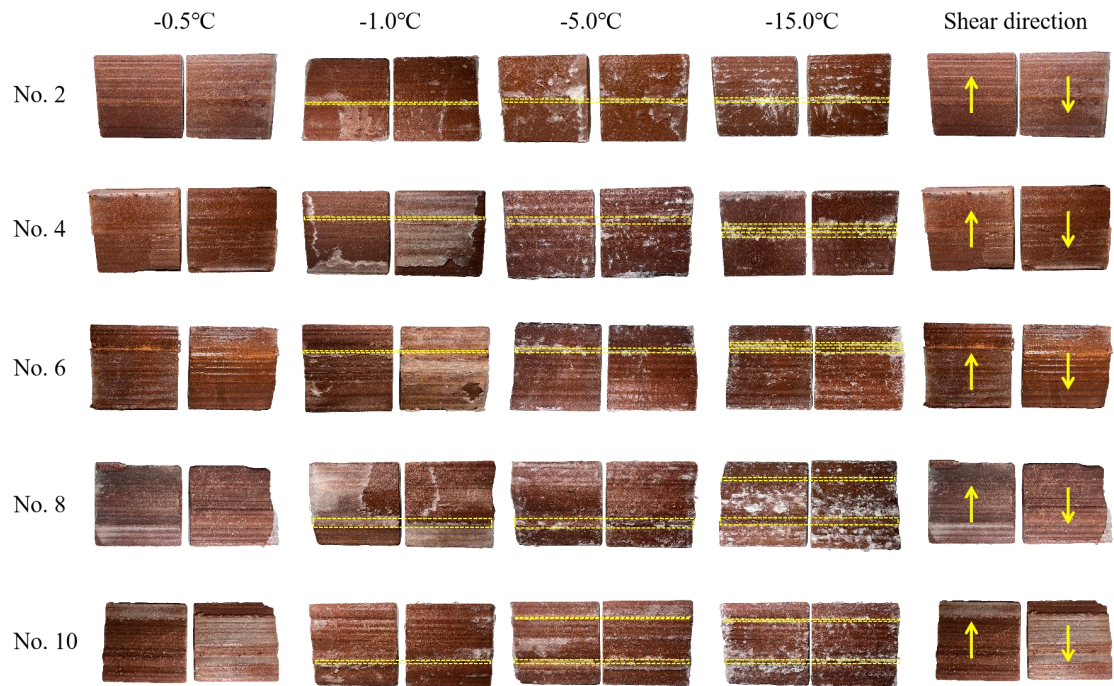
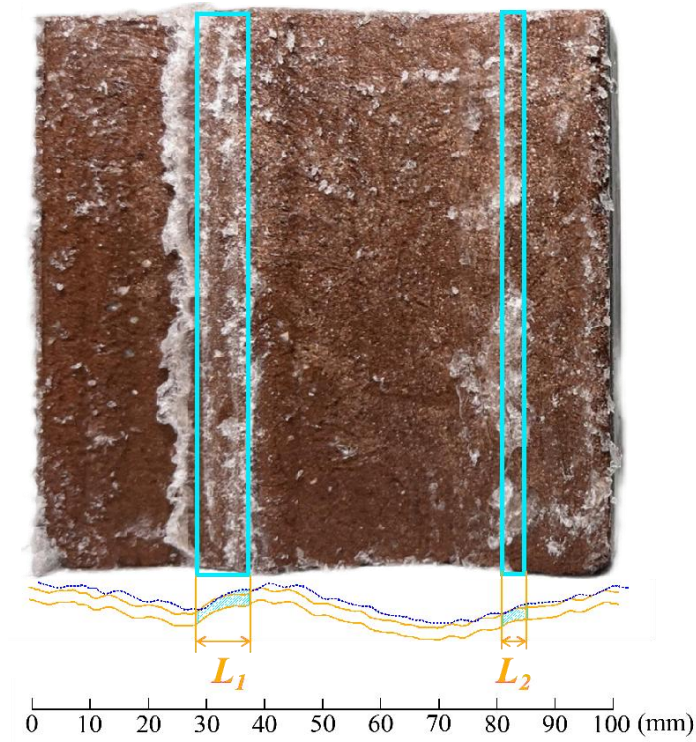
(a) Shear rupture modes

(b) Determination of the aggregation area of the rupture ice

**Figure 6.** Shear rupture modes and aggregation area of ice-filled joints at different freezing temperatures. The yellow dotted lines show the main aggregation of rupture ice. Ice after rupture will aggregate in roughness bulges perpendicular to the shear direction.

However, the experimental results show that the shearing failure of many rough ice-filled joints at -0.5 °C is the debonding of ice-rock interfaces (Figs. 6, 12, 13, 18). More shear experiments were carried out on rough ice-rock interfaces with profiles of No. 4 and No. 8 on the same experimental condition ( $\sigma_n = 0.5$  MPa,  $v = 0.2$  mm/min). It shows that the shear strength of rock-ice-rock “sandwich” is a little larger than that of ice-rock interface, although the change laws of them against temperature are very similar. Another novel finding is that the shear strength of ice-rock interface is larger than the shear strength of solid ice itself below -1 °C (Fig. 21b). Therefore, the shear failure below -1 °C displays the cracking of joint ice instead of ice-rock interface, and some aggregation areas of rupture ice occur before large bulges (Figs. 6, 12, 13, 18). However, the shear strength of solid ice is larger than that of ice-rock interface above -1 °C. This is the main reason for the shear failure of rough ice-filled joints along ice-rock interfaces at -0.5 °C. The freezing temperature of -1 °C is the transition point of shear failure modes. Figure 22 presents that the shear failure is along the ice-rock interface when the freezing temperature is approximate -0.5 °C, however, the area of ice attached to the joints has a great increment with the decrement of freezing temperature from -0.5 °C to -15 °C. It further illustrates that the shear strength of rough ice-rock interface is larger than that of the solid ice below -5°C. Mamot et al. (2018) also found that the shear failure modes of the smooth ice-filled joints

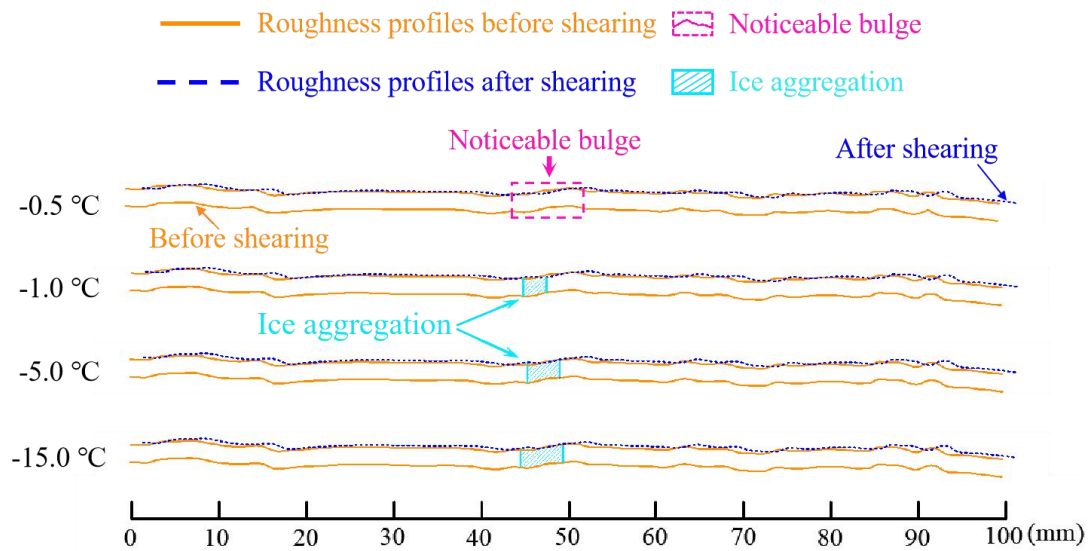
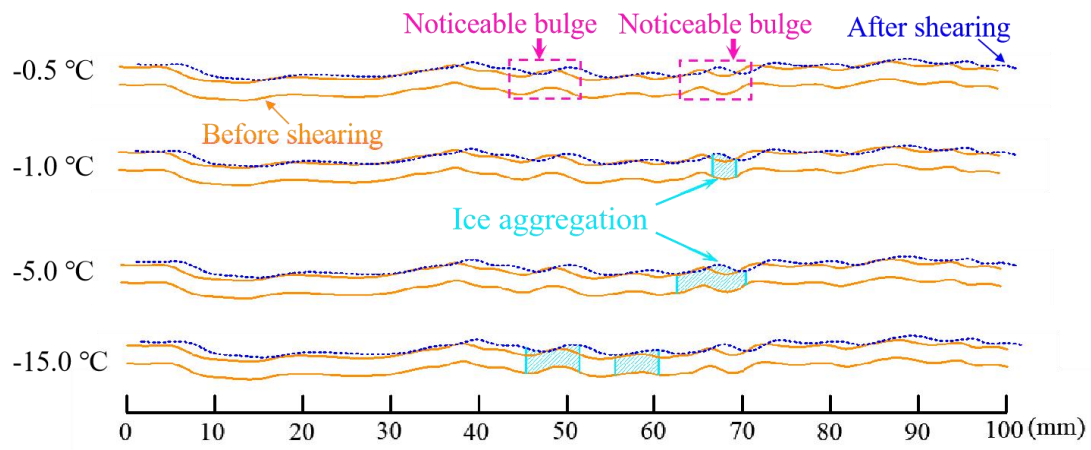
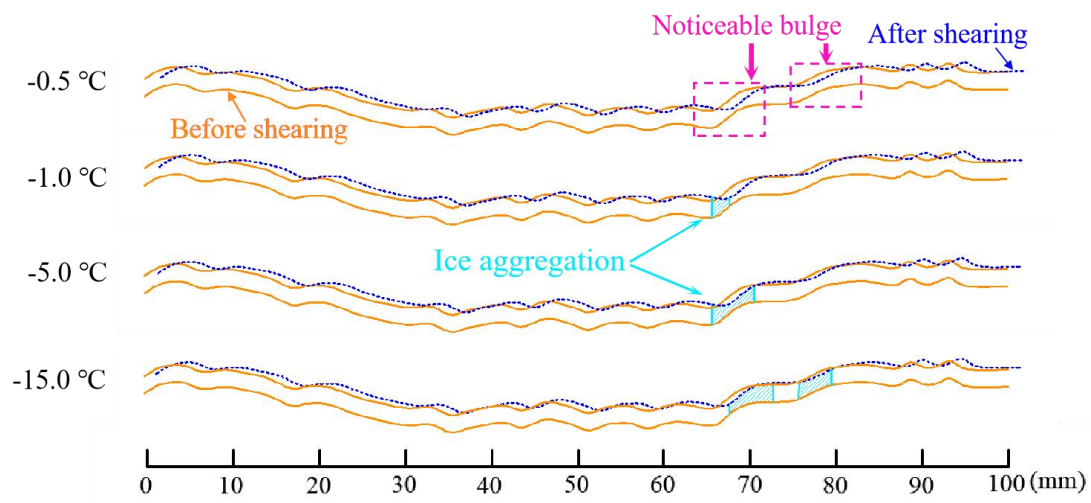
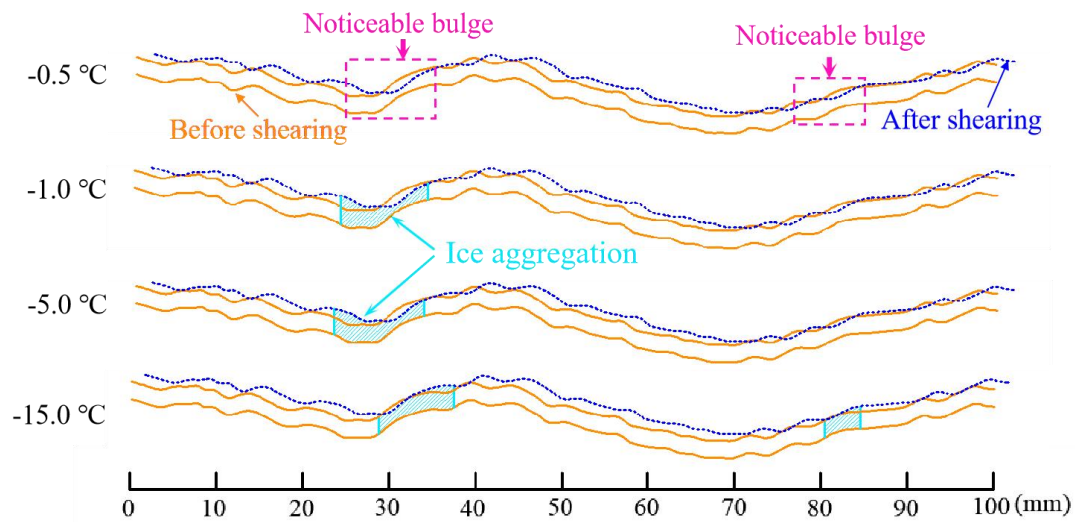
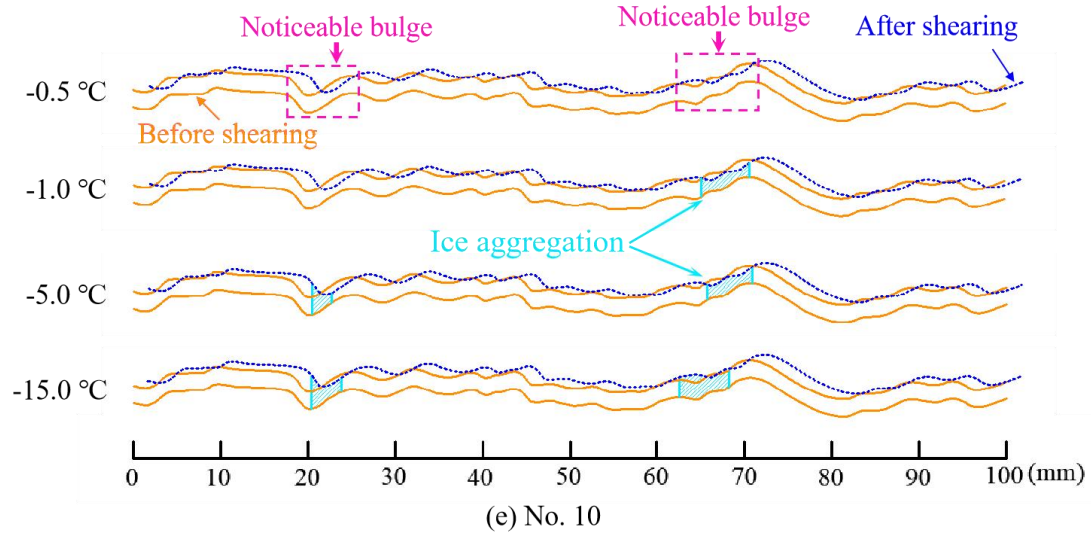
**Figure 7.** Shear aggregation areas of ice along the profile of roughness. Experimental condition:  $v = 0.2$  mm/min,  $d = 2$  mm,  $\sigma_n = 0.5$  MPa. Some blue profiles (dotted curves) are located under the orange profiles (solid curves) after shearing, which means the width of joints becomes smaller. Generally, the reduction of joint width occurs before some bulges and the rupture ice will aggregate before these bulges. The bulges causing the reduction of joint width and aggregation of ice are called noticeable bulges. The noticeable bulges have larger inclination angles and they are far away from the joint edges.

The aggregation area and location along the rough profile of joints after shear failure are plotted in Fig. 7. It can be observed that the aggregation ice appears before several high bulges and the aggregation location is almost independent of the freezing temperature if aggregation ice occurs. The climbing bulges in front of the aggregation ice are noticeable and influential. It implies that the influence of joint roughness on the shear strengths of these ice-filled joints may be only controlled by several noticeable bulges instead of the JRC index. Figure 8 shows that the shear strengths of No. 6 and No. 10 display obvious reduction trends, which may be in accordance with the ice aggregation area. The ice aggregation area decreases with increasing the freezing temperature, because the bonding strength between ice and joint surface becomes to be weaker, and the shear rupture happens along the ice-rock interface instead of solid ice when the freezing temperature is larger than  $-0.5$  °C.

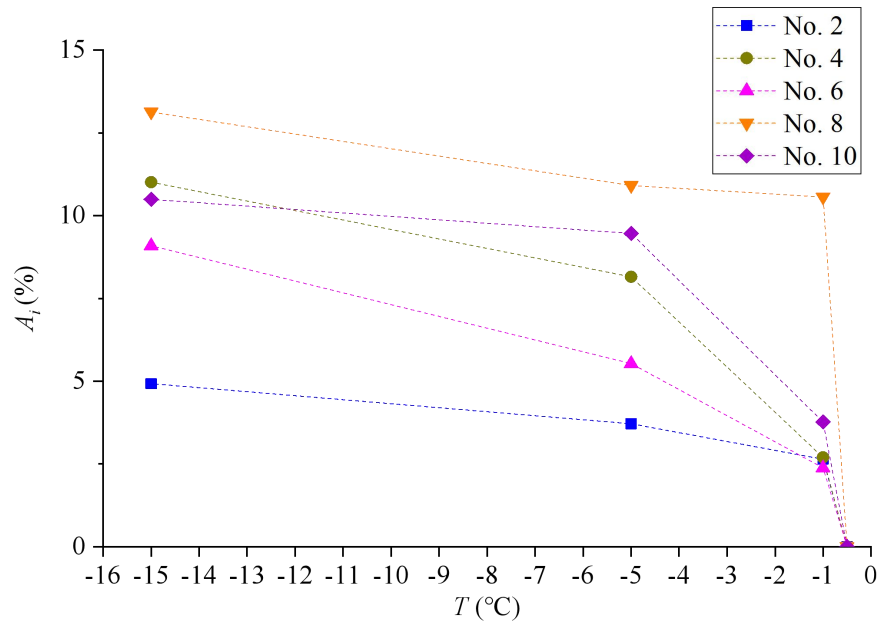
**Figure 8.** Aggregation area of rupture ice increases with the reduction of freezing temperature. Experimental conditions:  $v = 0.2$  mm/min,  $d = 2$  mm,  $\sigma_n = 0.5$  MPa.  $A_i$ : aggregation area percentage of rupture ice.

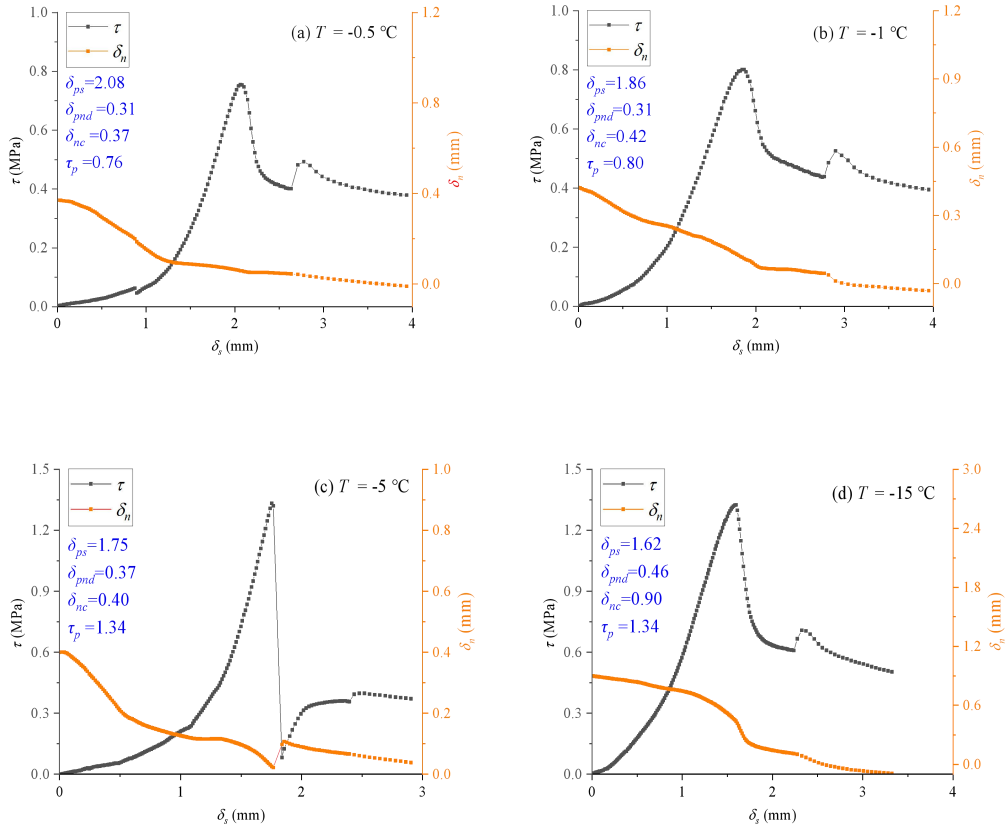
**Figure 9.** Shear strength and normal displacement versus the shear displacement for the profile of No. 4 in the temperature group.  $\delta_{ps}$  and  $\delta_{pnd}$  are the shear displacement and normal shear dilatancy at the point of peak shear strength,  $\tau_p$  and  $\delta_{nc}$  is the initial compression deformation.

Several typical shear stress-displacement and normal-shear displacement curves for the profile of No. 4 are plotted in Fig. 9. The ice-filled joint shows significant residual shear strength beyond the peak point, which slightly decreases with increasing shear displacement. This residual shear strength is caused by the friction effect between the upper and lower ice-filled blocks. In addition, the normal shear dilatancy displays increasing trend with shear displacement, which is caused by the climbing effect of ice-filled

joints. It should be noted that the shear strength has a second rising point at the residual strength stage, because the shear rate is increased from 0.2 mm/min to 1 mm/min in order to accelerate the completion of the shear process. Schulson and Fortt (2012) claimed that the friction between ice interfaces increases when the shear rates increase from 0.06 mm/min to 0.6 mm/min. Therefore, the sudden rise of residual shear strength can be attributed to the accelerated shear rate.

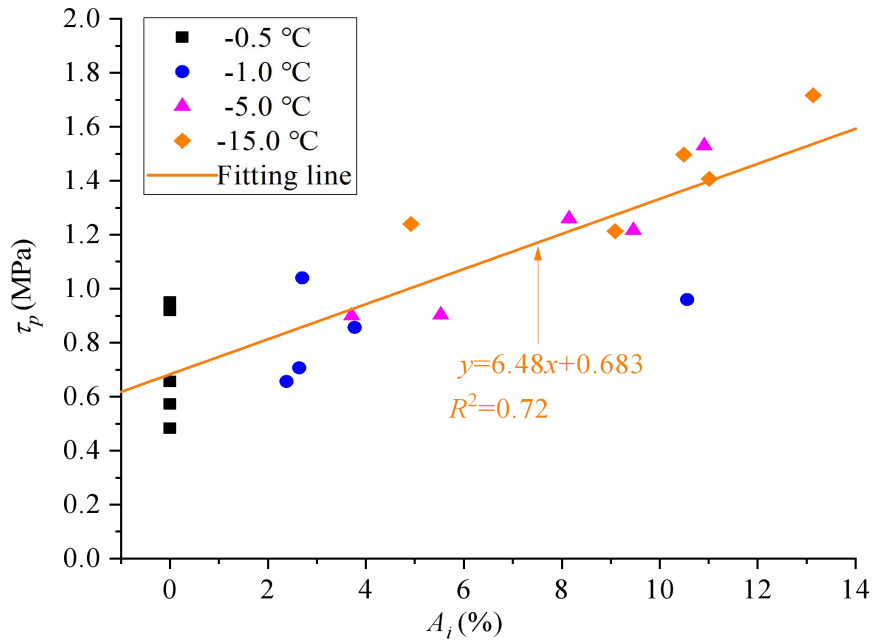
**Figure 10.** Peak shear strength linearly increases with increasing aggregation areas of rupture ice. Experimental condition:  $v = 0.2$  mm/min,  $d = 2$  mm and  $\sigma_n = 0.5$  MPa.

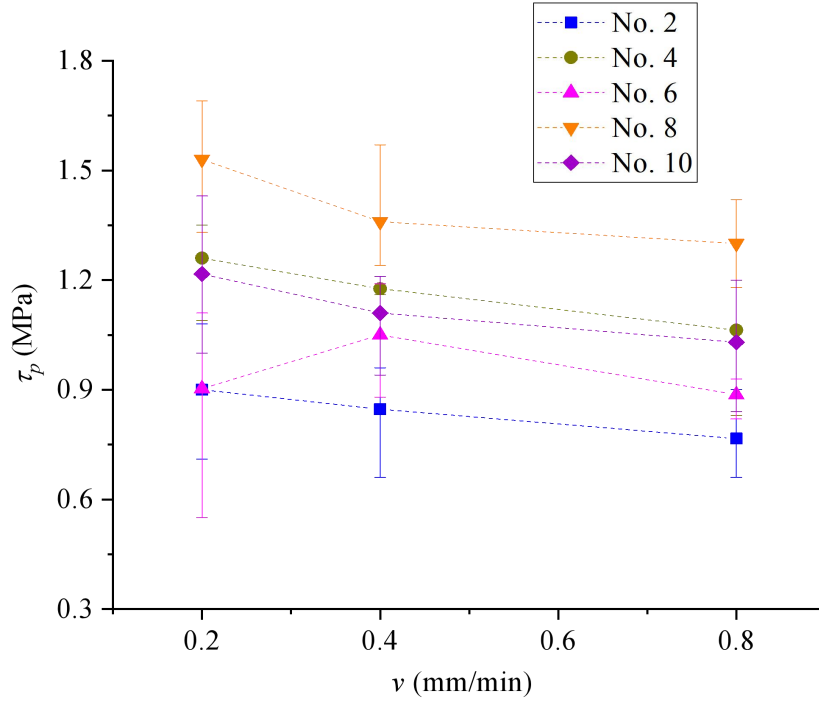
**Figure 11.** Effect of shear rate on the peak shear strength. Experimental condition:  $T = -5$  °C,  $d = 2$  mm and  $\sigma_n = 0.5$  MPa.

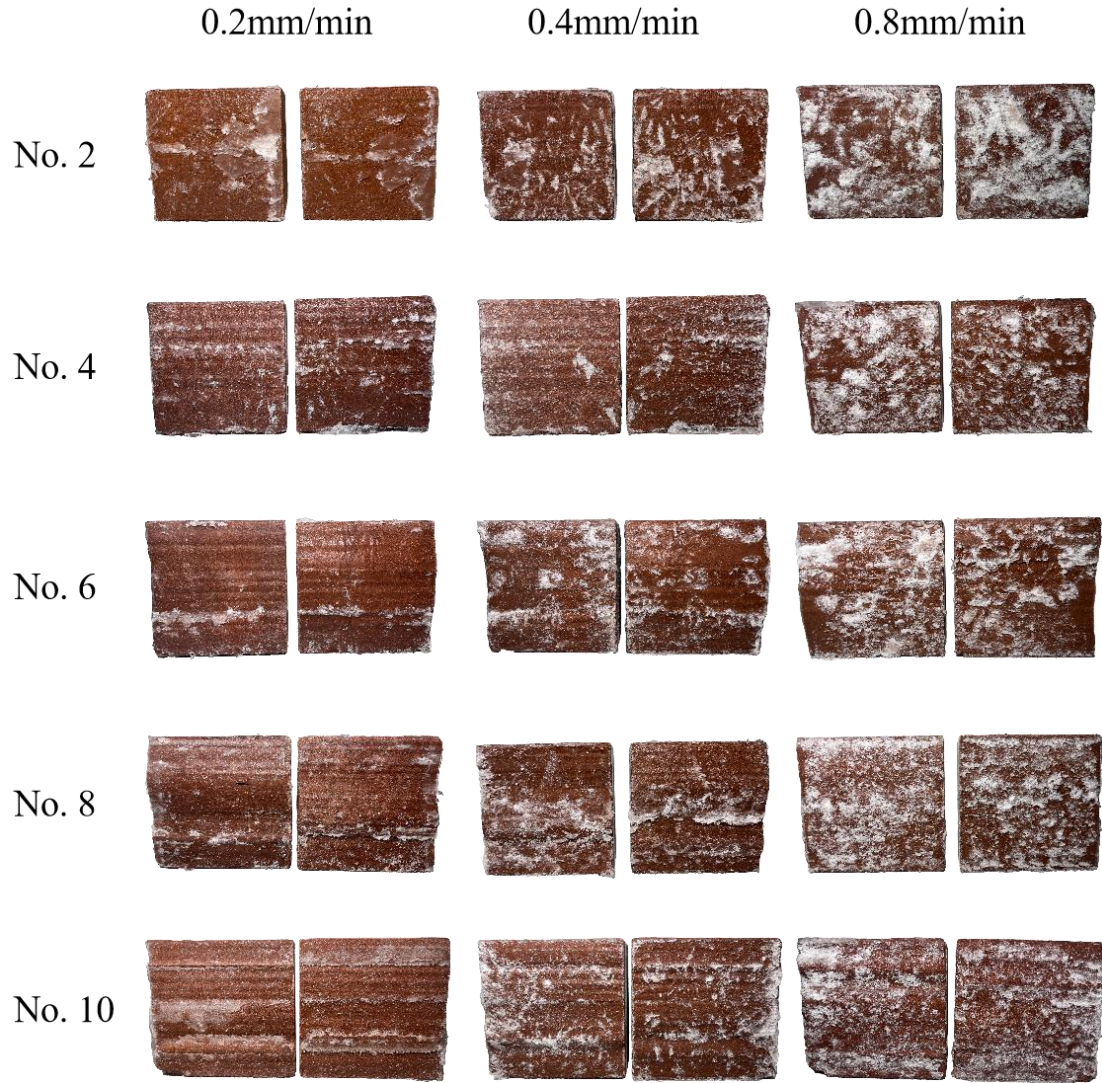
**Figure 12.** The shear rupture characteristics of joint ice under different shear rates. Experimental condition:  $T = -5\text{ }^{\circ}\text{C}$ ,  $d = 2\text{ mm}$  and  $\sigma_n = 0.5\text{ MPa}$ . The ice crystal that cannot adapt to shear slip at high shear rates will form brittle failure. The joint ice of brittle failure shows more micro fractures which make it more reflective. This will cause a white appearance of the rupture ice on the joint surface. The ductile failure of ice displays a transparent appearance without white color, which is hard to observe. Therefore, a larger area of white appearance implies a much more serious brittle failure of joint ice.

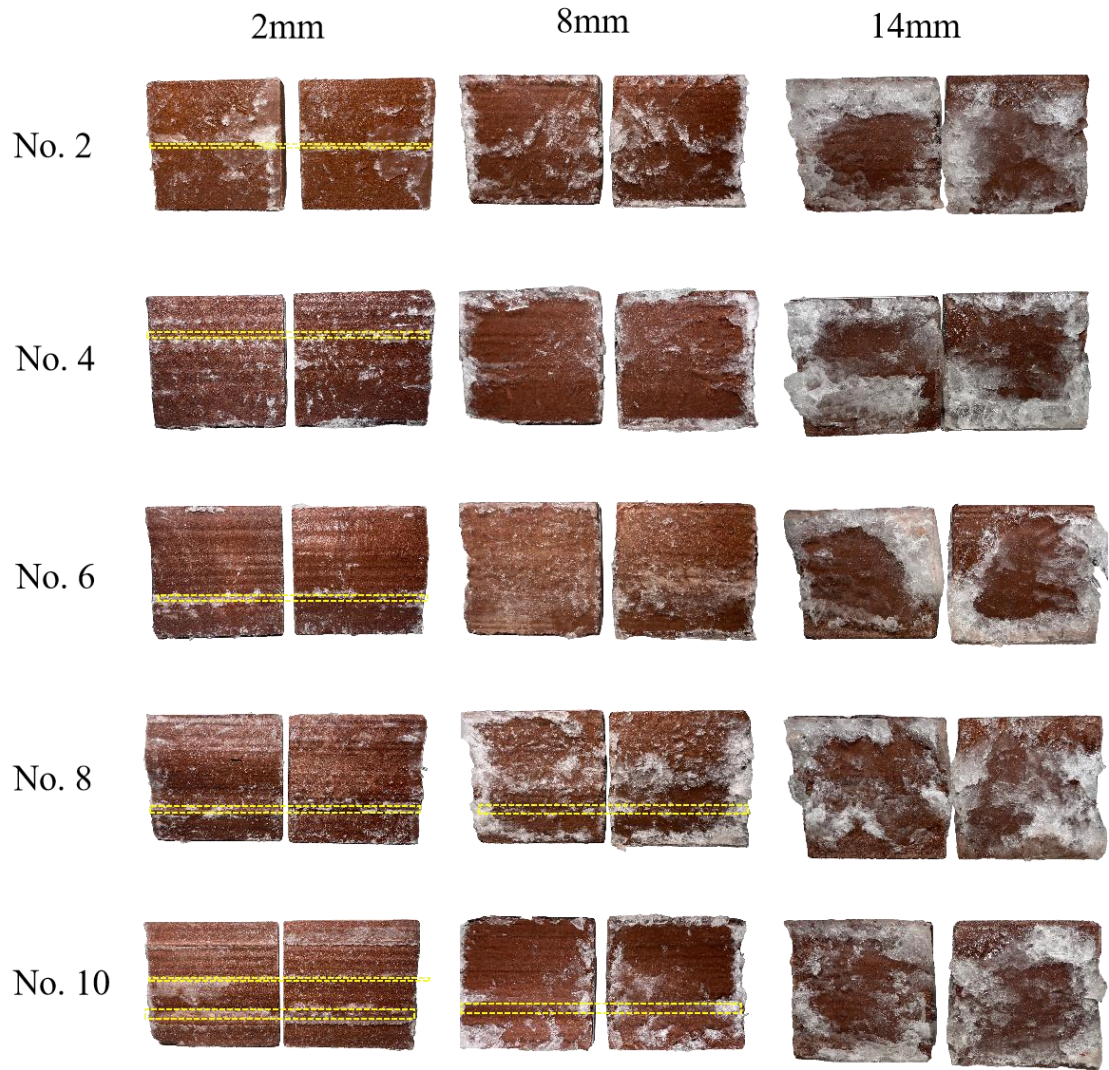
**Figure 13.** The shear rupture characteristics of ice-filled joints with different openings. Experimental condition:  $T = -5\text{ }^{\circ}\text{C}$ ,  $d = 2\text{ mm}$  and  $\sigma_n = 0.5\text{ MPa}$ . The yellow lines show the main aggregation of rupture ice. Ice after rupture will aggregate in roughness bulges perpendicular to the shear direction. The aggregation phenomenon disappears

349 as the joint openings increase. The aggregation phenomenon of profiles No. 2, No. 4 and No. 6 disappear in 8 mm  
 350 joint openings. All profiles' aggregation phenomena disappear in 14 mm joint openings.

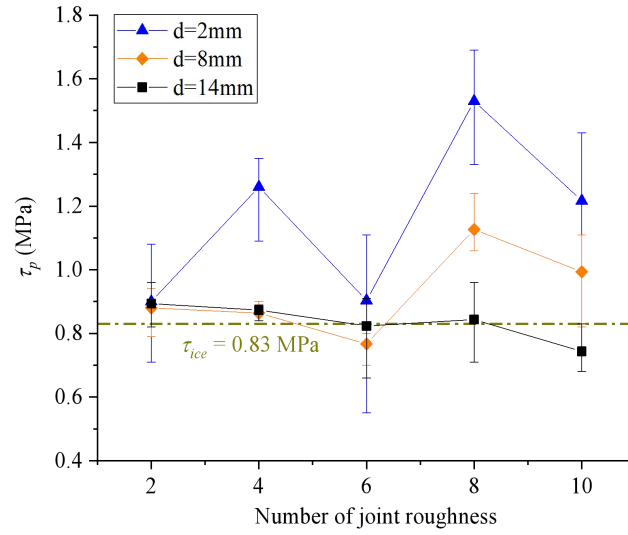
351  
 352 **Figure 14.** Effect of joint opening on the peak shear strength. Experimental condition:  $T = -5\text{ }^{\circ}\text{C}$ ,  $v = 0.2\text{ mm/min}$   
 353 and  $\sigma_n = 0.5\text{ MPa}$ .

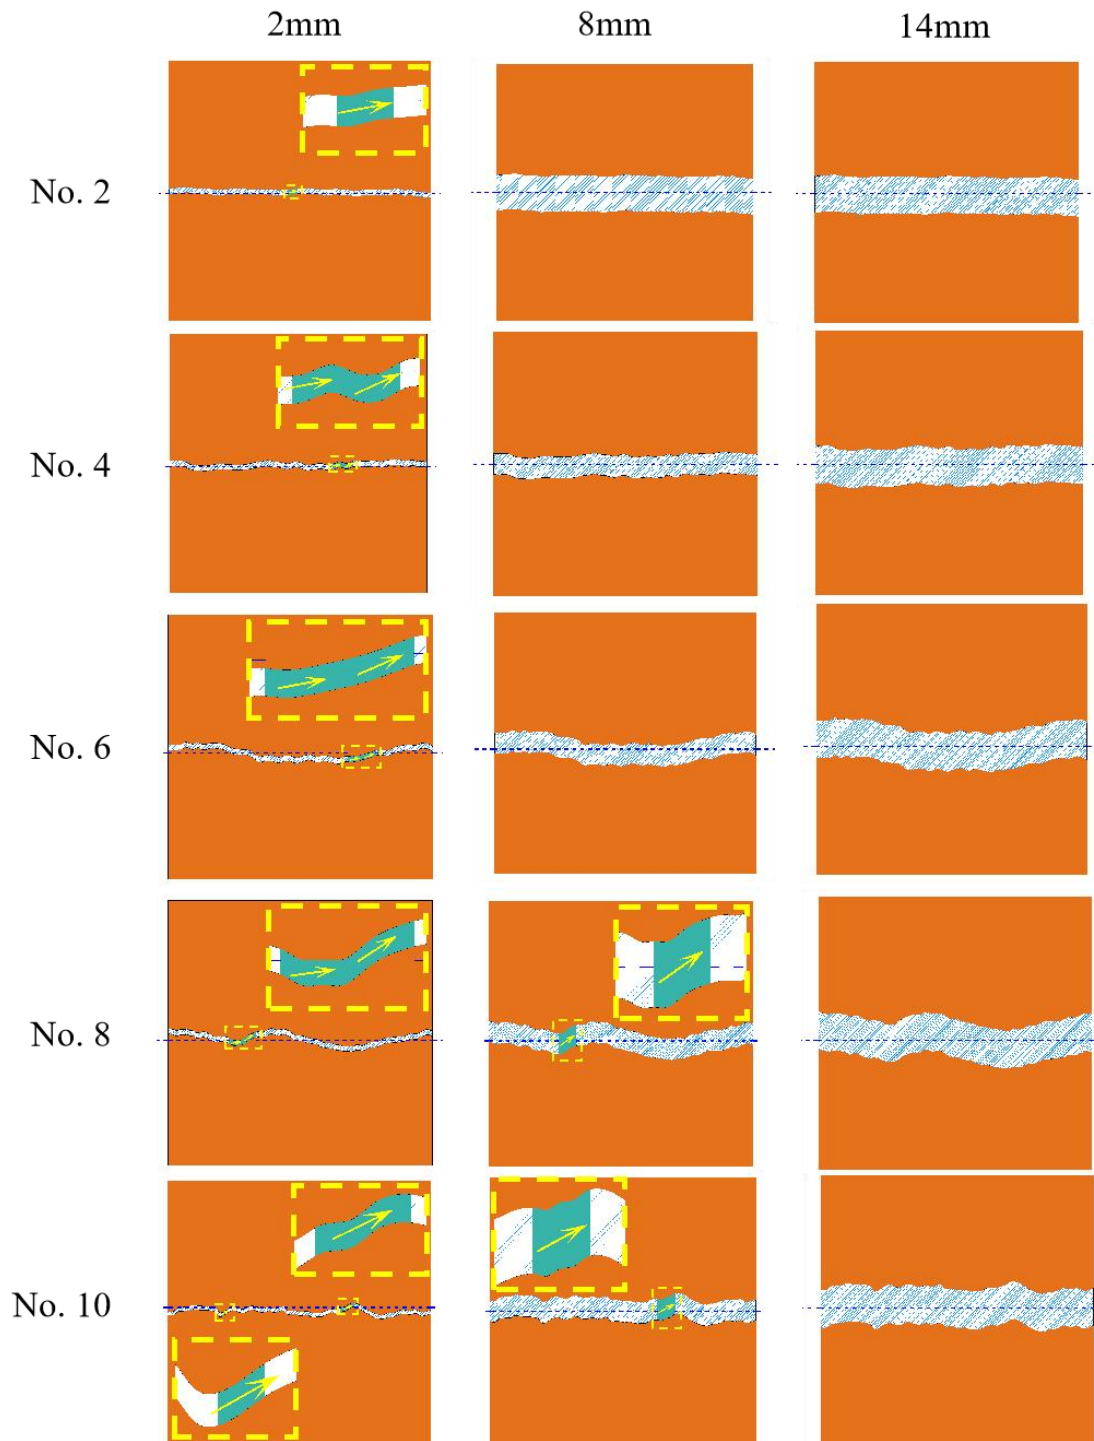
**Figure 15.** Influence of joint roughness on the shearing slip path. Experimental condition:  $T = -5\text{ }^{\circ}\text{C}$ ,  $\nu = 0.2$  mm/min and  $\sigma_n = 0.5\text{ MPa}$ .

The influence of joint opening and roughness on the shear strength can be explained by using the shear failure path of ice-filled joints as shown in Fig. 15. When  $d=2$  mm, the shear climbing will occur before some large bulges for all the joint profiles. This climbing action induces the aggregation of rupture ice and change of shear path. As a consequence, the shear strength will improve. When  $d=8$  mm, the shear failure path will not be disturbed for the profiles of No. 2, No. 4 and No. 6, however, the shear failure path changes due to the climbing action for the profiles of No. 8 and No. 10, in which a significant aggregation of rupture ice is produced. Therefore, the shear strengths of ice-filled joints for the profiles of No. 2, No. 4 and No. 6 are approximately equal to the solid ice, while the shear strengths for the profiles of No. 8 and No. 10 are much larger than 0.83 MPa. When  $d = 14$  mm, the shear failure happens inside the joint ice for all joint profiles, therefore, the shear failure path and shear strength will not be influenced by the joint roughness and no aggregation of rupture ice occurs. The shear dilatancy deformation of the ice-filled joints in Fig. 16 has further proved the climbing actions, including all the profiles with joint opening of 2 mm, and the profiles of No. 8 and No. 10 with joint opening of 8 mm. The climbing effect of the No. 2 ice-filled joint with opening of 2 mm is not remarkable, therefore the shear dilatancy is very small and the shear strength also is close to pure solid ice (0.83 MPa). Regardless of the critical filling thickness, the present study shows that the shear strength of ice-filled

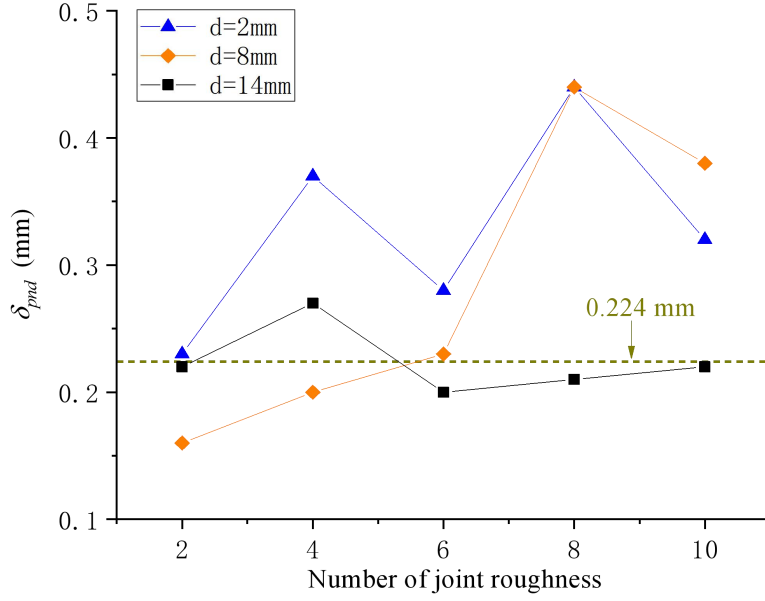
**Figure 16.** Effect of joint opening on the shearing dilatancy. Experimental condition:  $T = -5\text{ }^{\circ}\text{C}$ ,  $v = 0.2\text{ mm/min}$  and  $\sigma_n = 0.5\text{ MPa}$ .

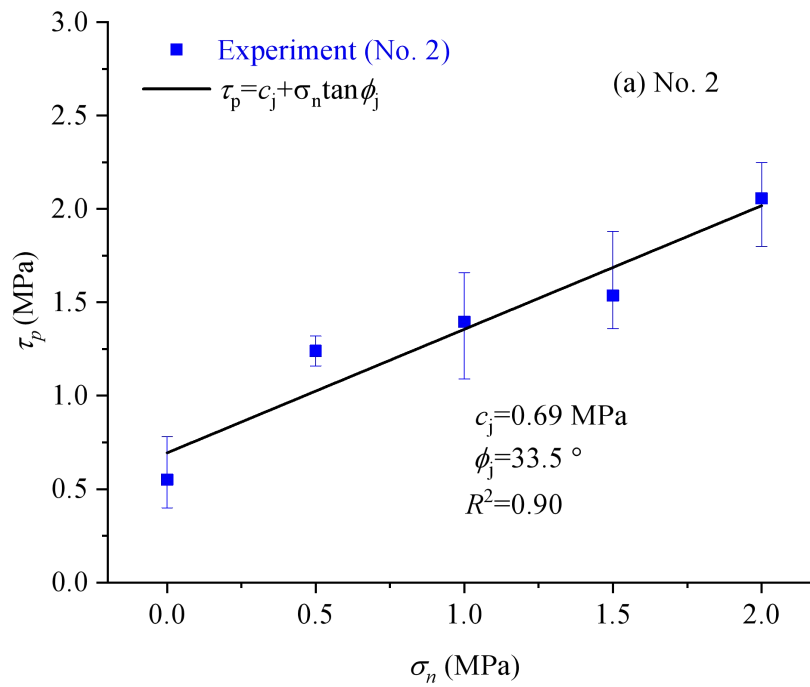
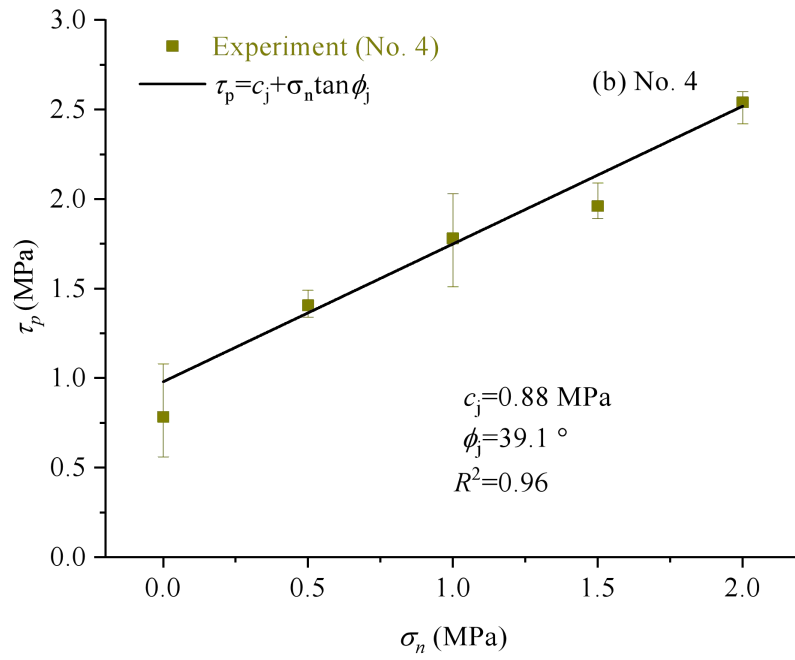
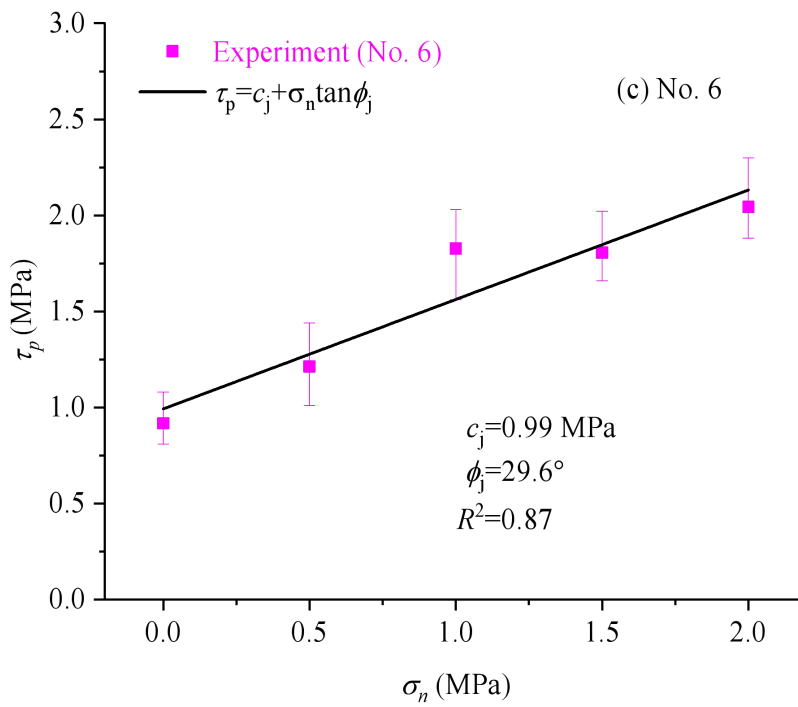
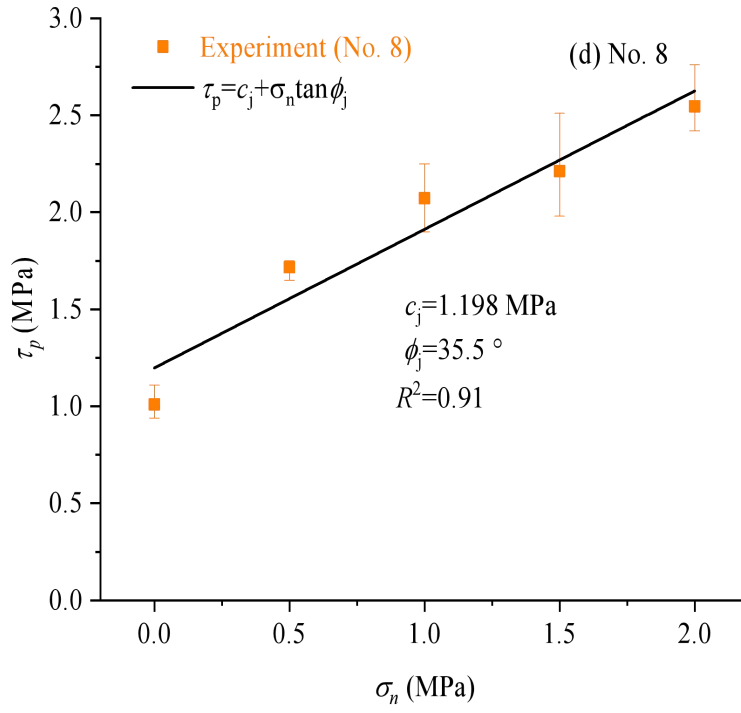
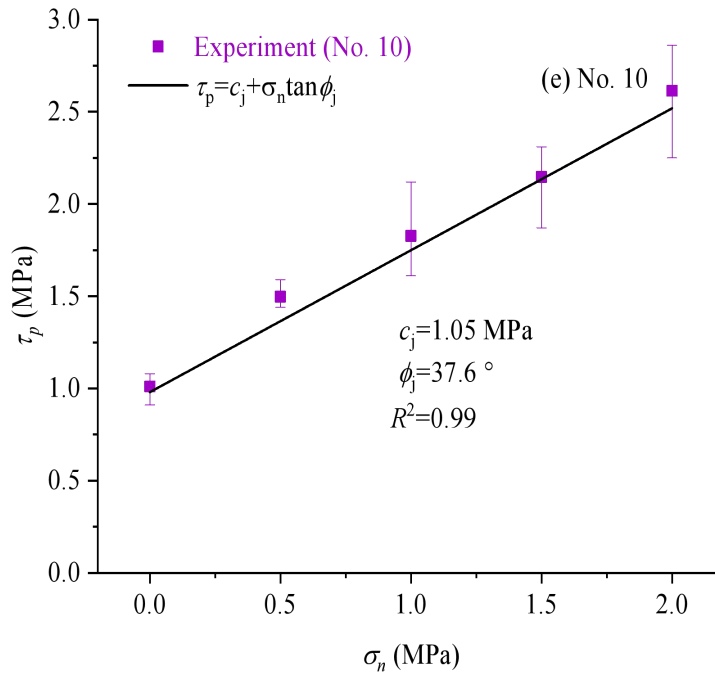
**Figure 17.** Effect of normal stress on the peak shear strength of ice-filled joints. Experimental condition:  $T = -15^\circ\text{C}$ ,  $v = 0.2$  mm/min and  $d = 2$  mm.

Figure 17 shows Mohr-coulomb criterion can be well used to calculate the shear strength of ice-filled joints against the normal stress. The shear rupture modes of the joint ice are given in Fig. 18. A

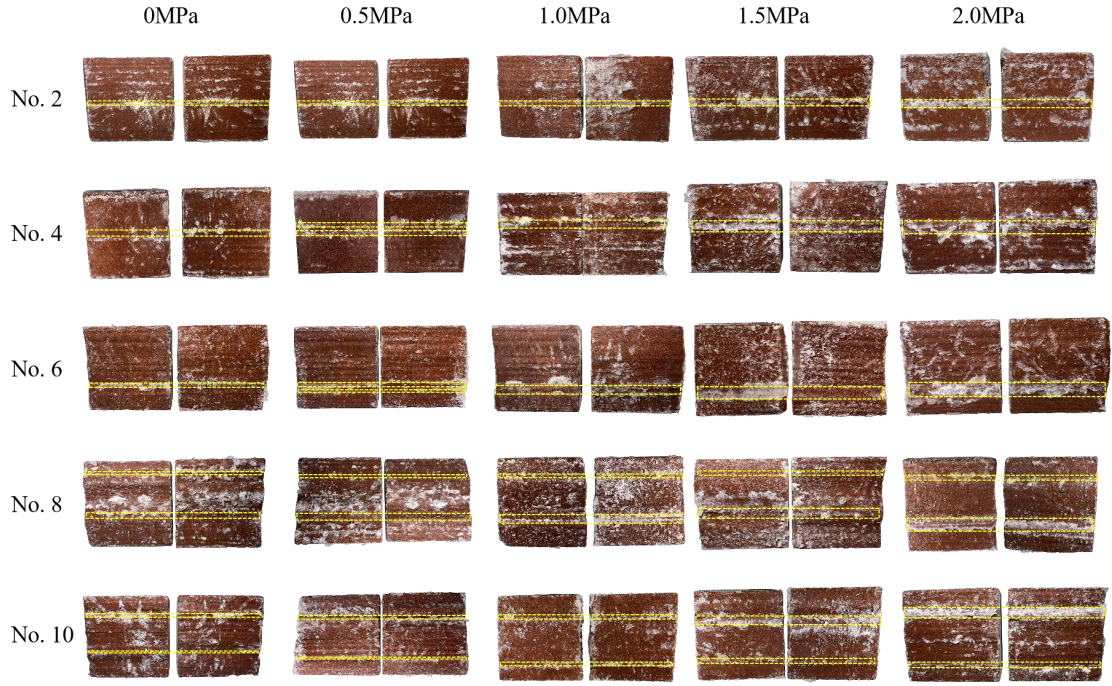
**Figure 18.** Aggregation of rupture ice under different normal stresses. Experimental condition:  $T = -15\text{ }^{\circ}\text{C}$ ,  $d = 2$  mm and  $v = 0.2\text{ mm/min}$ . The yellow lines show the main aggregation of rupture ice.

remarkable ice aggregation phenomenon can be found on the surface of joints and the aggregation occurs at a stable location of the joint profile regardless of the normal stress. The aggregation area of rupture ice increases with increasing normal stress, because climbing bulges is harder and the solid ice is easier to be crush at the front of large bulges under the higher normal stress (Fig. 19). In Section 3.1, it has illustrated that the aggregation area of rupture ice is an important index to reflect the shear strength of ice-filled joints at different freezing temperatures. Actually, the shear strength also linearly increases with increasing the aggregation area of rupture ice under different normal stress as shown in Fig. 20. It further illustrates that only some large bulges causing the aggregation of rupture ice can contribute to the improvement of shear strength instead of the total roughness index, such as JRC.

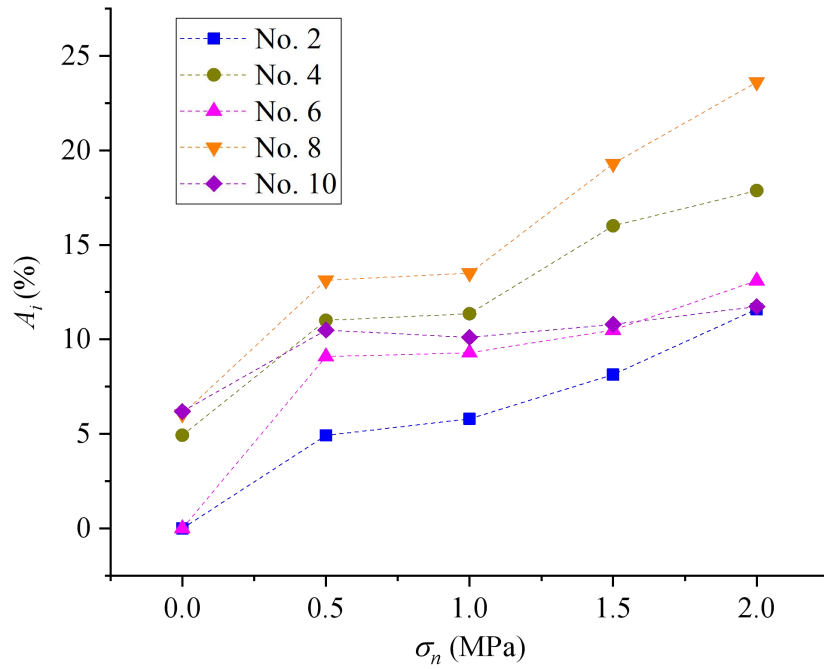
**Figure 19.** Aggregation area of rupture ice increases with increasing normal stress. Experimental condition:  $T = -15\text{ }^{\circ}\text{C}$ ,  $d = 2\text{ mm}$  and  $v = 0.2\text{ mm/min}$ .

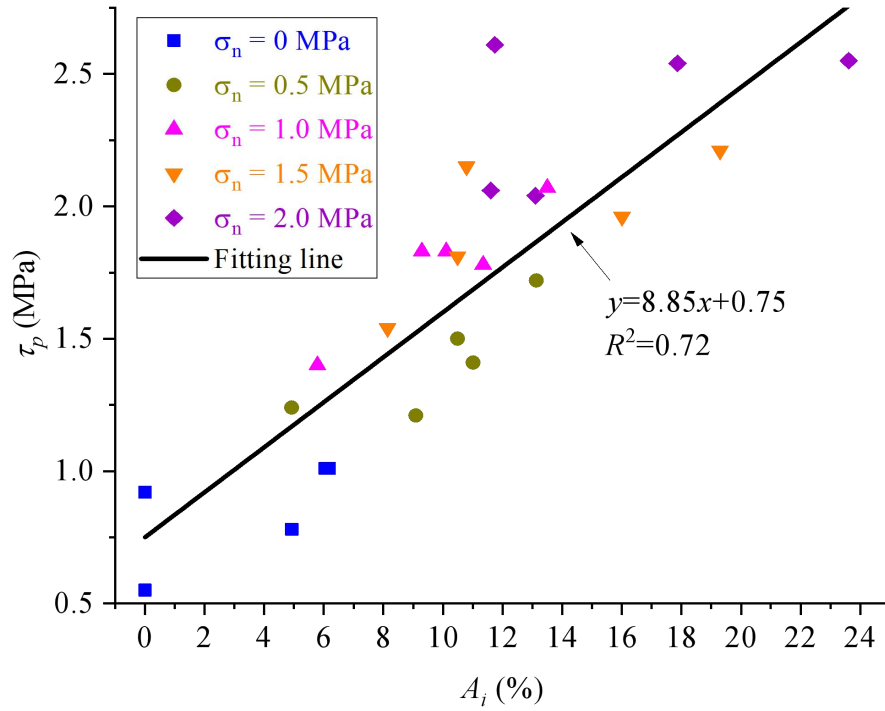
**Figure 20.** Peak shear strength linearly increases with increasing aggregation areas of rupture ice. Experimental condition:  $T = -15\text{ }^{\circ}\text{C}$ ,  $d = 2\text{ mm}$  and  $v = 0.2\text{ mm/min}$ .
