# The temperature-dependent shear strength of ice-filled joints in rock mass considering the effect of joint roughness, opening and shear rates

**Abstract.** Global warming causes many rockfall activities of the alpine mountains, especially when ice-filled joints in the rock mass become thawed. The warming and thawing of frozen soils and intact rocks were widely studied in the past several decades, however, the variation of shear strengths of ice-filled joints was not fully understood. In this study, a series of compression-shear experiments were conducted to investigate the shear strength of ice-filled rock joints by considering the effects of joint roughness, temperature, opening, shear rates and normal stress. The joint roughness can improve the shear strength of ice-filled joints. However, the contribution of joint roughness is controlled by some noticeable bulges instead of the JRC index. The shear strength linearly increases with increasing the aggregation of rupture ice area before these noticeable bulges. As the joint opening increases, the effect of joint roughness decreases and the shear strength of ice-filled joints tends to be equal to the shear strength of pure ice. I

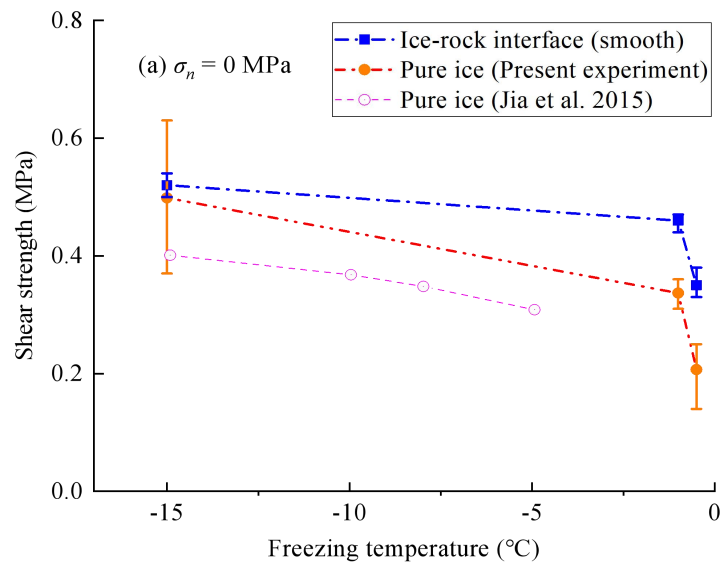
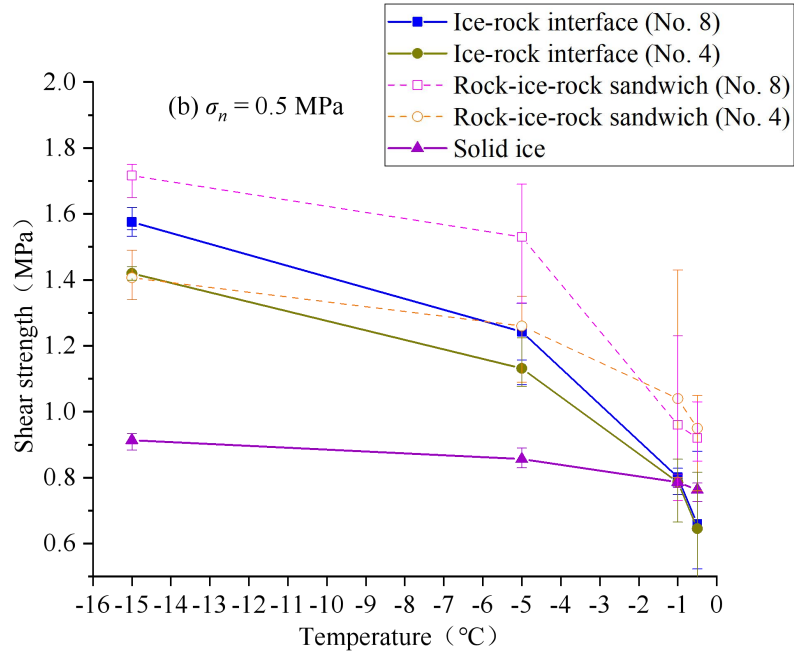
**Figure 21.** Influence of freezing temperature on the direct shear strength of ice and ice-filled joints. Experimental condition:  $v = 0.2 \text{ mm/min}$ .

In this paper, the influence of freezing temperature, shear rate, joint opening and normal stress on the shear strength of ice-filled joints in rock masses was comprehensively investigated by experiments. The shear strength remarkably reduces with increasing freezing temperature, because the shear strengths of solid ice and ice-rock interface decrease with increasing temperature. In order to deeply understand the warming degradation mechanism of ice-filled joints, the shear strength of pure ice and ice-rock bonding interface under different freezing temperatures also were tested in this study (Fig. 21).

The test results show that the shear strength of smooth ice-rock bonding interface is larger than that of pure solid ice at the freezing temperature from -15 to -0.5 °C (Fig. 21a). It implies that the shear failure should be inside the solid ice instead of ice-rock interface. When the freezing temperature increase from -1 °C to -0.5 °C, the shear strengths of the ice-rock interface and the solid ice reduce very quickly. Jia et al. (2015) also claimed the same change law of solid ice against the temperature.

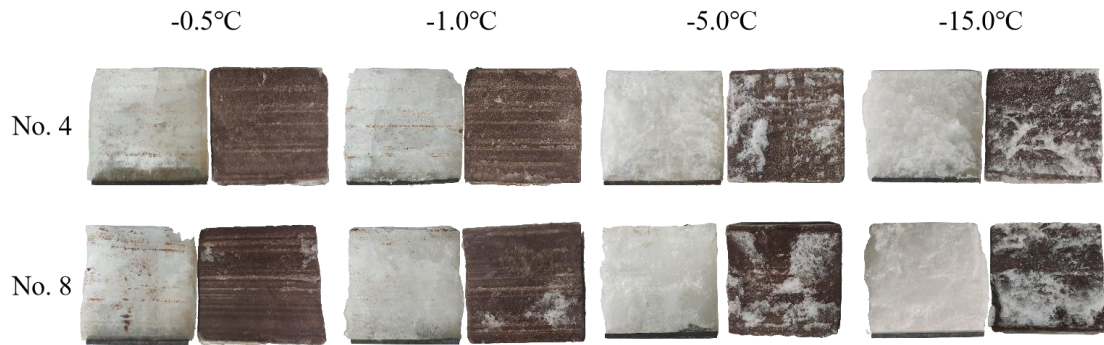
**Figure 22.** Shear failure characteristics of ice-rock interfaces under different temperatures. Experimental condition:  $v = 0.2 \text{ mm/min}$ ,  $\sigma_n = 0.5 \text{ MPa}$ .

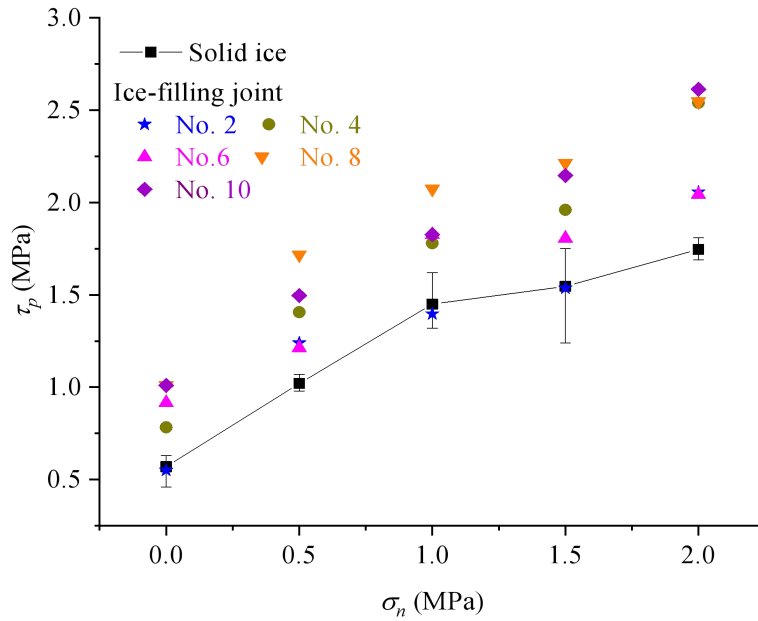
**Figure 23.** Shear failure characteristics of ice-rock interfaces under different normal stress. Experimental condition:  $v = 0.2\text{mm/min}$ ,  $d = 2\text{ mm}$ ,  $T = -15\text{ }^{\circ}\text{C}$ .
