1 **The temperature-dependent shear strength of ice-filled**
2 **joints in rock mass considering the effect of joint**
3 **roughness, opening and shear rates**

4 Shibing Huang^{1,2}, Haowei Cai¹, Zekun Xin¹, Gang Liu¹

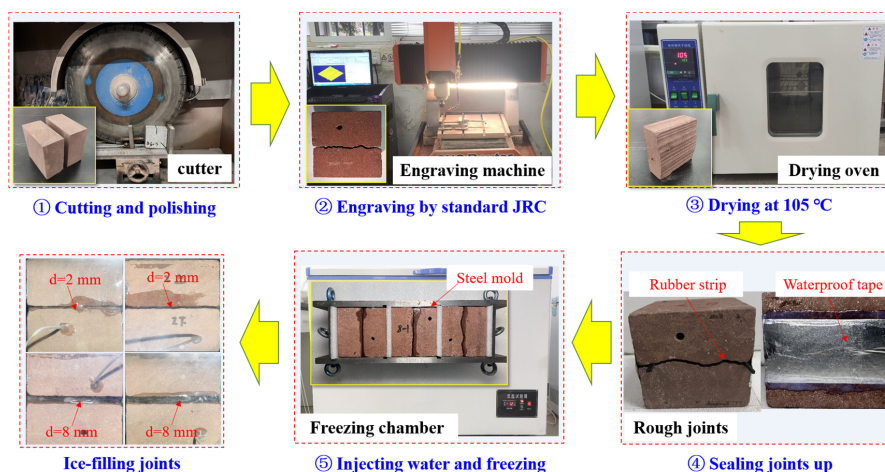
111 **Figure 1.** Preparation of ice-filled joints. The preparation steps are as follows: ① Cutting and polishing, ②
 112 Engraving by standard, ③ Drying at 105 °C, ④ Sealing joints up, ⑤ Injecting water and freezing.

100 ④ The joint opening was divided into different specified thicknesses which were controlled by
 101 inserting rubber strips, and a piece of waterproof tape was pasted on the surface in order to store water.
 102 ⑤ When the waterproof tape was tightly bonded on the rock surface, liquid water should be injected
 103 into the artificial joint until no water leaks out. After that, the water-filled joint rock mass was put into a
 104 steel mold to freeze in a freezing chamber. The steel mold was used to control the joint opening because
 105 the volume of joint water would expand during freezing. Then ice-filled joint samples can be derived
 106 after freezing at $-20\text{ }^{\circ}\text{C}$ for 12 h. The manufacturing procedure and related ice-filled joint samples were
 107 shown in Fig. 1.

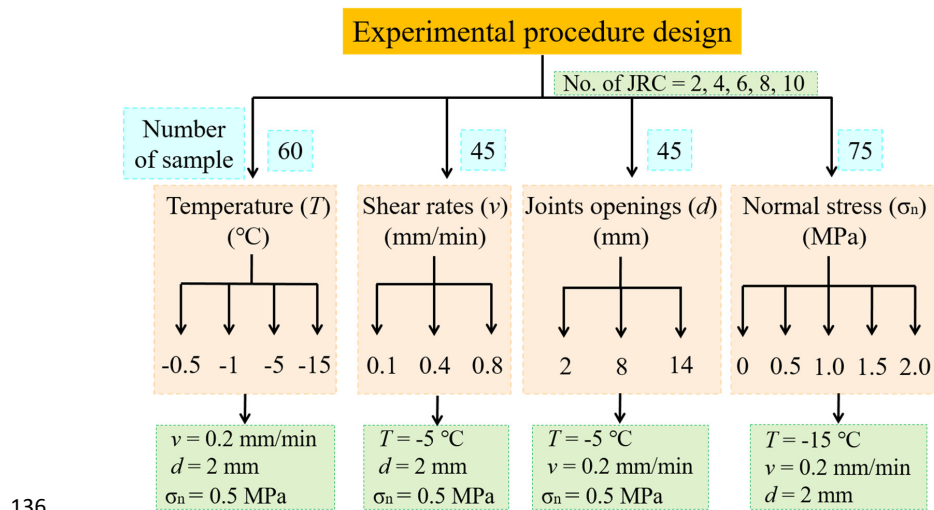
137 **Figure 2.** Distribution of rock samples containing ice-filled joints. T : Temperature. v : Shear rates. d : Joint openings.

138 σ_n : Normal stress.

121 as $-15\text{ }^{\circ}\text{C}$, $-5\text{ }^{\circ}\text{C}$, $-1\text{ }^{\circ}\text{C}$ and $-0.5\text{ }^{\circ}\text{C}$, respectively. The shear rates are 0.2 mm/min , 0.4mm/min and
122 0.8mm/min in the shear rate group. In the joint opening group, the openings of ice-filled joints are 2 mm ,
123 8 mm and 14 mm , respectively. The freezing depth on the earth may be small, however, it can exceed
124 100 m in some alpine caves, where the in-situ stress is close to 2 MPa . Therefore, in the normal stress
125 group, the normal stresses are set as 0 MPa , 0.5 MPa , 1 MPa , 1.5 MPa and 2 MPa , respectively. Three
126 parallel experiments were performed on each group to eliminate the discreteness of ice-filled joint
127 samples and experiment error. There are approximately 225 ice-filled joint samples prepared in this
128 experiment. The distribution of these ice-filled joint samples were shown in Fig. 2.

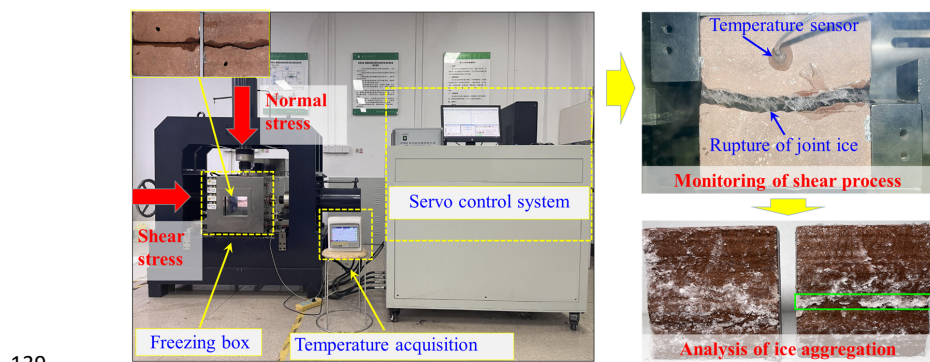
140 **Figure 3.** Shear experiment procedure and equipment

129 All the water-containing joints were frozen in a freeze box at a specific temperature for about 12 h, and
130 they were used to conduct the direct shear experiment on a temperature-controlled shearing instrument
131 under the scheduled low temperature and normal stress. A temperature sensor was implanted into the
132 sample to accurately monitor the internal temperature change of ice-filled joint samples. When the
133 scheduled freezing temperature was reached, the normal stress was applied with a loading rate of 0.2
134 kN/s . Then the shear process was performed in the displacement mode with the designed shear rate. After
135 the shear experiment, the rupture modes of ice-filled joints were captured and analyzed by using a camera.

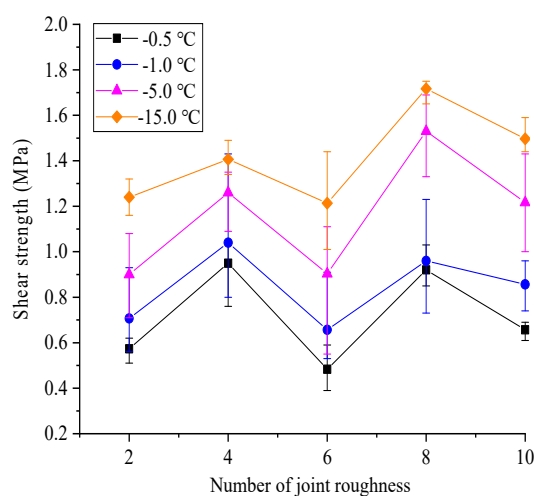
172
173 **Figure 4.** Shear strength against joint roughness at different freezing temperatures. Experimental condition: $v = 0.2$
174 mm/min , $d = 2\text{ mm}$, $\sigma_n = 0.5\text{ MPa}$.

162 with increasing the freezing temperature, because the bonding strength between ice and joint surface
163 becomes to be weaker, and the shear rupture happens along the ice-rock interface instead of solid ice
164 when the freezing temperature is larger than $-0.5\text{ }^{\circ}\text{C}$.
165 In addition, when the freezing temperature is close to $0\text{ }^{\circ}\text{C}$, the pre-melting of ice-rock interface induced
166 by the normal stress will cause a reduction of bonding strength. Therefore, the shear strength between
167 bonded ice-rock interfaces is much smaller than the shear strength of solid ice at a high freezing
168 temperature close to the melting point of bulk ice, such as $-0.5\text{ }^{\circ}\text{C}$. It should be noted that the aggregation
169 phenomenon of rupture ice disappears when $T = -0.5\text{ }^{\circ}\text{C}$ because the high-temperature ice is ductile failure
170 along the ice-rock interface instead of the joint ice itself. However, the climbing effect still makes a

171 significant contribution to the increase of shear strength.

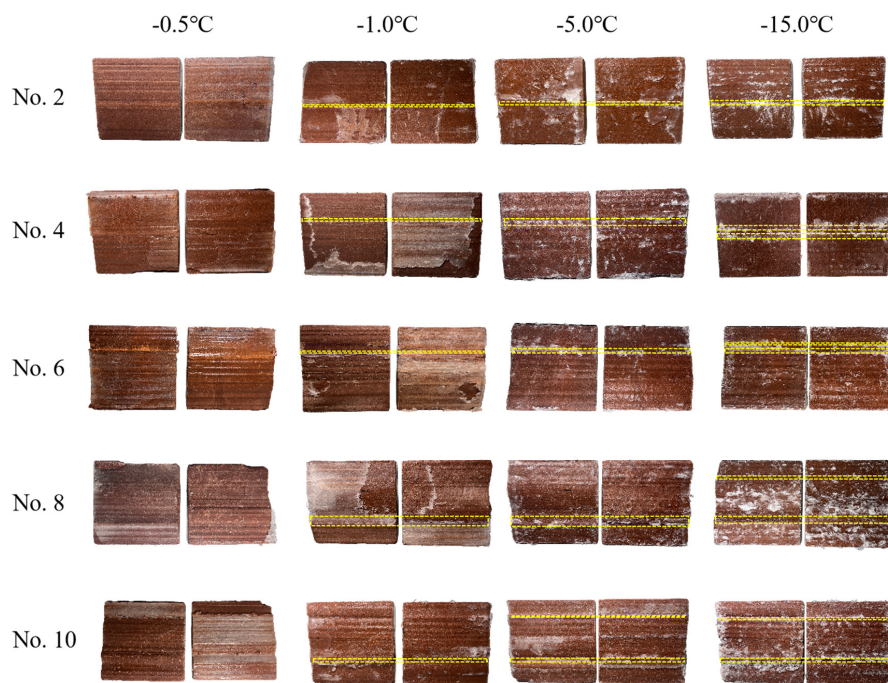
176 **Figure 5.** Shear rupture modes of ice-filled joints at different freezing temperatures. The yellow lines show the main
 177 aggregation of rupture ice. Ice after rupture will aggregate in roughness bulges perpendicular to the shear direction.

151 change law of shear strength against JRC may be explained by the shear rupture mode as shown in Fig.
152 5. There are several aggregation regions of rupture ice close to large climbing bulges on the surface of
153 joints. The peak shear strength of ice-filled joints is related to the aggregation area of rupture ice; because
154 a large shear force is required to promote the solid ice to shear slide along the slope of bulges. The
155 aggregation area and location along the rough profile of joints after shear failure are plotted in Fig. 6. It
156 can be observed that the aggregation ice appears before several high bulges and the aggregation location
157 is almost independent of the freezing temperature if aggregation ice occurs. The climbing bulges in front
158 of the aggregation ice are noticeable and influential. It implies that the influence of joint roughness on
159 the shear strengths of these ice-filled joints may be only controlled by several noticeable bulges instead

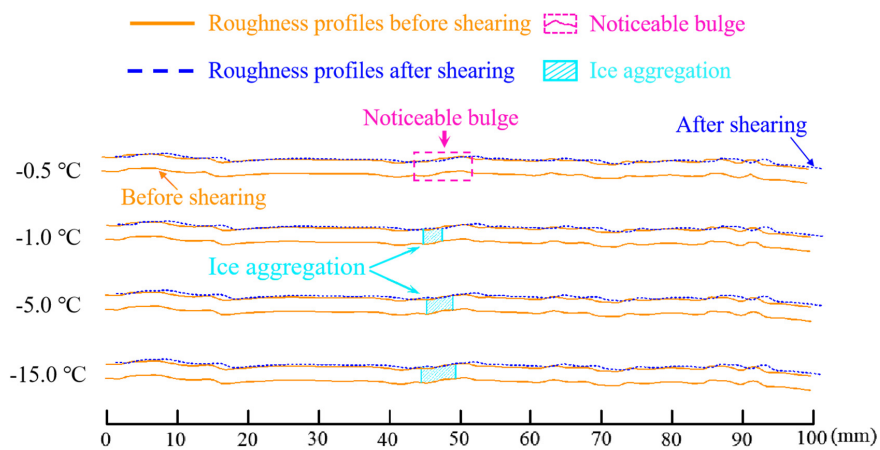
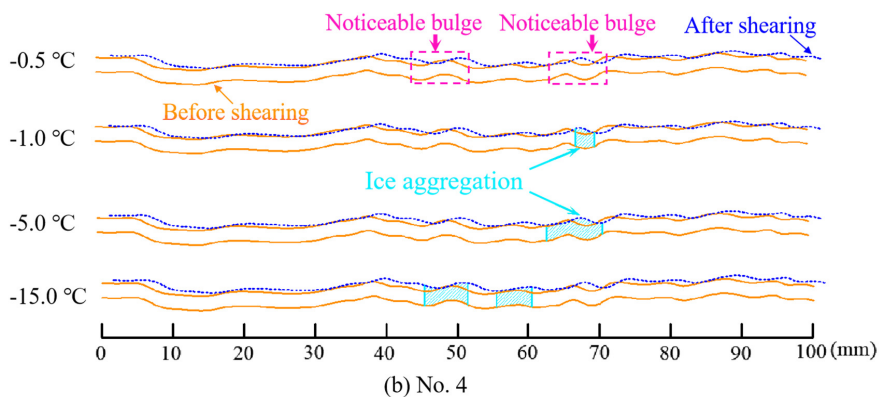
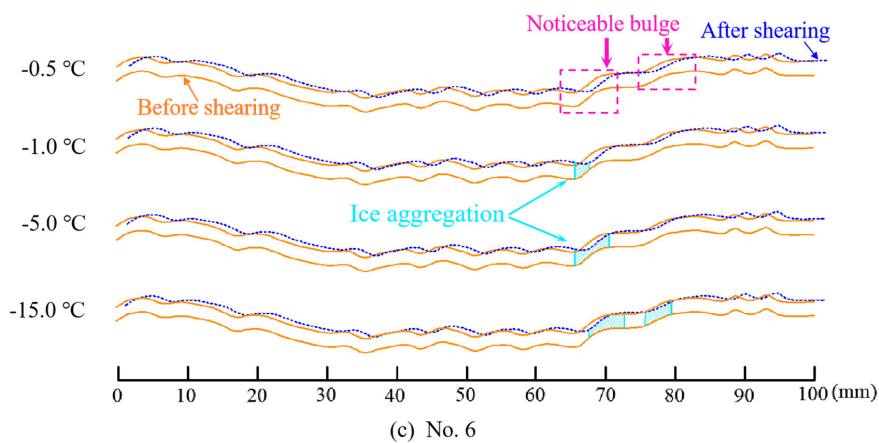
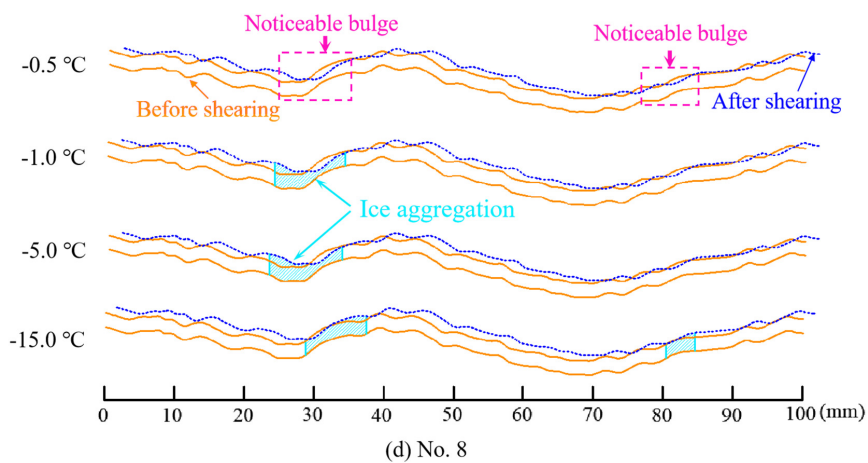
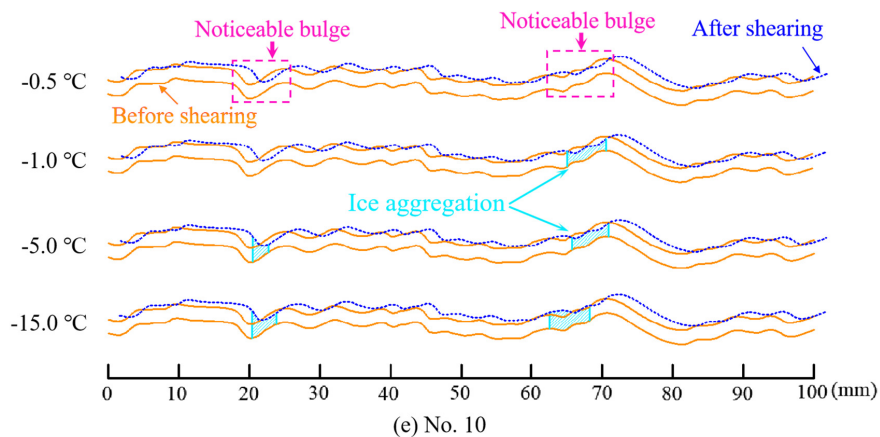
183 **Figure 6.** Shear aggregation areas of ice along the profile of roughness. Experimental condition: $v = 0.2$ mm/min, d
 184 $= 2$ mm, $\sigma_n = 0.5$ MPa. Some blue profiles are located under the orange profiles after shearing, which means the
 185 width of joints becomes smaller. Generally, the reduction of width occurs before some bulges and the rupture ice
 186 will aggregate before these bulges. These bulges are defined as noticeable bulges. Therefore, the bulges causing the
 187 reduction of joint width and aggregation of ice are called noticeable bulges in this study.

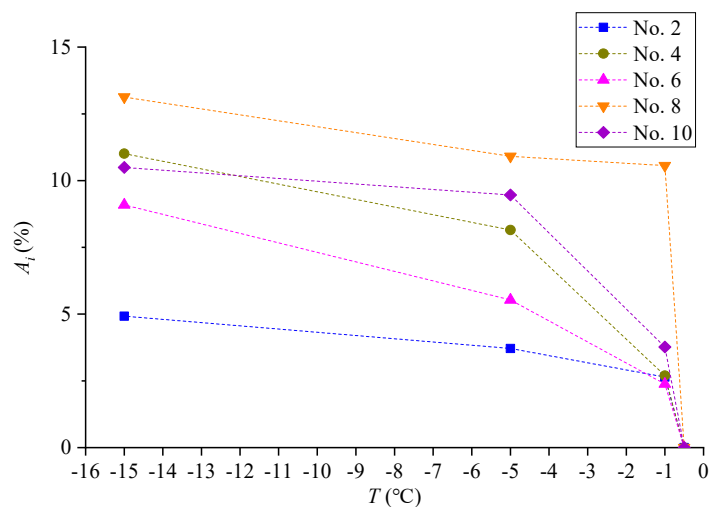
189 **Figure 7.** Aggregation area of rupture ice increases with the reduction of freezing temperature. Experimental
190 conditions: $v = 0.2$ mm/min, $d = 2$ mm, $\sigma_n = 0.5$ MPa. A_i : aggregation area of rupture ice.

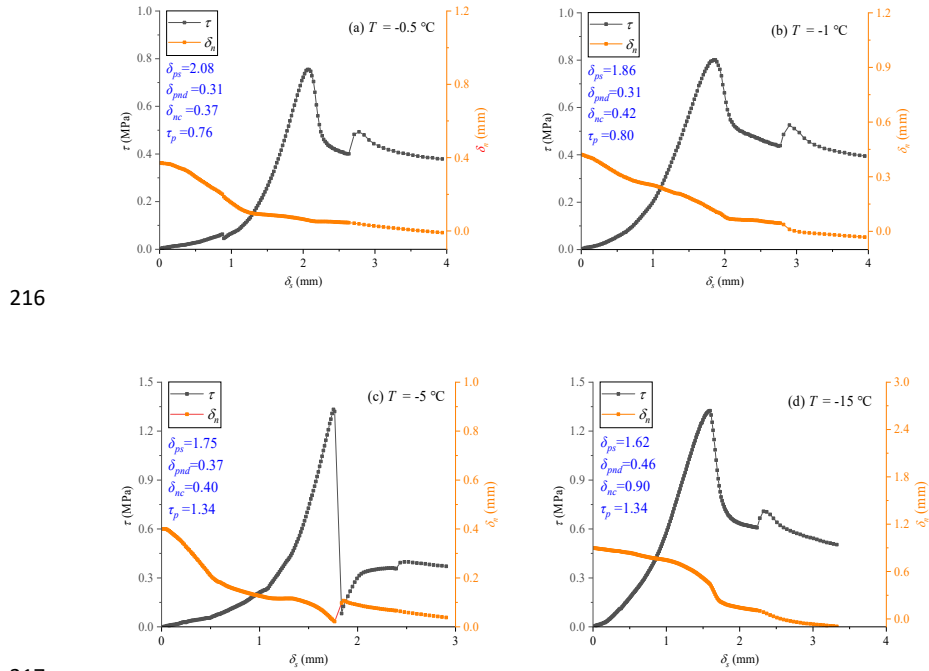
201 Several typical shear stress-displacement and normal-shear displacement curves for the profile of No. 4
202 are plotted in Fig. 8. The ice-filled joint shows significant residual shear strength beyond the peak point,
203 which slightly decreases with increasing shear displacement. This residual shear strength is caused by
204 the friction effect between the upper and lower ice-filled blocks. In addition, the normal shear dilatancy
205 displays increasing trend with shear displacement, which is caused by the climbing effect of ice-filled
206 joints. It should be noted that the shear strength has a second rising point at the residual strength stage,
207 because the shear rate is increased from 0.2 mm/min to 1 mm/min in order to accelerate the completion
208 of the shear process. Schulson and Fortt (2012) claimed that the friction between ice interfaces increases

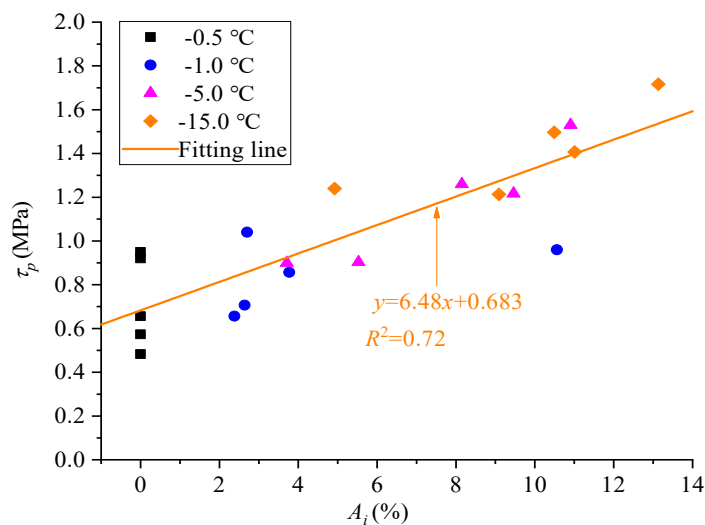
238
239 **Figure 9.** Peak shear strength linearly increases with increasing aggregation areas of rupture ice. Experimental
240 condition: $v = 0.2$ mm/min, $d = 2$ mm and $\sigma_n = 0.5$ MPa.

228 stress in the process of climbing the steep bulges. As a consequence, only these steep bulges causing
229 aggregation of rupture ice contribute to the improvement of shear strength. The variation law of shear
230 dilatancy against the roughness also is in accordance with the shear strength of ice-filled joints, but it is
231 different from the change law of JRC (Table 4). In Fig. 6, the gathering of fragmented ice mainly arises
232 in the front of the steepest bulge. It illustrates that the improvement of shear strength of joint ice is caused
233 by a part of the steepest bulge instead of the total roughness. Therefore, JCR may be not suitable for the
234 prediction of shear strength of ice-filled joints. For example, although the JCR of No. 6 is much larger
235 than No. 4, the effective steep bulge to cause ice aggregation after failure is smaller than that of No. 4
236 (Fig. 7). This phenomenon confirms that the improvement of shear strength is only caused by some

237 noticeable steep bulges instead of the total bulges.

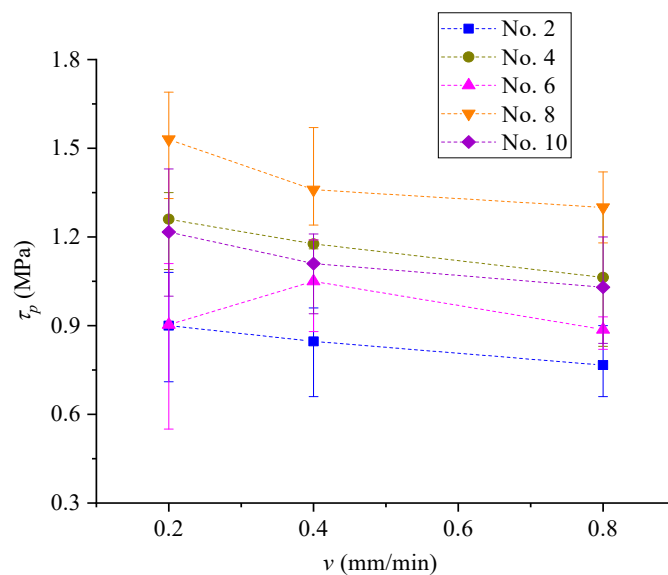
256 **Figure 10.** Effect of shear rate on the peak shear strength. Experimental condition: $T = -5$ °C, $d = 2$ mm and $\sigma_n = 0.5$

257 MPa.

242 The shear rates have significant effects on the strength of solid ice as observed in the previous literature
243 (Petrovic, 2003). Low shear rates are used to conduct quasi-static shear experiments, including 0.2
244 mm/min, 0.4 mm/min and 0.8 mm/min. Figure 10 shows that the peak shear strength slightly decreases
245 with increasing shear rates. Solid ice is a kind of typical elasto-plastic material. When the shear rate is
246 slow, the ice crystal has enough time to shear slip and it will present ductile failure characteristics. At a
247 low shear rate, the free water on the slip interface will reorganize at the water-ice interface to form ice,
248 however, it is hard for the ice crystal to adjust to adapt the shear slip at high shear rates, which will cause
249 the shear rupture of ice crystals and hinder the growth of ice on the water-ice interface (Lou et al., 2019).
250 Figure 11 shows that a high shear rate will induce brittle failure of joint ice and more fragmented ice

251 crystals are produced. As a result, the shear strength reduces with increasing shear rates from 0.2 mm/min
252 to 0.8mm/min. The previous literature shows that there is a critical loading rate for the transition from
253 ductile to brittle behavior of polycrystalline ice (Timco and Frederking, 1982; Gold, 2018). In this study,
254 the transition point of ice-filled joint is not definitely derived due to the limitation of the shear rate range.

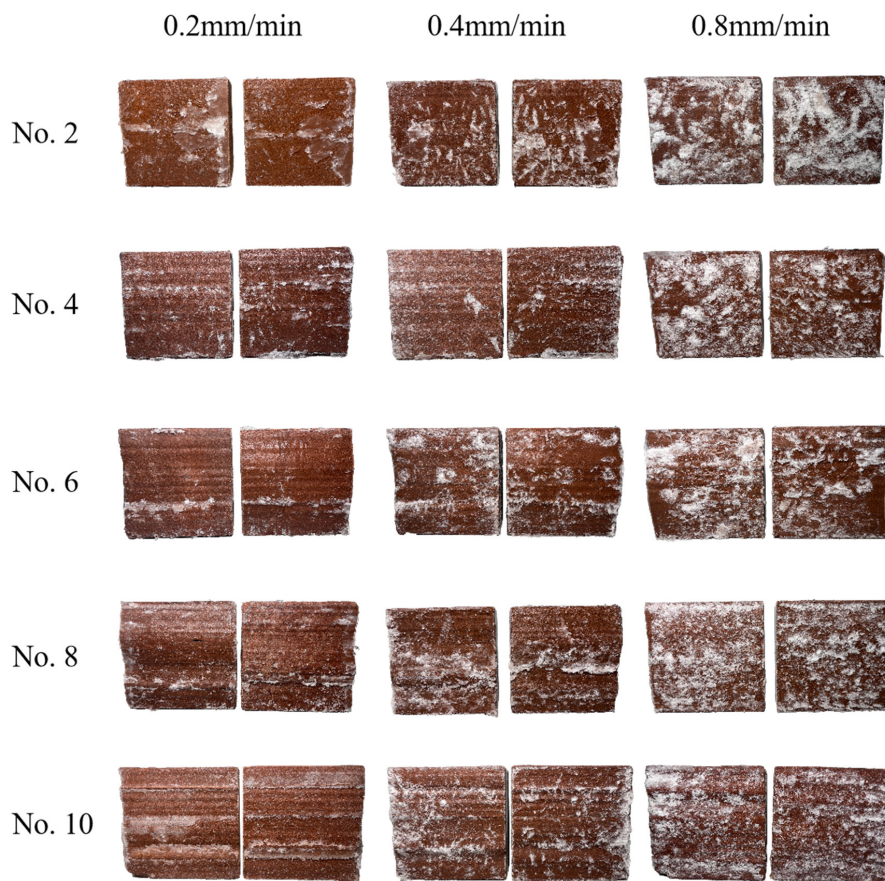
259 **Figure 11.** The shear rupture characteristics of joint ice under different shear rates. Experimental condition: $T = -$

261 failure. The joint ice of brittle failure shows more micro fractures which make it more reflective. This will cause a

262 white appearance of the rupture ice on the joint surface. The ductile failure of ice displays a transparent appearance

264 serious brittle failure of joint ice.

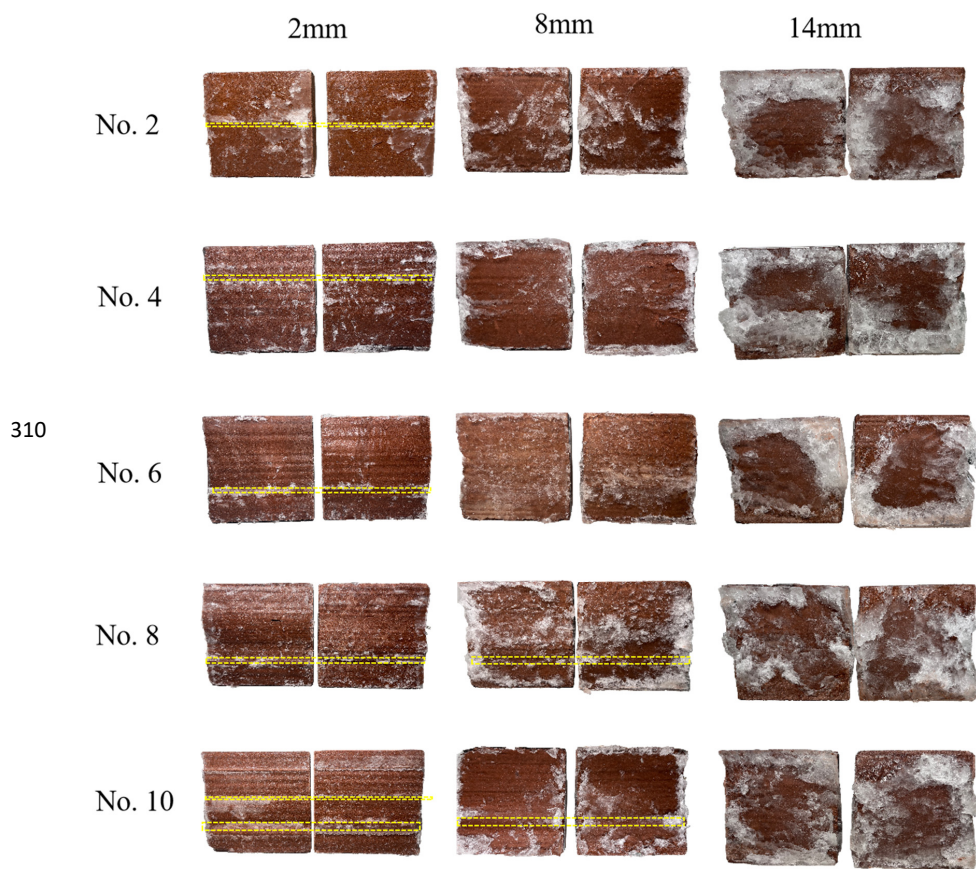
311 **Figure 12.** The shear rupture characteristics of ice-filled joints with different openings. Experimental condition: $T =$
312 $-5\text{ }^{\circ}\text{C}$, $d = 2\text{ mm}$ and $\sigma_n = 0.5\text{ MPa}$. The yellow lines show the main aggregation of rupture ice. Ice after rupture will
313 aggregate in roughness bulges perpendicular to the shear direction. The aggregation phenomenon disappears as the
314 joint openings increase. The aggregation phenomenon of profiles No. 2, No. 4 and No. 6 disappear in 8 mm joint
315 openings. All profiles' aggregation phenomena disappear in 14 mm joint openings.

284 roughness. In addition, there is not any significant ice aggregation on the joint surfaces of No. 2, No. 4
285 and No. 6 when the joint opening is 8 mm, and the shear failure happens inside the joint ice. However,
286 for the ice-filled joints of No. 8 and No. 10, the shear strengths are larger than 0.83 MPa, which illustrates

287 that the critical filling thickness for the profiles of No. 8 and No. 10 should be larger than 8 mm but
288 smaller than 14 mm. There is aggregation ice arising before large bulges, and these large bulges would
289 prevent the direct shear failure of joint ice and improve the shear strength.

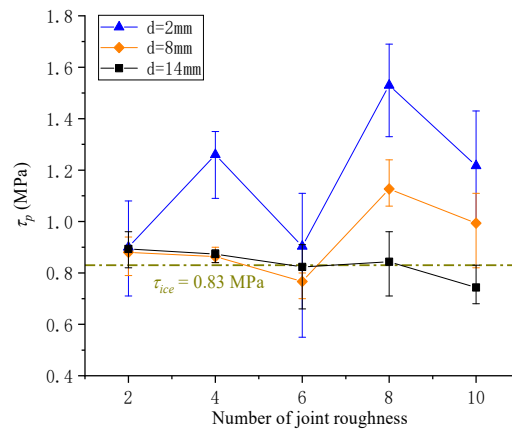
317 **Figure 13.** Effect of joint opening on the peak shear strength. Experimental condition: $T = -5\text{ }^\circ\text{C}$, $v = 0.2\text{ mm/min}$

318 and $\sigma_n = 0.5\text{ MPa}$.

276 13 shows that when the joint opening increases from 2 mm to 14 mm, the shear strength of ice-filled
277 joints decreases. The shear strength of pure solid ice also is measured in the laboratory, which is
278 approximately 0.83 MPa on the condition that $T = -5\text{ }^{\circ}\text{C}$, $v = 0.2\text{ mm/min}$ and $\sigma_n = 0.5\text{ MPa}$. When the
279 joint opening is 14 mm, the shear strengths of ice-filled joint are approximately 0.83 MPa and they are
280 independent of the joint roughness. When the joint opening is 8 mm, the shear strengths of ice-filled joint
281 are very close to the shear strength of pure solid ice (0.83 MPa) for the joint of No. 2, No. 4 and No. 6.
282 The reason is that 8 mm has exceeded the critical filling thickness of these joints (No. 2, No. 4 and No.
283 6), therefore the shear strength of these ice-filled joints is only controlled by the solid ice instead of joint

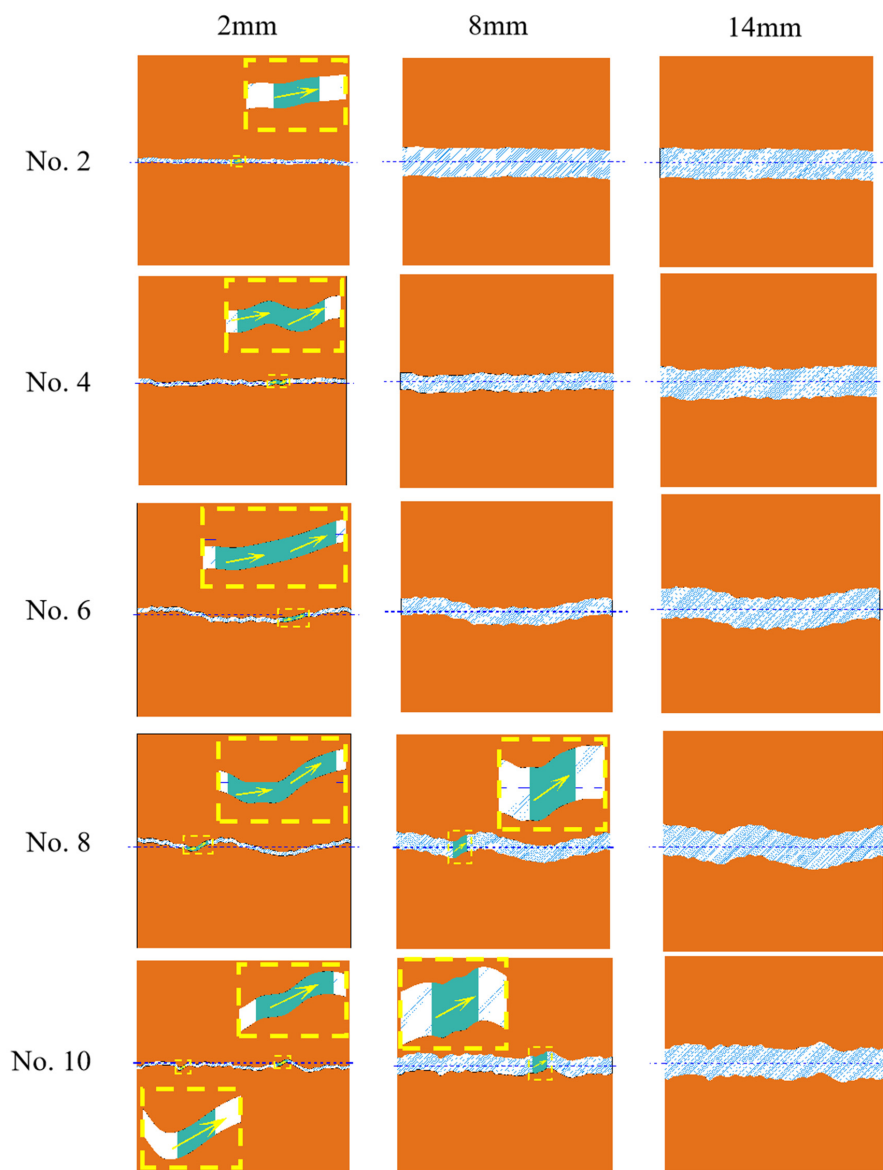
320 **Figure 14.** Influence of joint roughness on the shearing slip path. Experimental condition: $T = -5\text{ }^{\circ}\text{C}$, $v = 0.2\text{ mm/min}$

321 and $\sigma_n = 0.5\text{ MPa}$.

290 The influence of joint opening and roughness on the shear strength can be explained by using the shear
291 failure path of ice-filled joints as shown in Fig. 14. When $d=2$ mm, the shear climbing will occur before
292 some large bulges for all the joint profiles. This climbing action induces the aggregation of rupture ice
293 and change of shear path. As a consequence, the shear strength will improve. When $d=8$ mm, the shear
294 failure path will not be disturbed for the profiles of No. 2, No. 4 and No. 6, however, the shear failure
295 path changes due to the climbing action for the profiles of No. 8 and No. 10, in which a significant
296 aggregation of rupture ice is produced. Therefore, the shear strengths of ice-filled joints for the profiles
297 of No. 2, No. 4 and No. 6 are approximately equal to the solid ice, while the shear strengths for the
298 profiles of No. 8 and No. 10 are much larger than 0.83 MPa. When $d = 14$ mm, the shear failure happens

299 inside the joint ice for all joint profiles, therefore, the shear failure path and shear strength will not be
300 influenced by the joint roughness and no aggregation of rupture ice occurs. The shear dilatancy
301 deformation of the ice-filled joints in Fig. 15 has further proved the climbing actions, including all the
302 profiles with joint opening of 2 mm, and the profiles of No. 8 and No. 10 with joint opening of 8 mm.

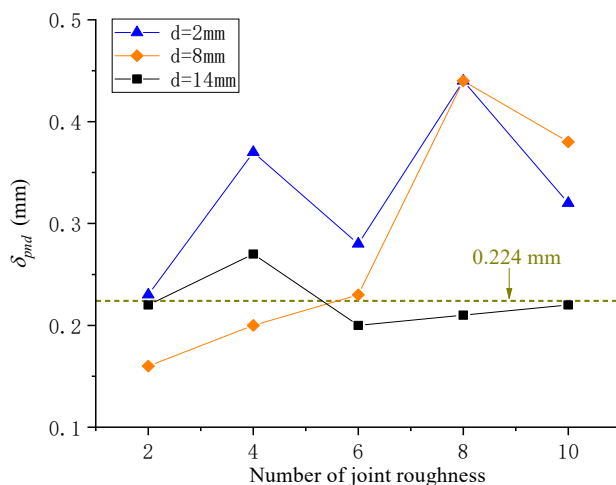
324 **Figure 15.** Effect of joint opening on the shearing dilatancy. Experimental condition: $T = -5\text{ }^{\circ}\text{C}$, $v = 0.2\text{ mm/min}$ and
 325 $\sigma_n = 0.5\text{ MPa}$.

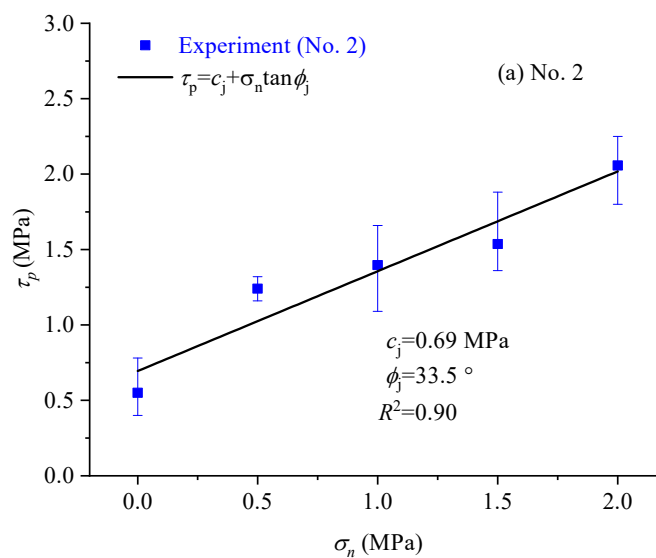
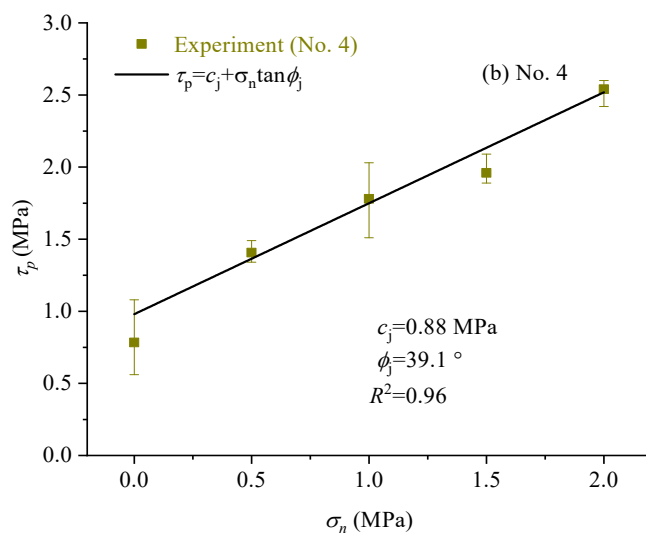
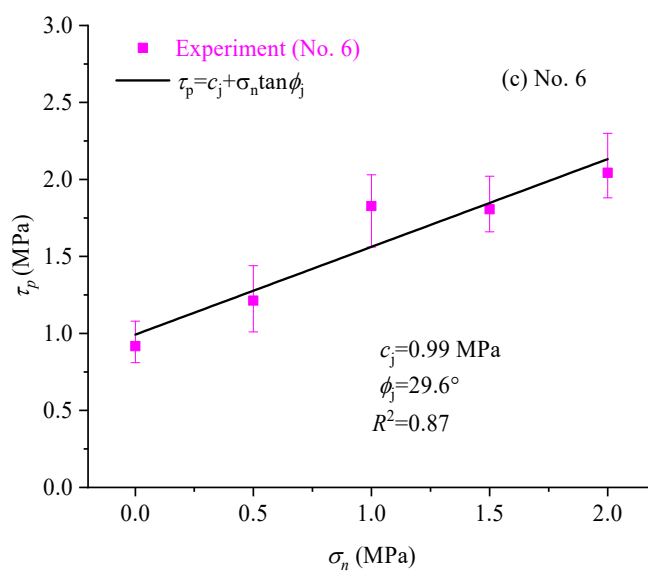
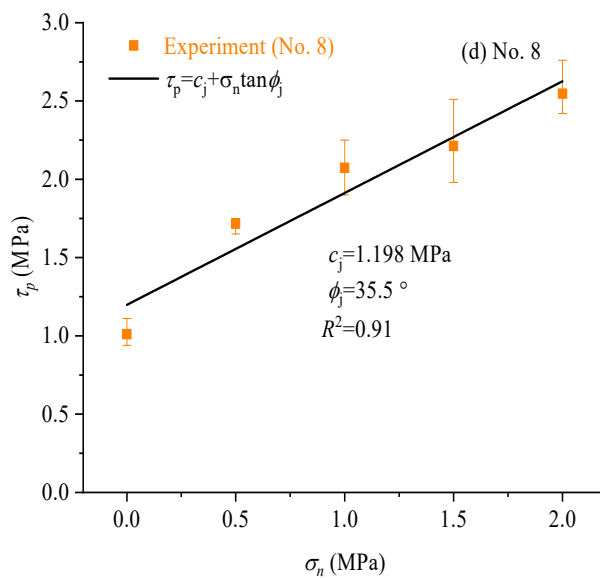
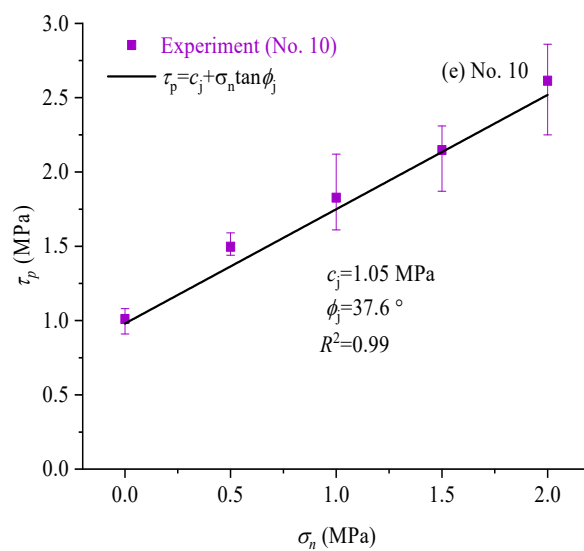
350 **Figure 16.** Effect of normal stress on the peak shear strength of ice-filled joints. Experimental condition: $T = -15^\circ\text{C}$,

351 $v = 0.2 \text{ mm/min}$ and $\sigma_n = 0.5 \text{ MPa}$.

334 Figure 16 shows Mohr-coulomb criterion can be well used to calculate the shear strength of ice-filled
 335 joints against the normal stress. The shear rupture modes of the joint ice are given in Fig. 17. A
 336 remarkable ice aggregation phenomenon can be found on the surface of joints and the aggregation occurs

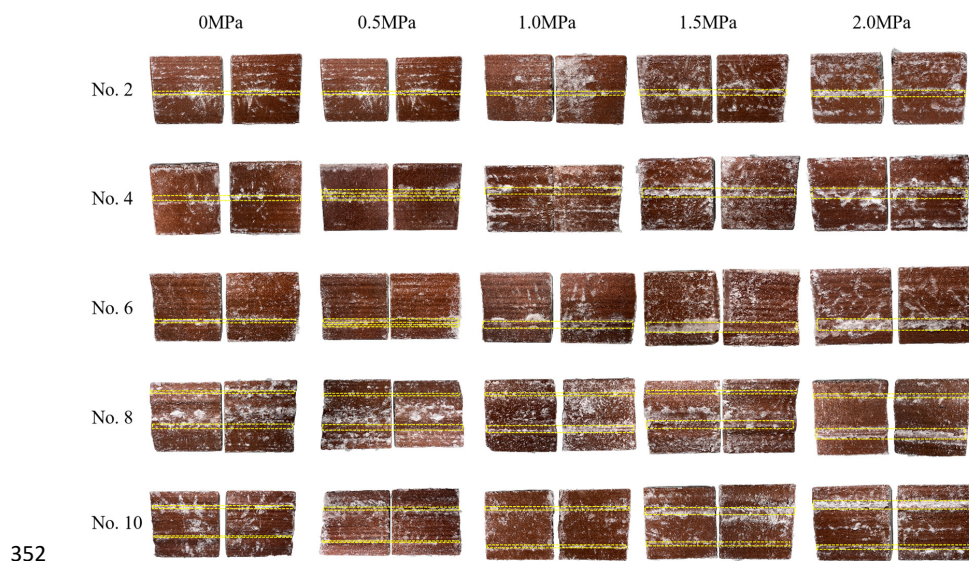
353 **Figure 17.** Aggregation of rupture ice under different normal stresses. Experimental condition: $T = -15\text{ }^{\circ}\text{C}$, $d = 2$

354 mm and $v = 0.2\text{ mm/min}$. The yellow lines show the main aggregation of rupture ice.

337 at a stable location of the joint profile regardless of the normal stress. The aggregation area of rupture ice
338 increases with increasing normal stress, because climbing bulges is harder and the solid ice is easier to
339 be crush at the front of large bulges under the higher normal stress (Fig. 18). In Section 3.1, it has
340 illustrated that the aggregation area of rupture ice is an important index to reflect the shear strength of
341 ice-filled joints at different freezing temperatures. Actually, the shear strength also linearly increases
342 with increasing the aggregation area of rupture ice under different normal stress as shown in Fig. 19. It
343 further illustrates that only some large bulges causing the aggregation of rupture ice can contribute to the
344 improvement of shear strength instead of the total roughness index, such as JRC.

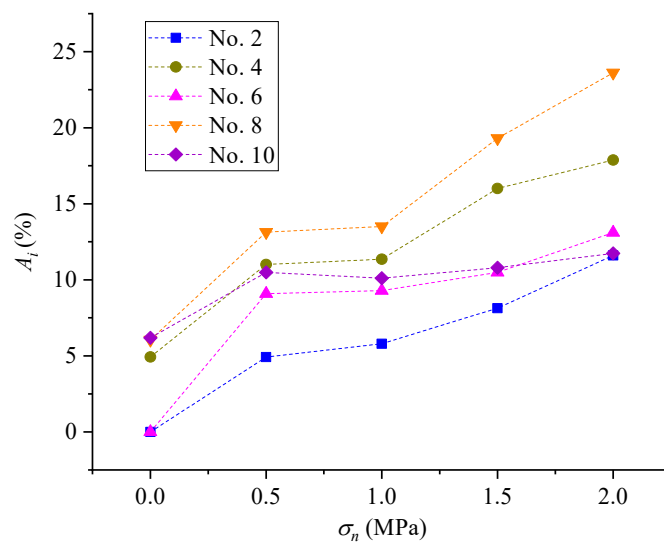
356 **Figure 18.** Aggregation area of rupture ice increases with increasing normal stress. Experimental condition: $T = -$

357 $15\text{ }^{\circ}\text{C}$, $d = 2\text{ mm}$ and $v = 0.2\text{ mm/min}$.

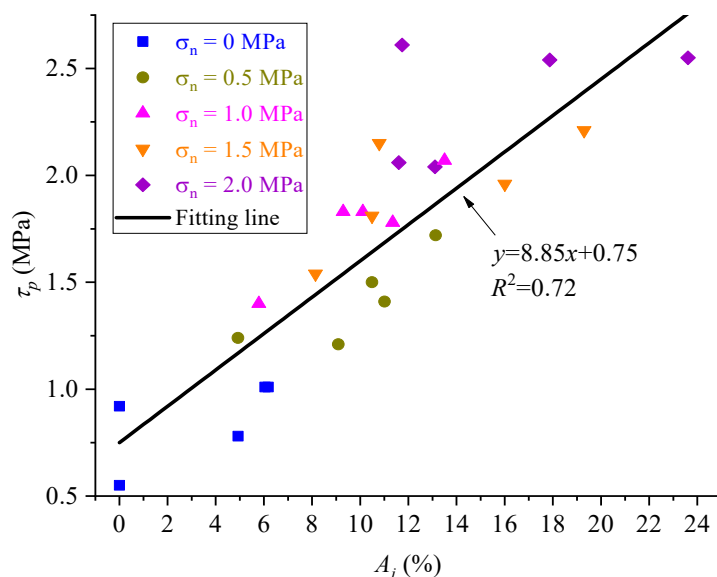
359 **Figure 19.** Peak shear strength linearly increases with increasing aggregation areas of rupture ice. Experimental

360 condition: $T = -15\text{ }^\circ\text{C}$, $d = 2\text{ mm}$ and $v = 0.2\text{ mm/min}$.

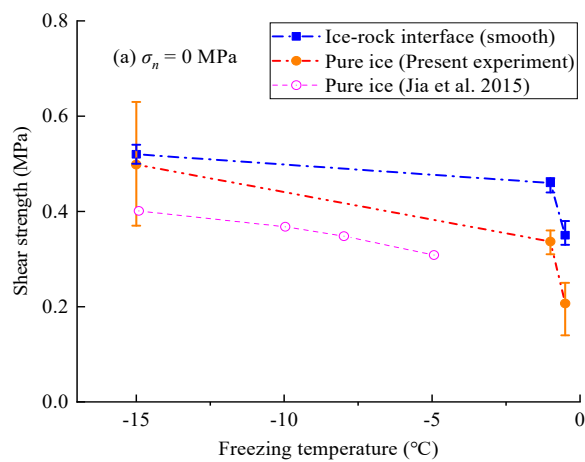
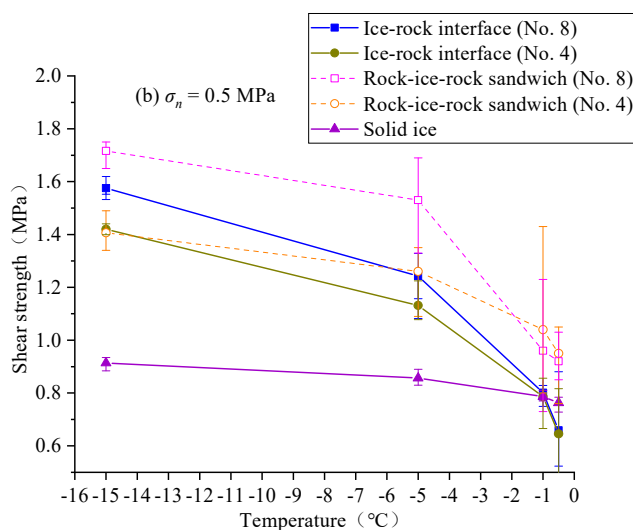
399 **Figure 20.** Influence of freezing temperature on the direct shear strength of ice and ice-filled joints. Experimental
 400 condition: $v = 0.2$ mm/min.

369 The test results show that the shear strength of smooth ice-rock bonding interface is larger than that of
370 pure solid ice at the freezing temperature from -15 to -0.5 °C (Fig. 20a). It implies that the shear failure
371 should be inside the solid ice instead of ice-rock interface. When the freezing temperature increase from
372 -1 °C to -0.5 °C, the shear strengths of the ice-rock interface and the solid ice reduce very quickly. Jia et
373 al. (2015) also claimed the same change law of solid ice against the temperature.

374 However, the experimental results show that the shearing failure of many rough ice-filled joints at -0.5 °C
375 is the debonding of ice-rock interfaces (Figs. 5, 11, 12, 17). More shear experiments were carried out on
376 rough ice-rock interfaces with profiles of No. 4 and No. 8 on the same experimental condition ($\sigma_n = 0.5$
377 MPa, $v = 0.2$ mm/min). It shows that the shear strength of rock-ice-rock “sandwich” is a little larger than
378 that of ice-rock interface, although the change laws of them against temperature are very similar. Another
379 novel finding is that the shear strength of ice-rock interface is larger than the shear strength of solid ice
380 itself below -1 °C (Fig. 20b). Therefore, the shear failure below -1 °C displays the cracking of joint ice
381 instead of ice-rock interface, and some aggregation areas of rupture ice occur before large bulges (Figs.
382 5, 11, 12, 17). However, the shear strength of solid ice is larger than that of ice-rock interface above -

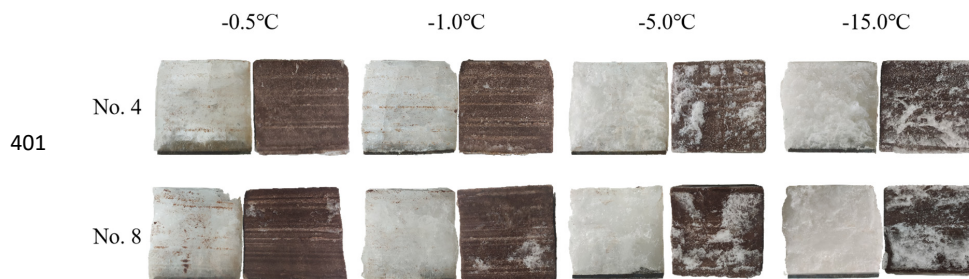
402 **Figure 21.** Shear failure characteristics of ice-rock interfaces under different temperatures. Experimental condition:
 403 $v = 0.2$ mm/min, $\sigma_n = 0.5$ MPa.

383 1 °C. This is the main reason for the shear failure of rough ice-filled joints along ice-rock interfaces at -
384 0.5 °C. The freezing temperature of -1 °C is the transition point of shear failure modes. Figure 21 presents
385 that the shear failure is along the ice-rock interface when the freezing temperature is approximate -0.5 °C,
386 however, the area of ice attached to the joints has a great increment with the decrement of freezing
387 temperature from -0.5 °C to -15 °C. It further illustrates that the shear strength of rough ice-rock interface
388 is larger than that of the solid ice below -5°C. Mamot et al. (2018) also found that the shear failure modes
389 of the smooth ice-filled joints changed from shearing cracking of joint ice to the debonding of ice-rock

390 interface when the freezing temperatures increased from -10 °C to -0.5 °C. The smooth joints have a little
391 ability to resist the shear slide of ice-filled joints. Mamot et al. (2018) claimed that three shear failure
392 modes may arise between -5 °C to -1 °C, including the debonding of ice-rock interface, shear cracking
393 of joint ice and their mixed mode. However, only the shear cracking of joint ice occurs at -5 °C to -1 °C
394 in this study. Therefore, the joint roughness has an effect on the shear strength of ice-filled joints and the
395 shear failure modes.

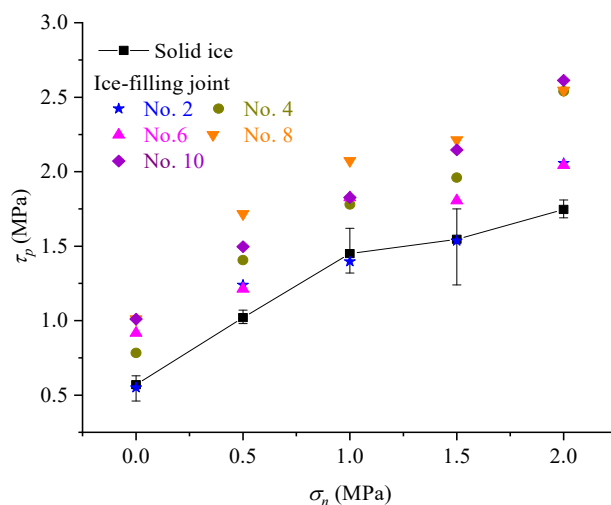
430
431 **Figure 22.** Shear failure characteristics of ice-rock interfaces under different normal stress. Experimental condition:
432 $v = 0.2\text{mm/min}$, $d = 2\text{ mm}$, $T = -15\text{ }^\circ\text{C}$.
